# Case Study

Flender gearbox 4<sup>th</sup> stage pinion tooth broken

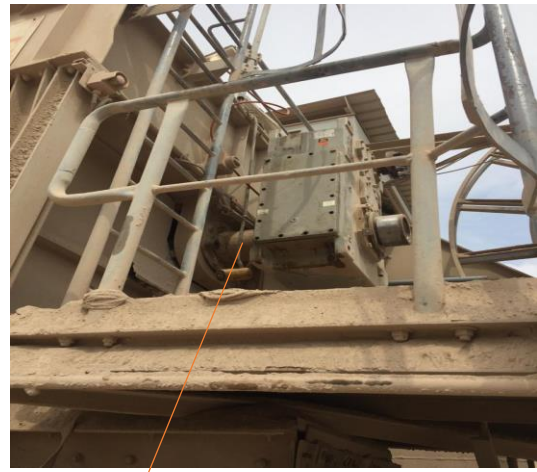
**Scrapper chain shaft**

Run out test was perform on the scrapper chain shaft, no run out was found. Alignment was found ok between the scrapper chain shaft and the gearbox.

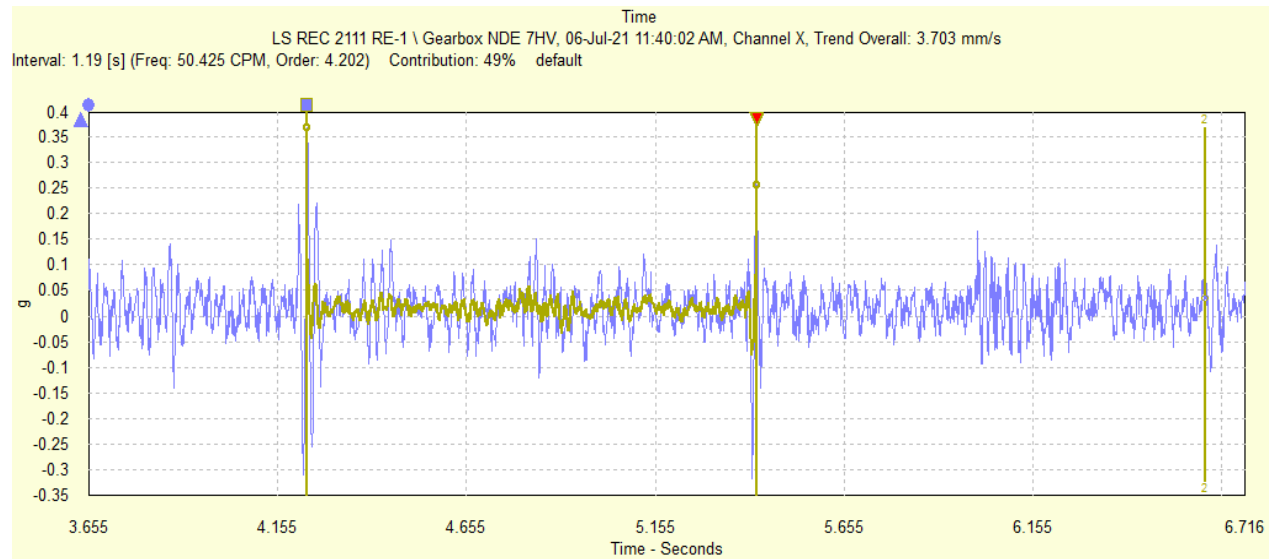
**Observation:** so in 2021 during the normal vibration data collection high impact was observed in the gearbox from fourth measuring position of the gearbox's the speed of the fourth pinion is very low i.e. 44RPM so we need a high resolution data to confirm the severity and possible defect. So a high resolution data was taken and a detailed vibration analysis was performed. As we all know time wave form is the best tool for gearbox analysis. During analysis It was observed that there is a continue impact in TWF with a difference of 44RPM.

TWF FOR FOURTH STAGE PINION CLEAR IMPACT WAS THERE WITH A DIFFERENCE OF 44RPM WHICH IS THE RPM OF FOURTH STAGE PINION.

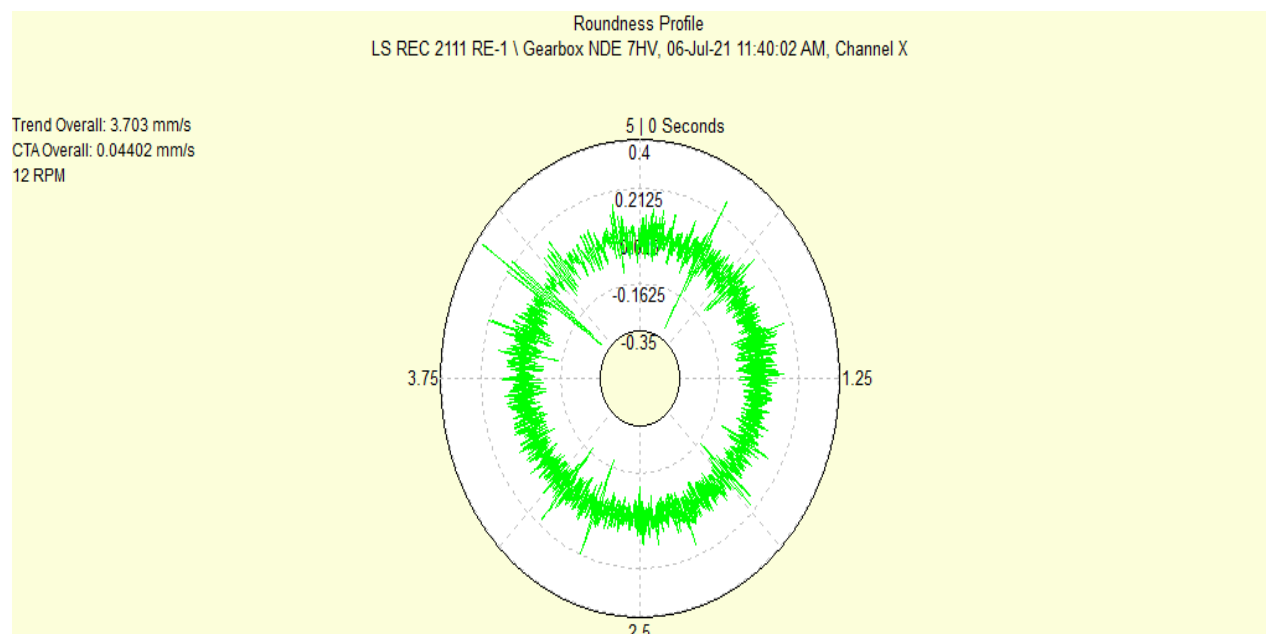
Roundness Plot for fourth stage pinion. Clear impact is there which indicates the broken tooth.

**Recommendation:** it was recommended to inspect the gearbox internals and plan for replacement.

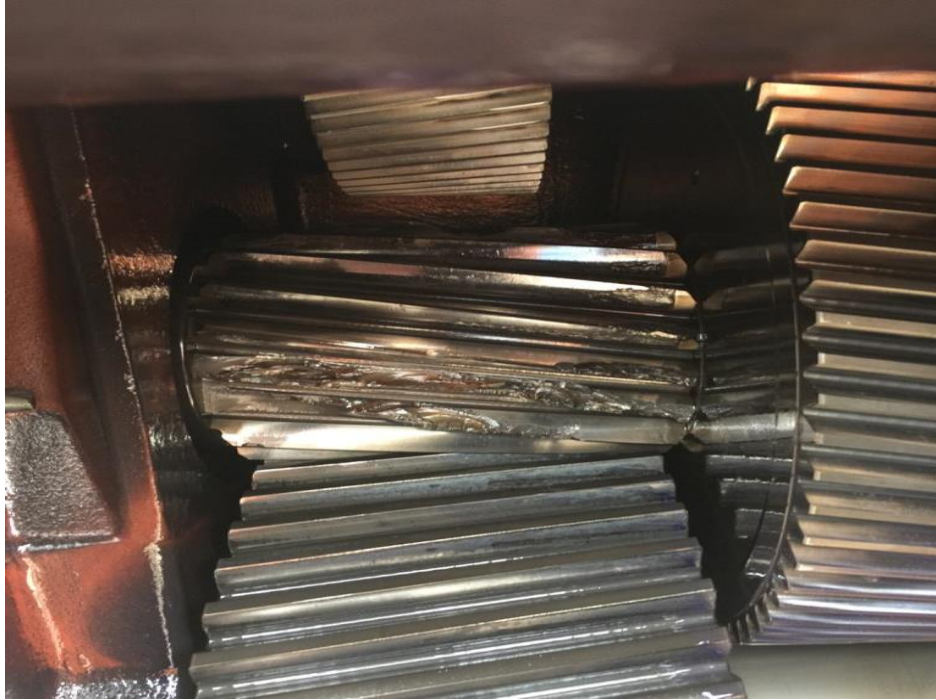
During the inspection broken tooth was found on fourth stage pinion.

So it's time to dig out the root cause failure of this gearbox as all the bearing and other internals are in good condition. And from the picture it was clear that there are high bending stress on this particular gear which caused the continue failure of this gear.

So a torque test was performed on the scrapper chain shaft with the help of strain gauge and a running torque 34,870Nm was found. But in manual this gearbox was designed for 31,672Nm so we have almost 3000 Nm extra where it's coming from?

OEM was called to answer this question, so finally we got our answer actually there are 52 bucket on the scraping chain their main function is to carry the hard limestone and feed it on to the conveying belt. so over the period of time these buckets got wear out and the local maintenance team repair the buckets with the hardex plates. So here is the root cause by repairing, each bucket weight was increased which caused the overloading of the gearbox and ultimately tooth failure due to continue overloading.

So we can't replace a bad bucket every time with new one because of production demand, so we convinced the OEM by our process and operation parameter to supply us a high rating gearbox with increased service factor and torque. After many technical discussion they supply us next suitable size of gearbox according to our technically specification. And this new gearbox is performing well since 2021.
