## Sop( C ) hot pump (2) report

| unit | Equipment name | Motor details | Pump details | Iso 10816-3 |
|---|---|---|---|---|
| SOP (C) | HOT PUMP (2) | 160 KW | Center hung pump | Normal 4.5 mm/sec |

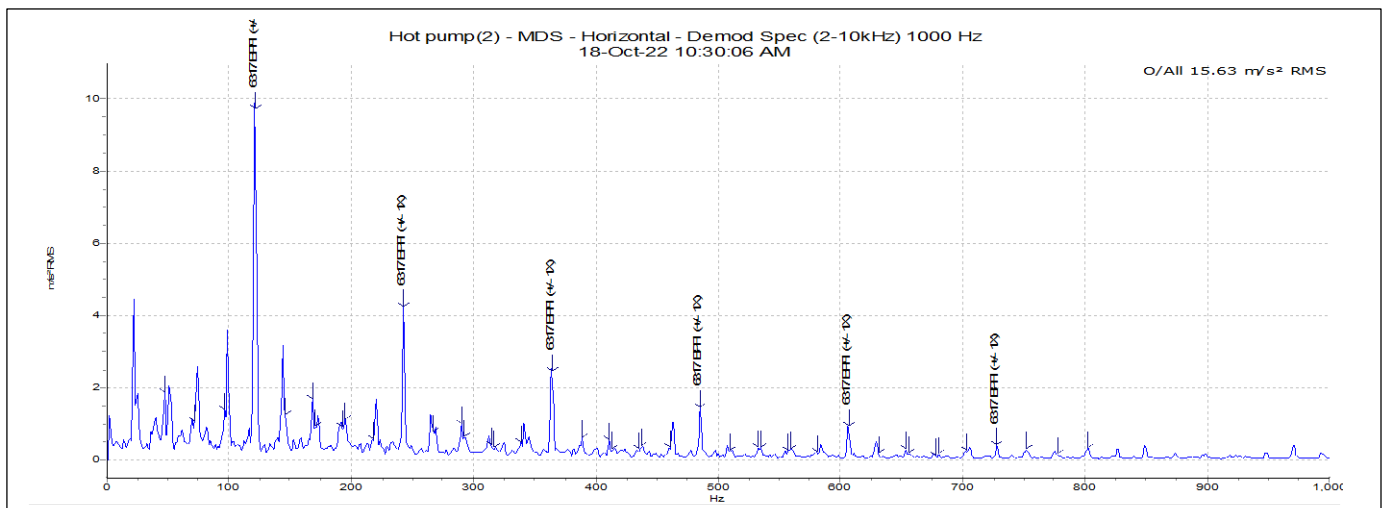
1. As per ISO 10816-3 standards, the health status of the machine is in Critical condition.
2. The maximum vibration acceleration (Arms) value is **18.39 m/s<sup>2</sup>** at motor DE bearing in Horizontal direction.

1. Acceleration signatures representing peaks at inner race frequencies which indicates the
2. Failure of bearing inner race.

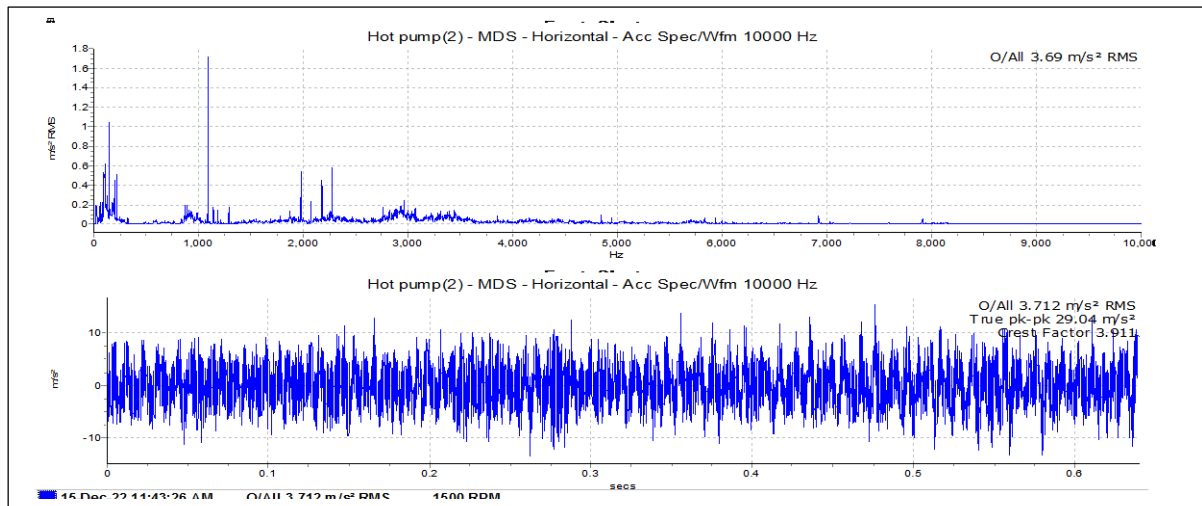
After change bearing acceleration reduced to **3.69 m/s<sup>2</sup>** as shown in figure below:

1. But we find high Velocity signatures representing dominant peaks which indicates the symptoms of cooked bearing.
2. The maximum vibration velocity (Vrms) value is **7.0 mm/sec** at motor DE bearing inHorizontal direction.

### We make decision to check bearing installation

- 1-After removing motor drive side housing there is bad interference bearing with shaft
- 2-After solving the problem the maximum vibration velocity (Vrms) value is **2.8 mm/sec** at motor DE bearing inHorizontal direction.

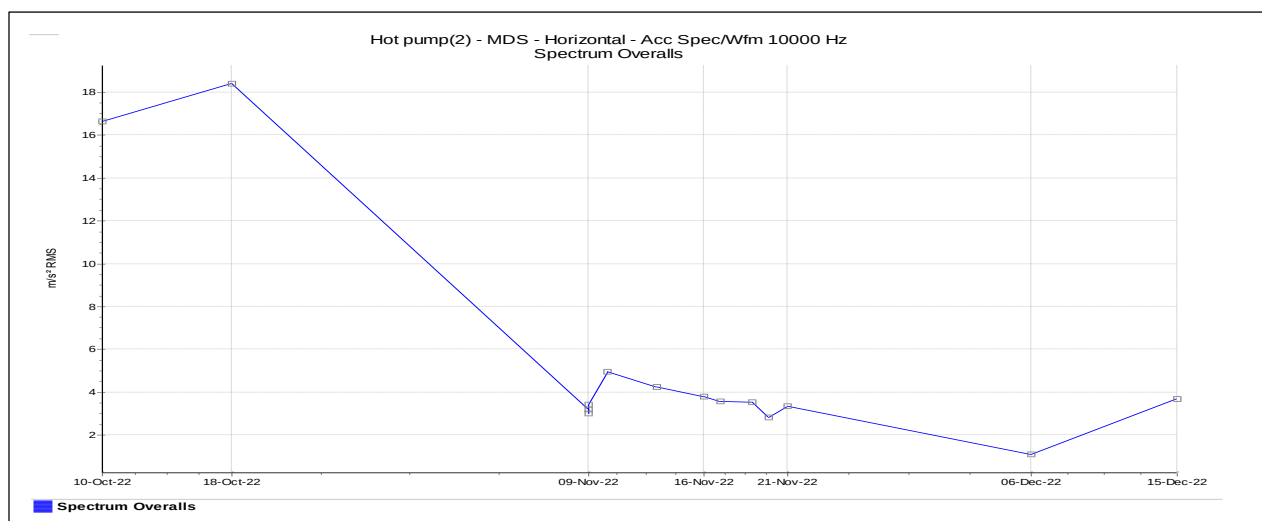
Find the trend of acceleration

| Measuring location | Direction | Before | After |
|---|---|---|---|
| | Acceleration | 18.2 m/s <sup>2</sup> | 3.8 m/s <sup>2</sup> |

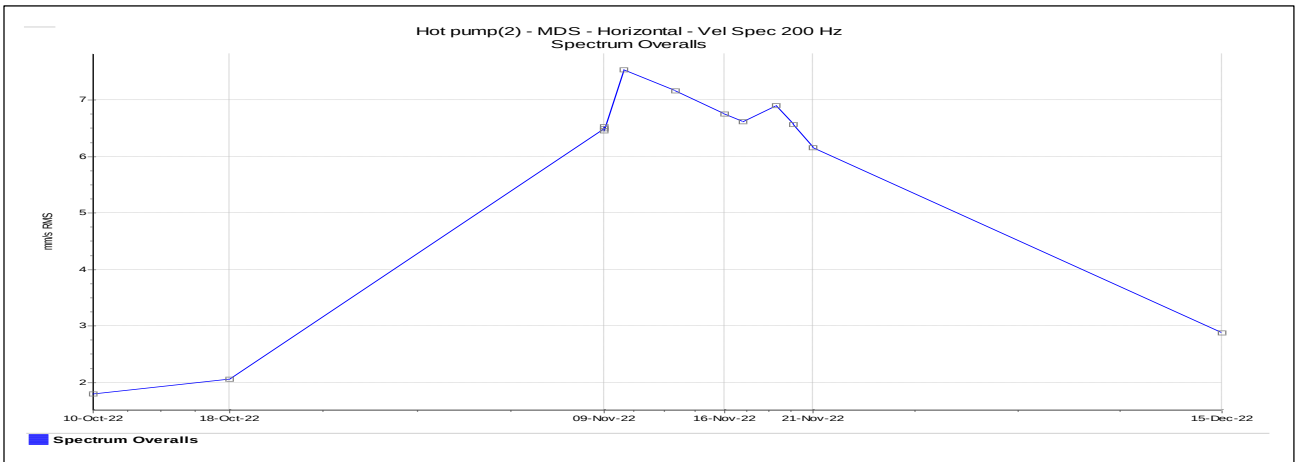
Find trend of velocity

| Measuring location | Direction | Before | After |
|---|---|---|---|
| MDE | H | 7.0 mm/sec | 2.8 mm/sec |
| | V | 4.5 mm/sec | 1.3 mm/sec |

The pump now operate in comfort zone
