# Case study – Ball mill, 2023

AMPs Reliability Gate Report

Kulemølle Øst

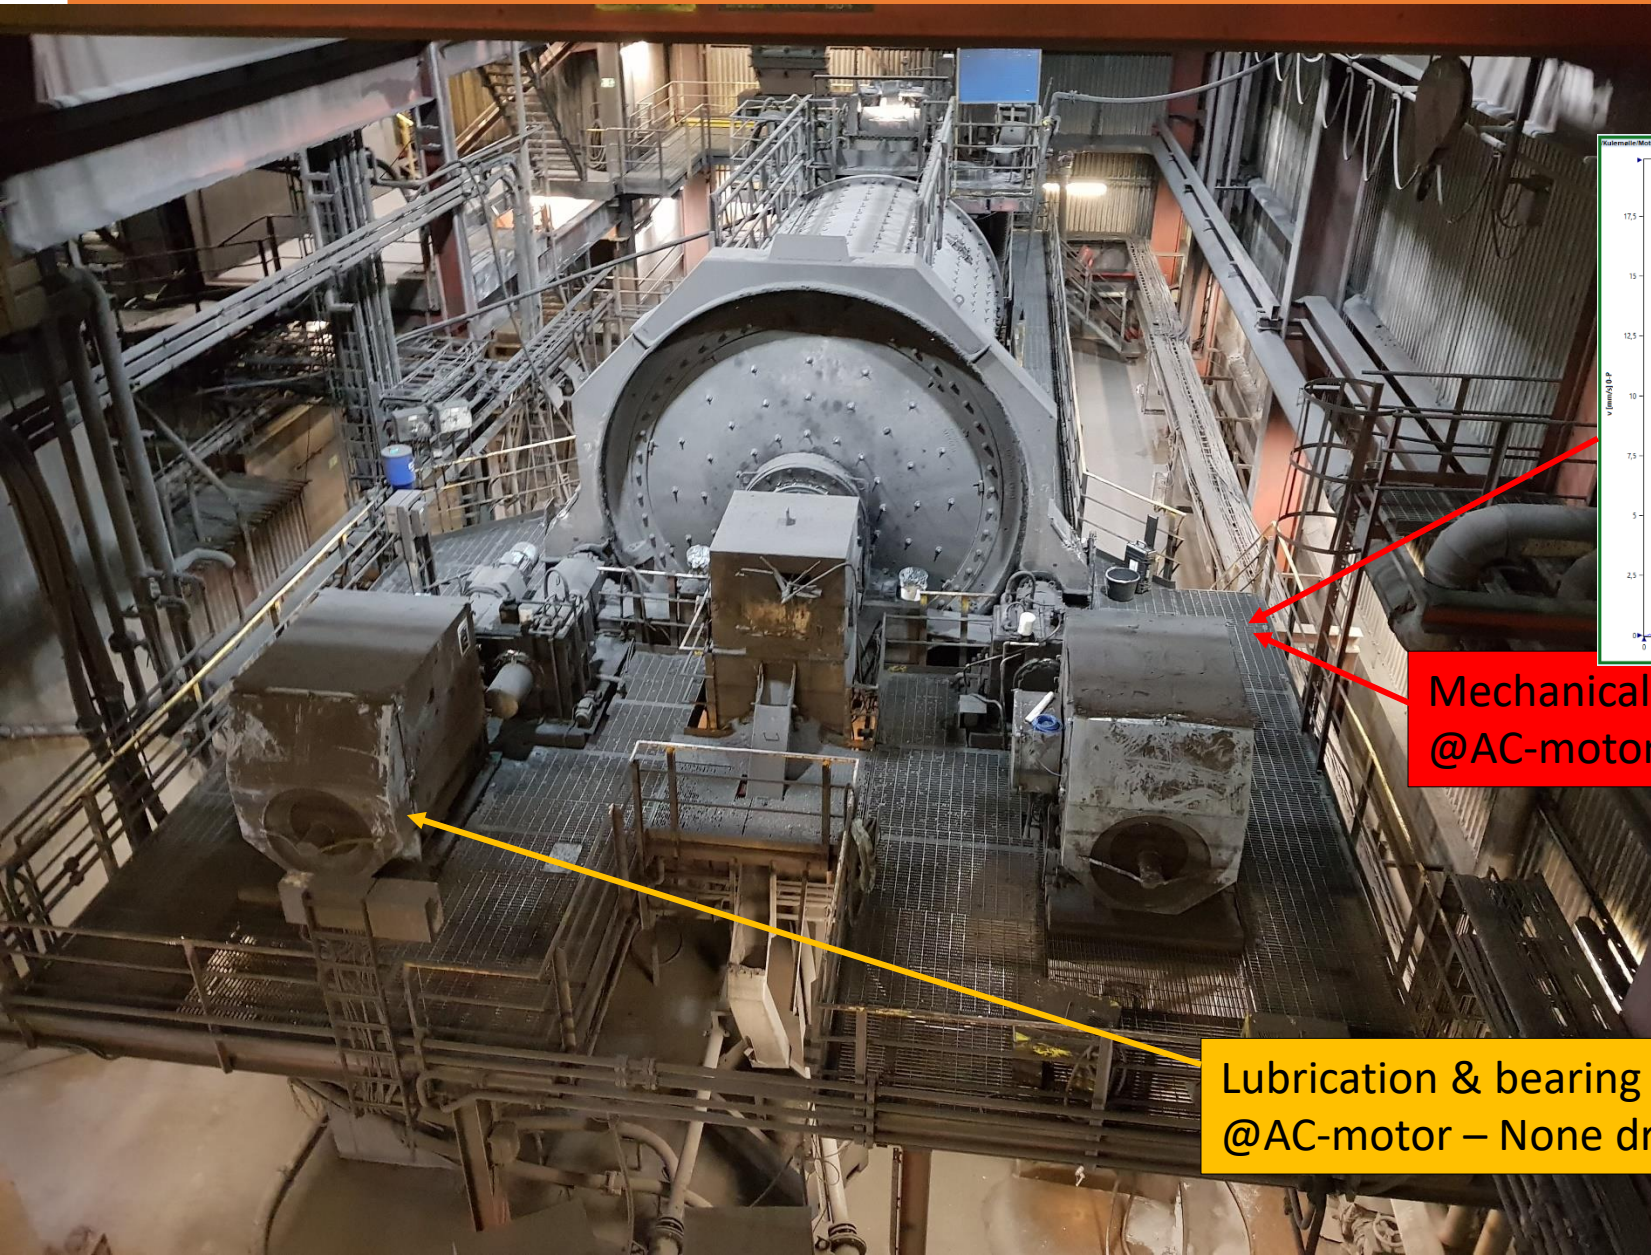
Mechanical / rotating loosenes  
@AC-motor – drive end

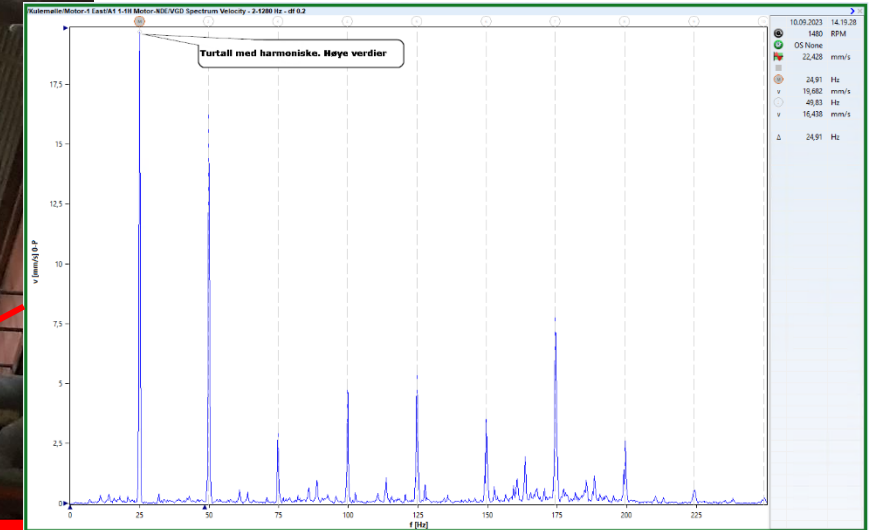
Lubrication & bearing wear (BPFO)  
@AC-motor – None drive end

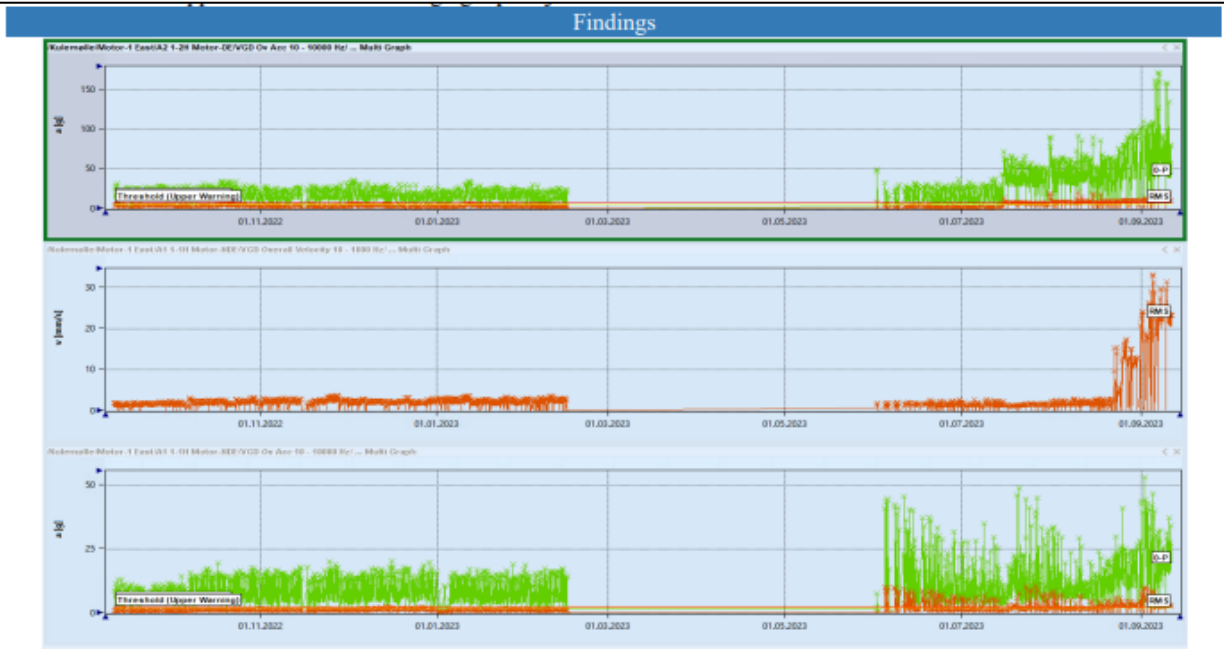
Alarm report

| Findings | Machine Component | Diagnostic | Severity | Prognostic & RUL | Confidence |
|---|---|---|---|---|---|
| No. 1 | Lager DE og NDE | Looseness - Alvorlig slitasje på maskinen | S4 | Maskinens levetid reduseres RUL <2% | 90% or Higher |

rapporterer om hørbar støy fra motoren.

Vi ser i overhalingsrapport fra  at det er foretatt arbeid i lagerhus/isolasjon. Dette kan være en mulig årsak til looseness-mønsteret, dersom isolasjonen er løst. Dette må kontrolleres/bekreftes.

- By studying the motor drawing, we suspect the bearing housing to be loose. Please inspect.

Det anbefales å stoppe motoren for feilsøking og reparasjon.

- Motor should be stopped to avoid breakdown

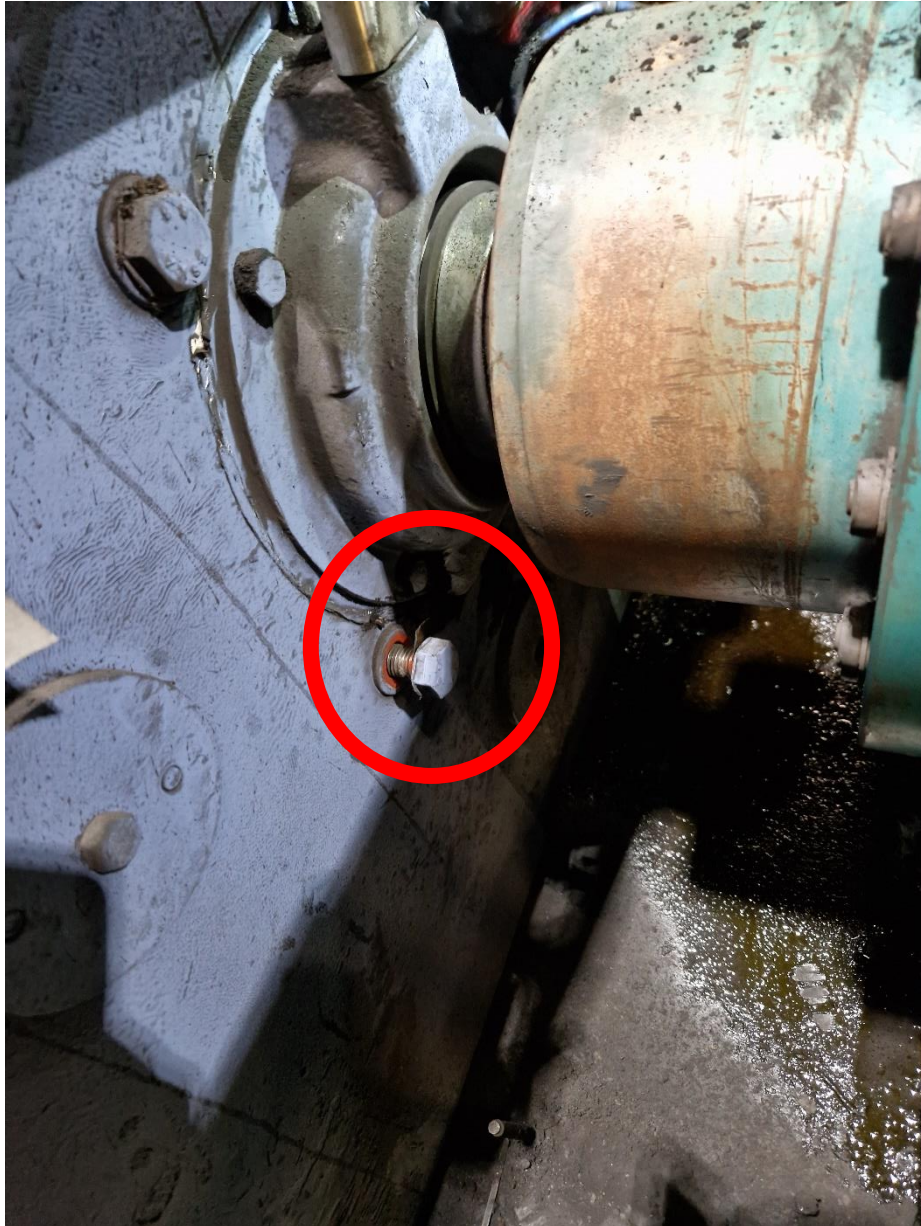
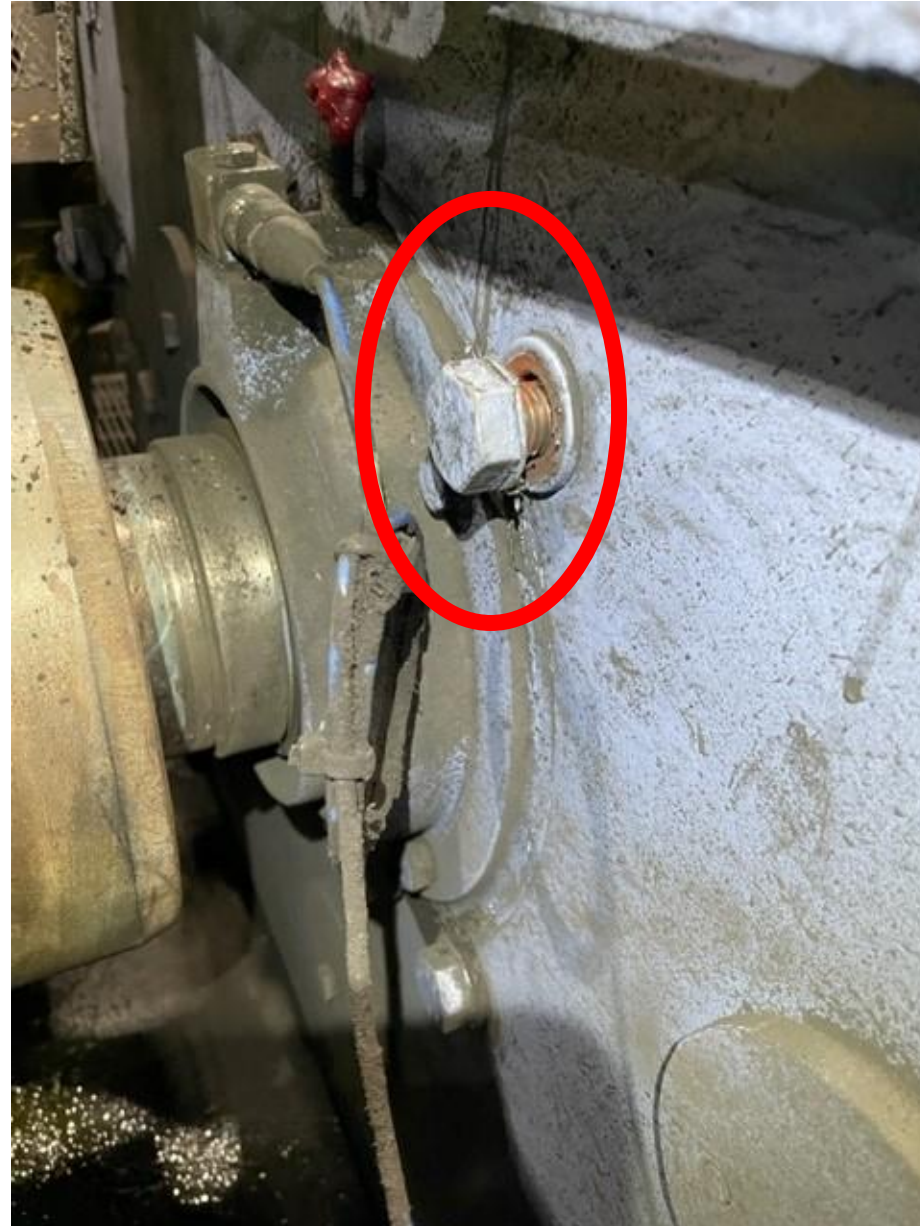
- All 4 bolts loose on the bearing housing. Pictures at next page.

- Tighten the loose bolts.

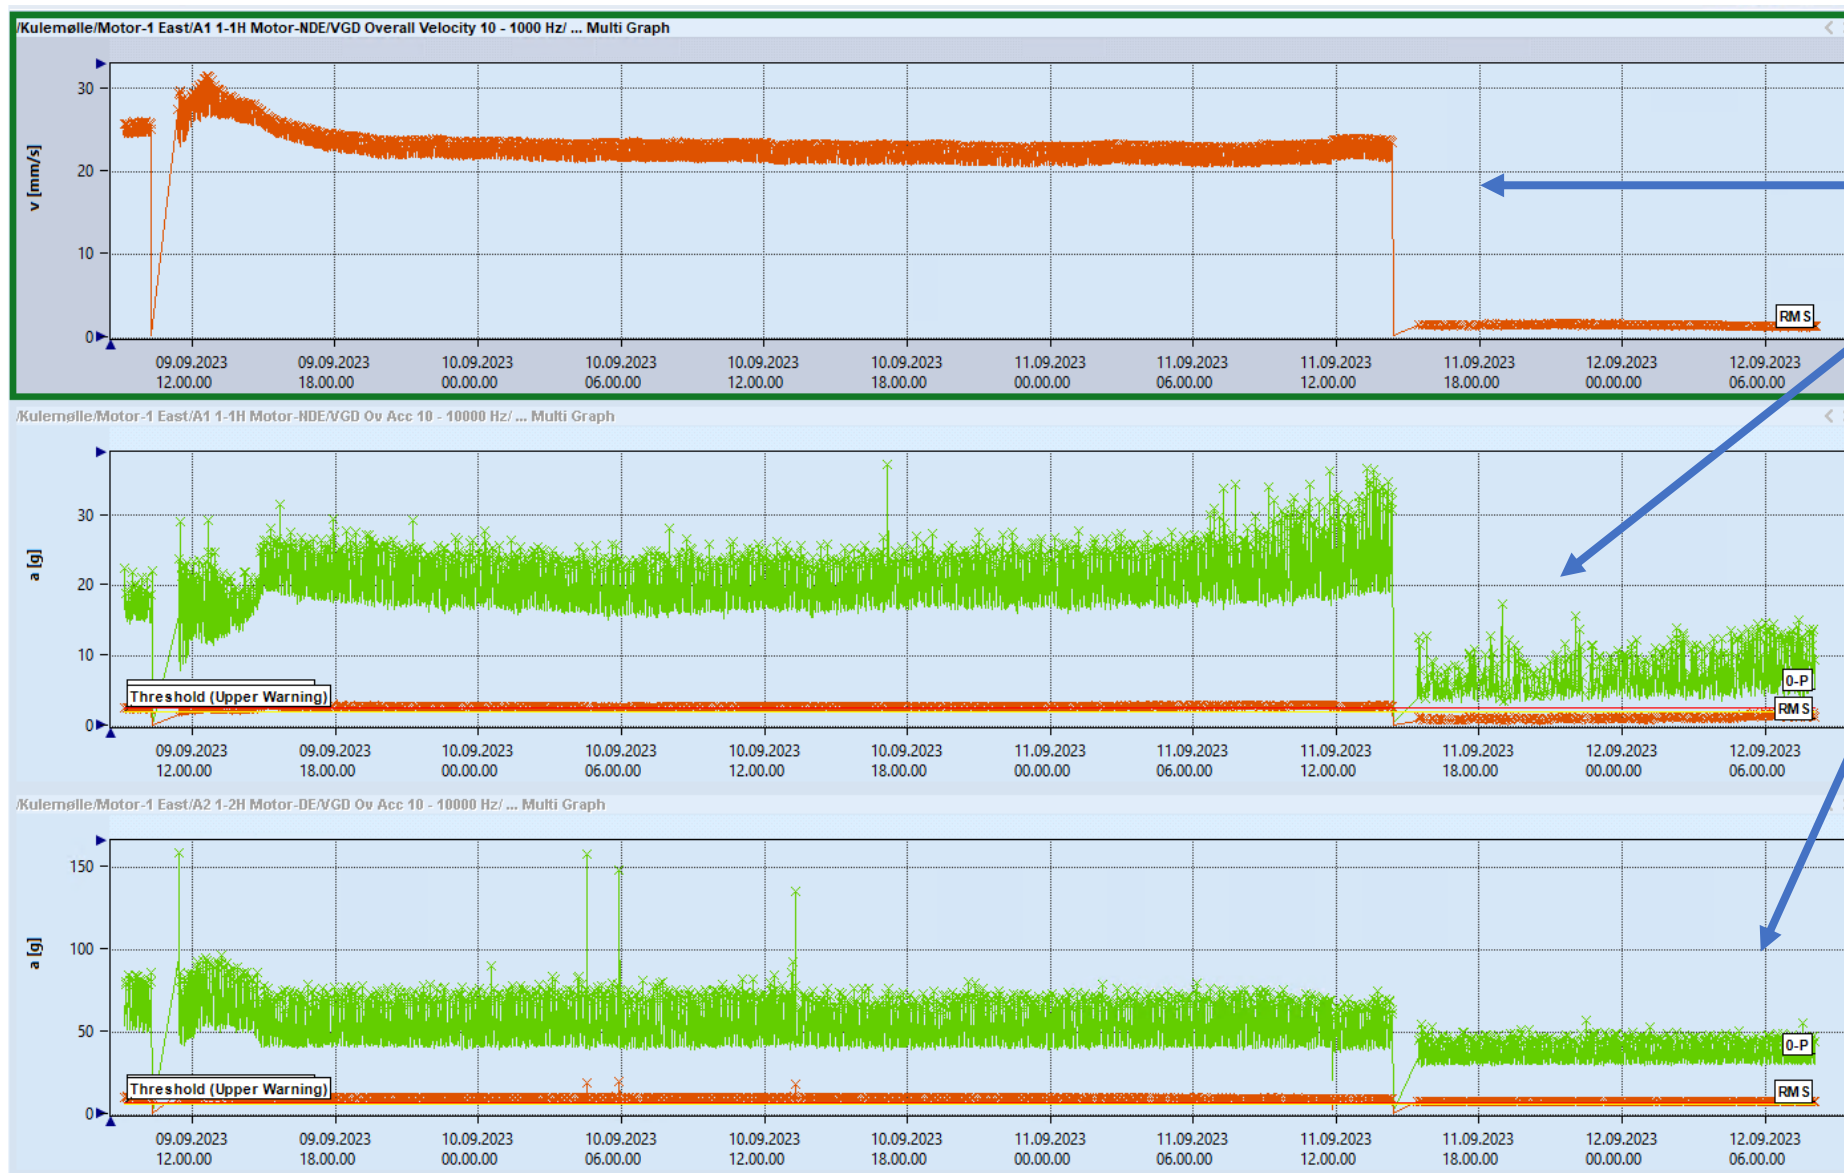
Drop in vibration after bearing housing was tighten !!!
