# CHW Pump No.2 Vibration Analysis Case Study Report

# CHW Pump No.2

## ANALYSIS REPORT

| Description | | | |
|---|---|---|---|
| Machine | CHW Pump No.2 | | |

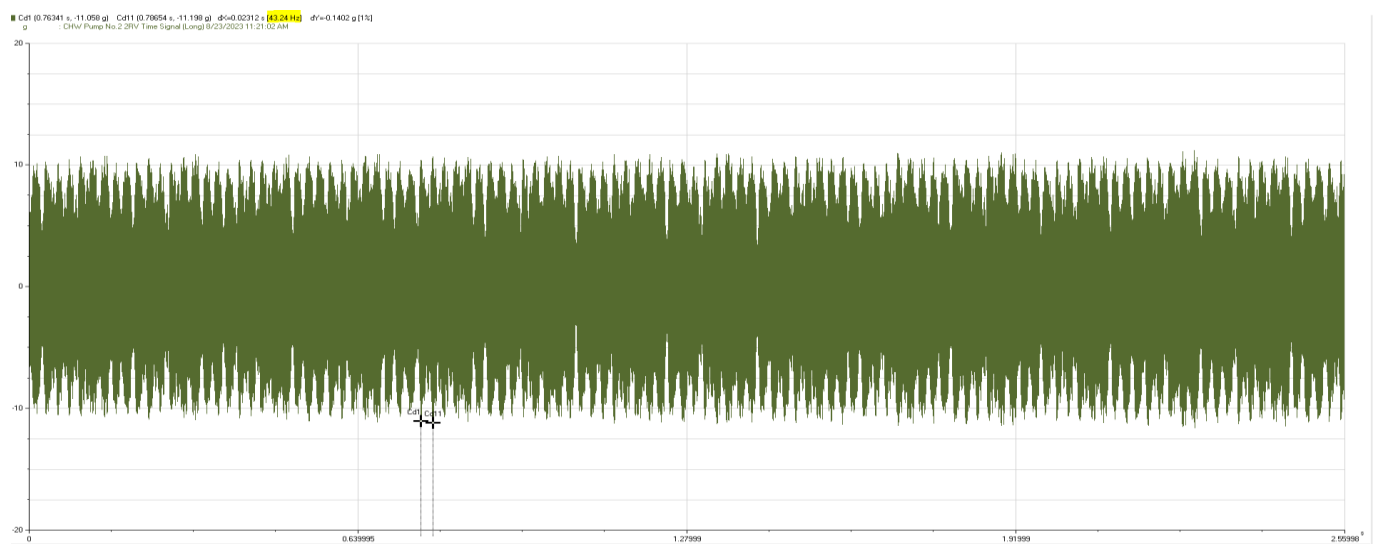
The time waveform analysis displayed modulation and impacting with a delta frequency of 45.26 hz equating to BPFO (Outer Race Defect)

The highest pk-pk value is 22g's increasing from 13g's.

The raw vibration time waveform above displays a high noise level with non-synchronous impacts. The delta frequency of the impacts equates to 43.24 hz with an amplitude of 22g's pk-pk.

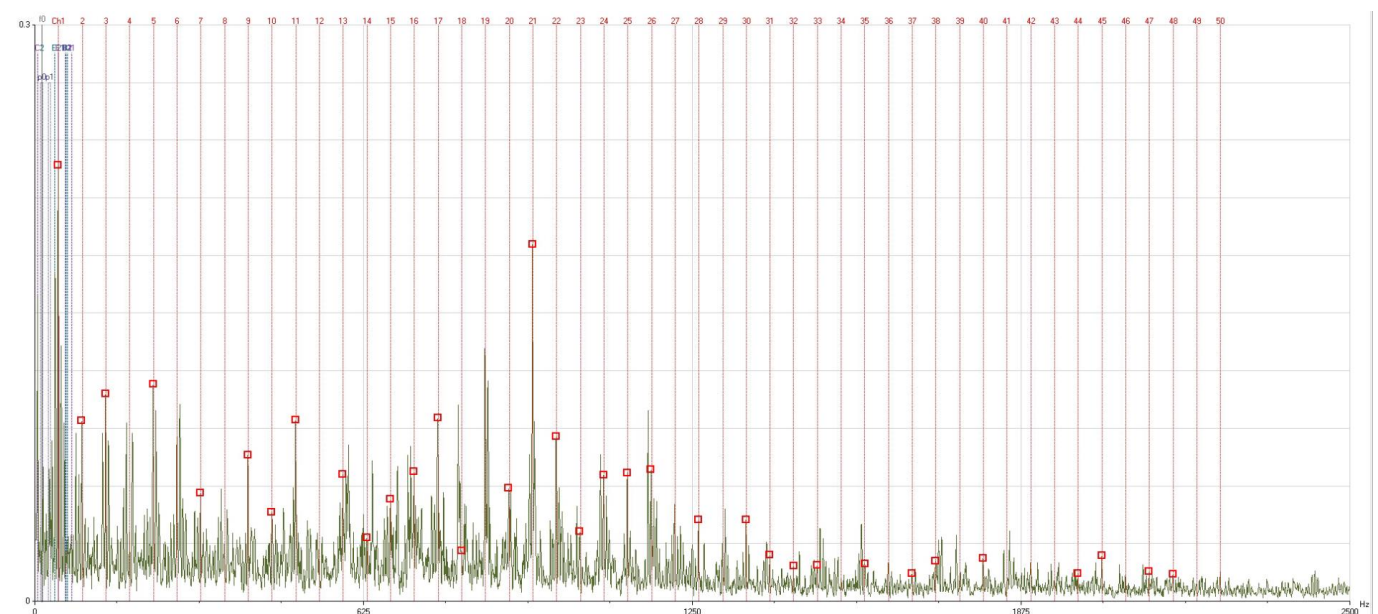
The motor DE bearing spectra displayed non-synchronous harmonics of BPFO (Outer Race Defect) at 45.26 hz, and each fundamental BPFO harmonics had sub-synchronous sidebands equating to the FTF bearing defect frequency at 5.65 hz.

Additionally, suspect bearing fluting is occurring due to the number of sidebands and electrical noise surrounding the BPFO fundamental frequencies.

The envelope spectrum above displays the non-synchronous harmonic of BPFO (Outer Race Defect) at 45.26 hz with sub-synchronous sidebands equating to the FTF-bearing (Cage defect frequency) at 5.65 hz.

Our recommendation would be to ensure a correctly specified VFD-rated motor is installed, examine the motor earth and ensure it is sufficient and correctly earthed or install ceramic/insulated bearings.

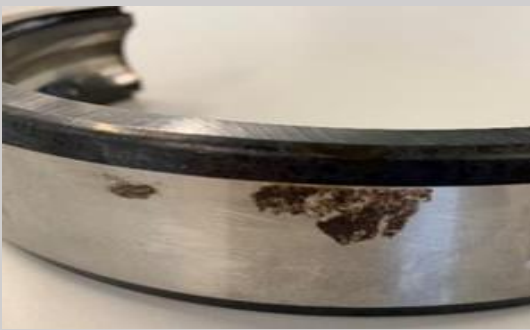
| Bearing Inspection – Outer Ring Housing Interface | |

Inspection of the housing interface of the outer race showed evidence of localised fretting corrosion. The inner race mounting interface was in good condition.

| Bearing Inspection – Outer Ring Housing Interface | |
|---|---|
| | Evidence of localised fretting corrosion visible with a reddish-brown oxide colour |

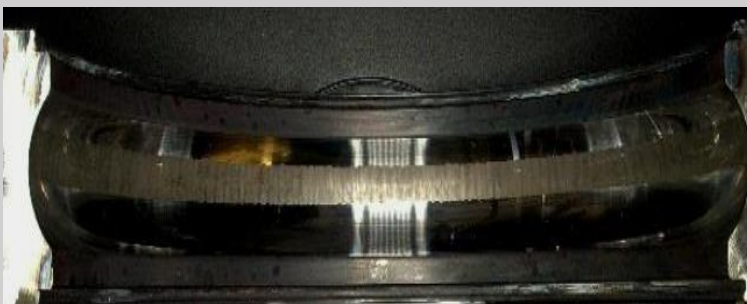
| Bearing Inspection – Outer Ring Housing Interface | |
|---|---|
| Bearing Inspection – Outer Raceway Running Surface | |

The motor bearing (location unknown) was found to have evidence of electrical fluting damage on both inner and outer raceways, probably caused by the variable frequency drive (VFD) supplying the motor.

| Bearing Inspection – Outer Ring Housing Interface | |
|---|---|
| | Evidence of electrical fluting damage on outer raceways |

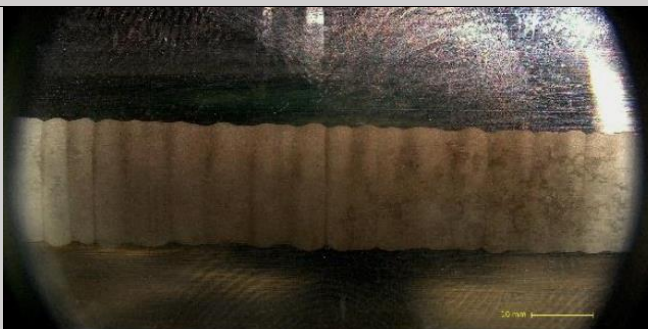
| Bearing Inspection – Outer Ring Housing Interface | |
|---|---|
| | Close up of electrical fluting damage on outer raceways |

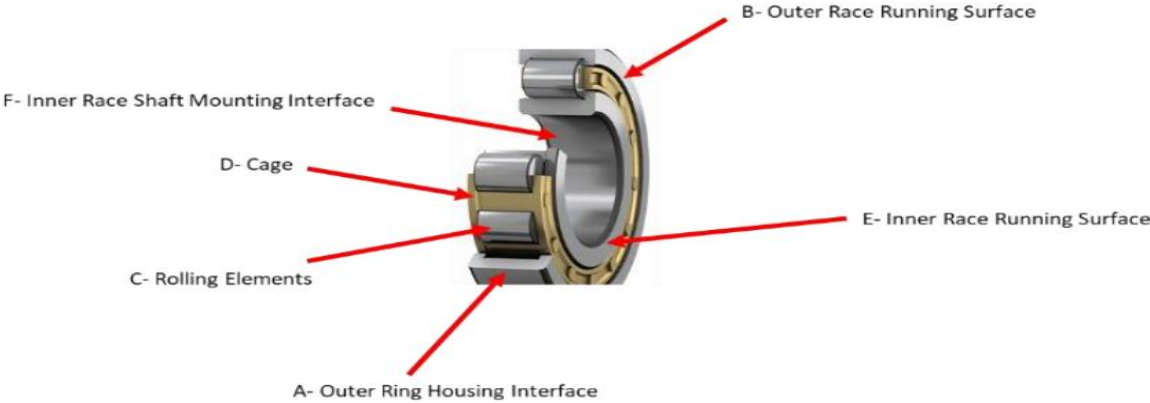
| Bearing Overview | |
|---|---|
| Overview of Inspected Condition | |

| A- Outer Ring Housing Interface | Localised fretting corrosion |
| B- Outer Race Running Surface | Evidence of electrical fluting |
| C- Rolling Elements | All rolling elements are discoloured |
| D- Cage | Good Condition |
| E- Inner Race Running Surface | Evidence of electrical fluting |
| F- Inner Race Shaft Mounting Interface | Good Condition |

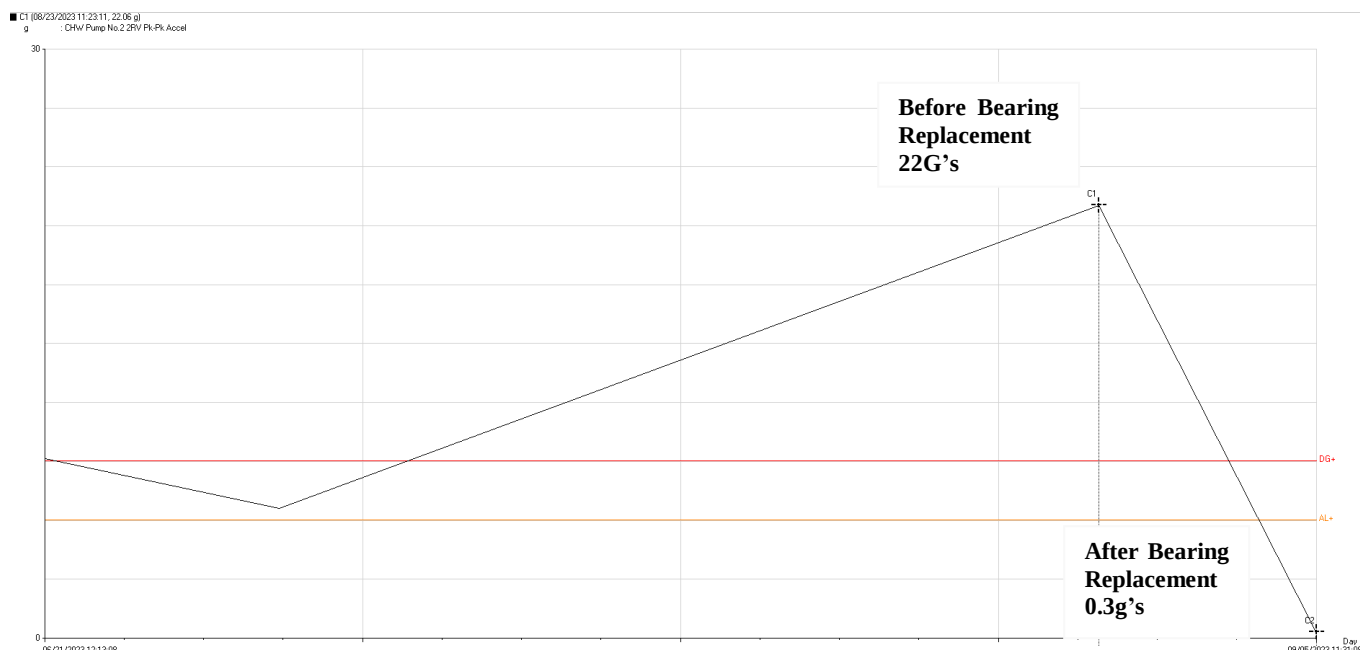
The vibration trend above (overall PK-PK G's) displays a clear decrease in vibration 'G' levels (22g's – 0.3g's) following the motor bearing replacement on the 26<sup>th</sup> of August 2023.

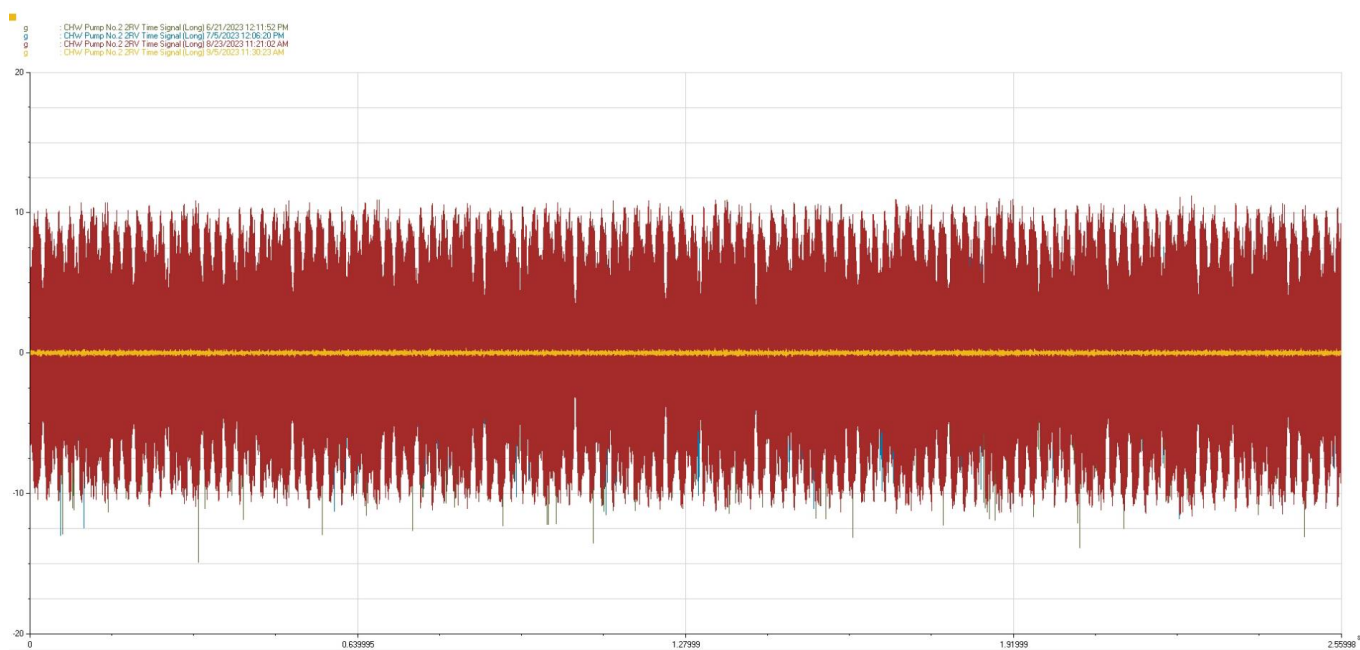
The merged time waveform above contains the previous four data sets from the Motor DE displaying a decrease in vibration values and friction levels following the motor bearing replacement on the 26<sup>th</sup> of August 2023.
