# HYDRAULIC POWER UNIT FAILURES

## 1. Worn Jaw Coupling

## 2. Worn Gear Pump

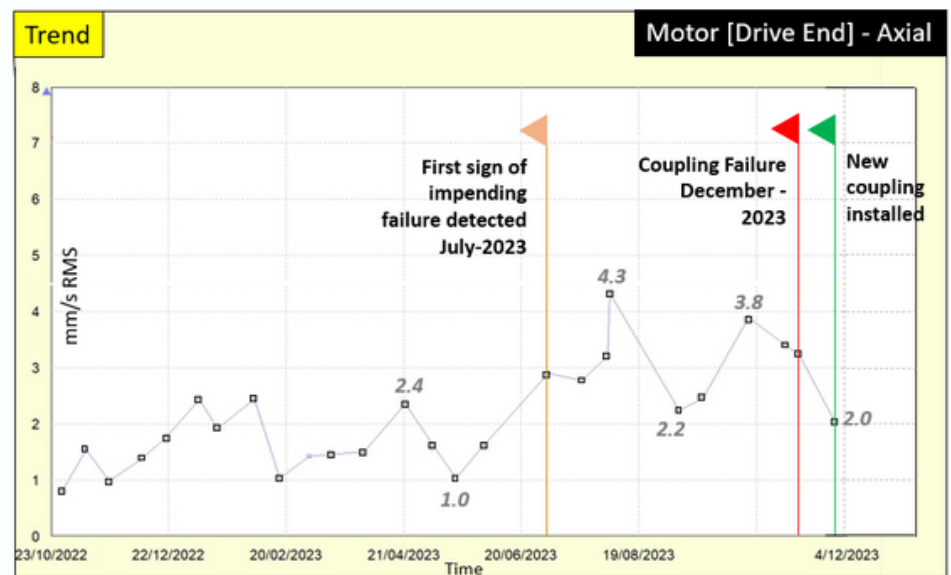
Figure 1

**Beware of overall vibration values!**

Don't expect a sharp increase in vibration levels. A 50% increase of regular vibration with the motor and pump in a healthy state is enough to raise the flag. A two-fold increase means something is wrong.

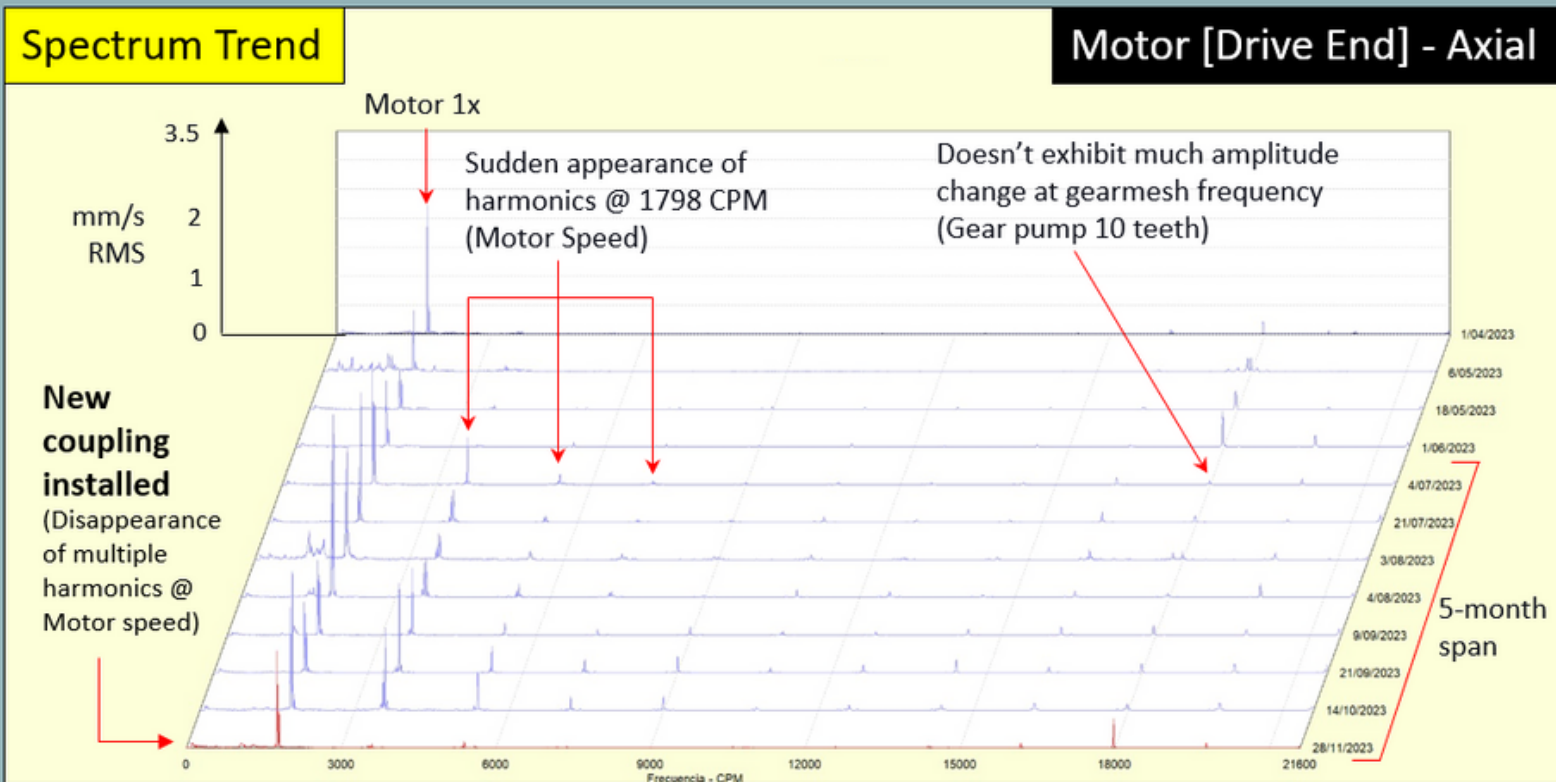
Figure 3

The sudden appearance of shaft harmonics indicates looseness.

According to references, a bearing loose on its housing bore exhibits higher amplitude at 3x or 4x. A glance at the spectrum lets us rule out that option.

The coupling and gear pump are the other possible sources of looseness downstream of the motor. Since the gearmesh frequency amplitude is primarily unaffected, the vibration has to come from the coupling.

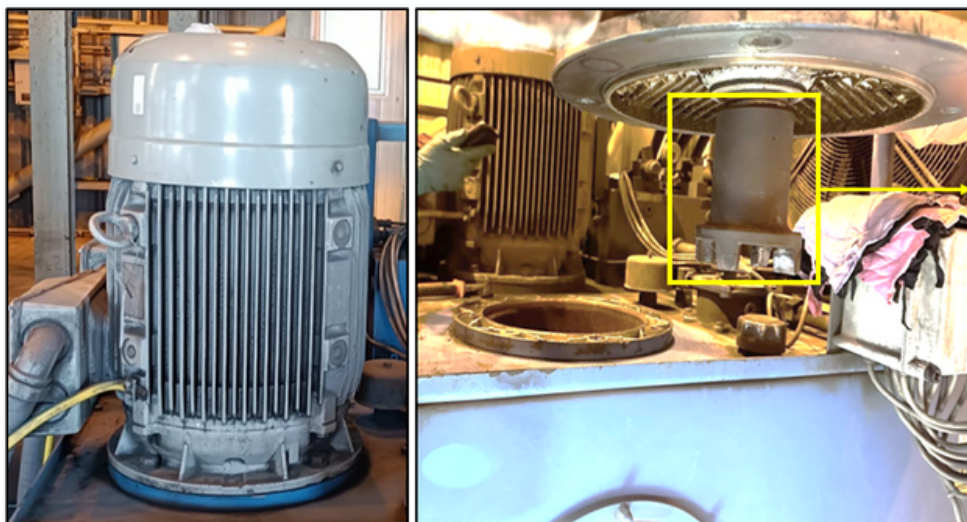
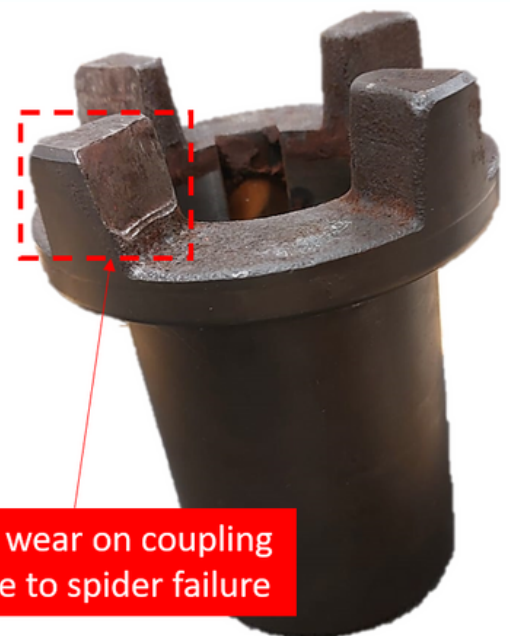
Figure 4

## Repair Inspection

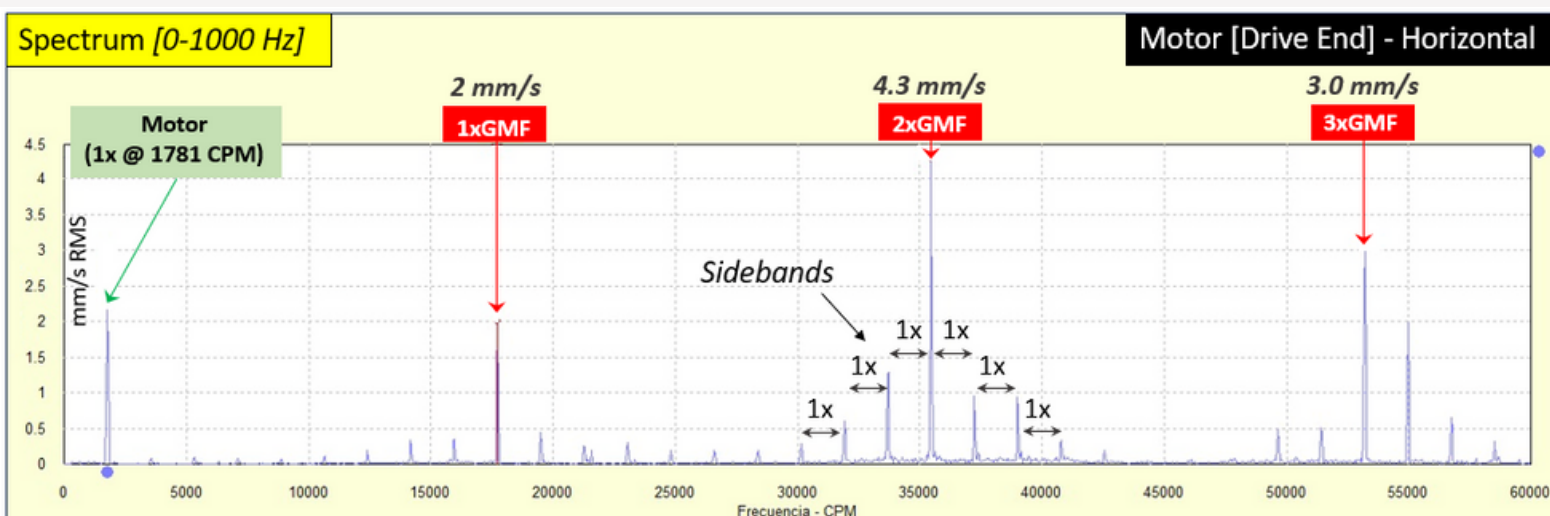
Figure 6

Compared to the spectrum related to a worn-out coupling, this spectrum shows the gearmesh frequency dominant with the 2x and 3x harmonic. Moreover, there are several sidebands around GMF, which suggests a strong modulation of gear mesh.

Also note the amplitudes of GMF, which are approximately equal to or higher than the amplitude at 1x (1781 CPM)

The characteristics described above point towards wear inside the gear pump.

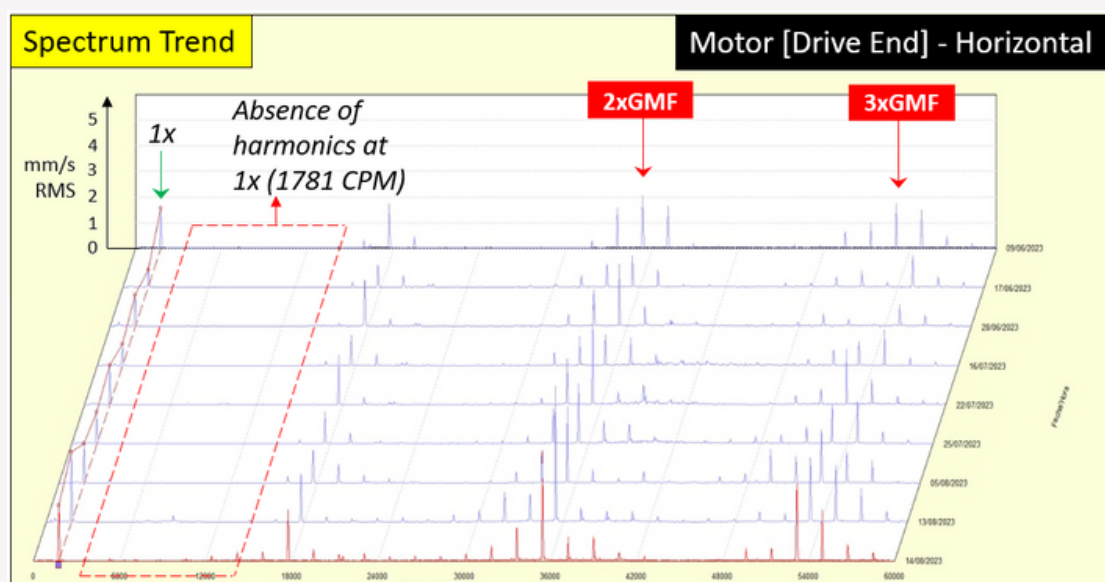
Figure 7

Note that the spectrum doesn't show the motor shaft speed harmonics and that the amplitude reached at GMF is significantly higher than the one in Figure 3.

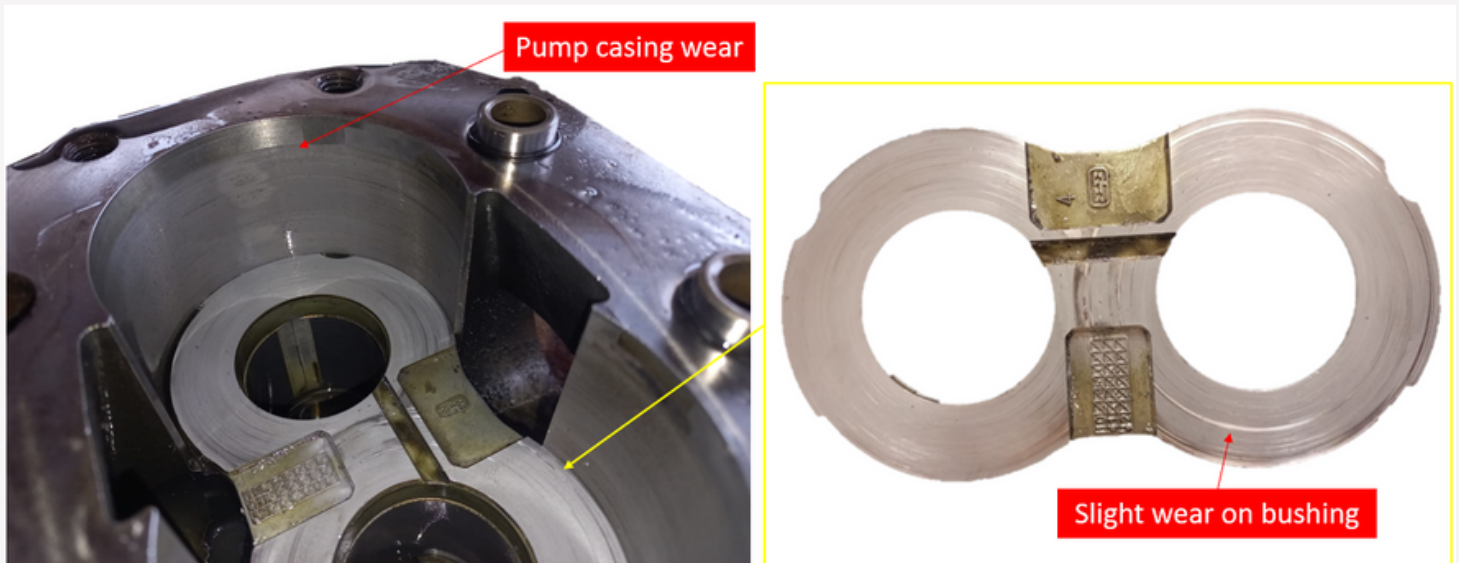
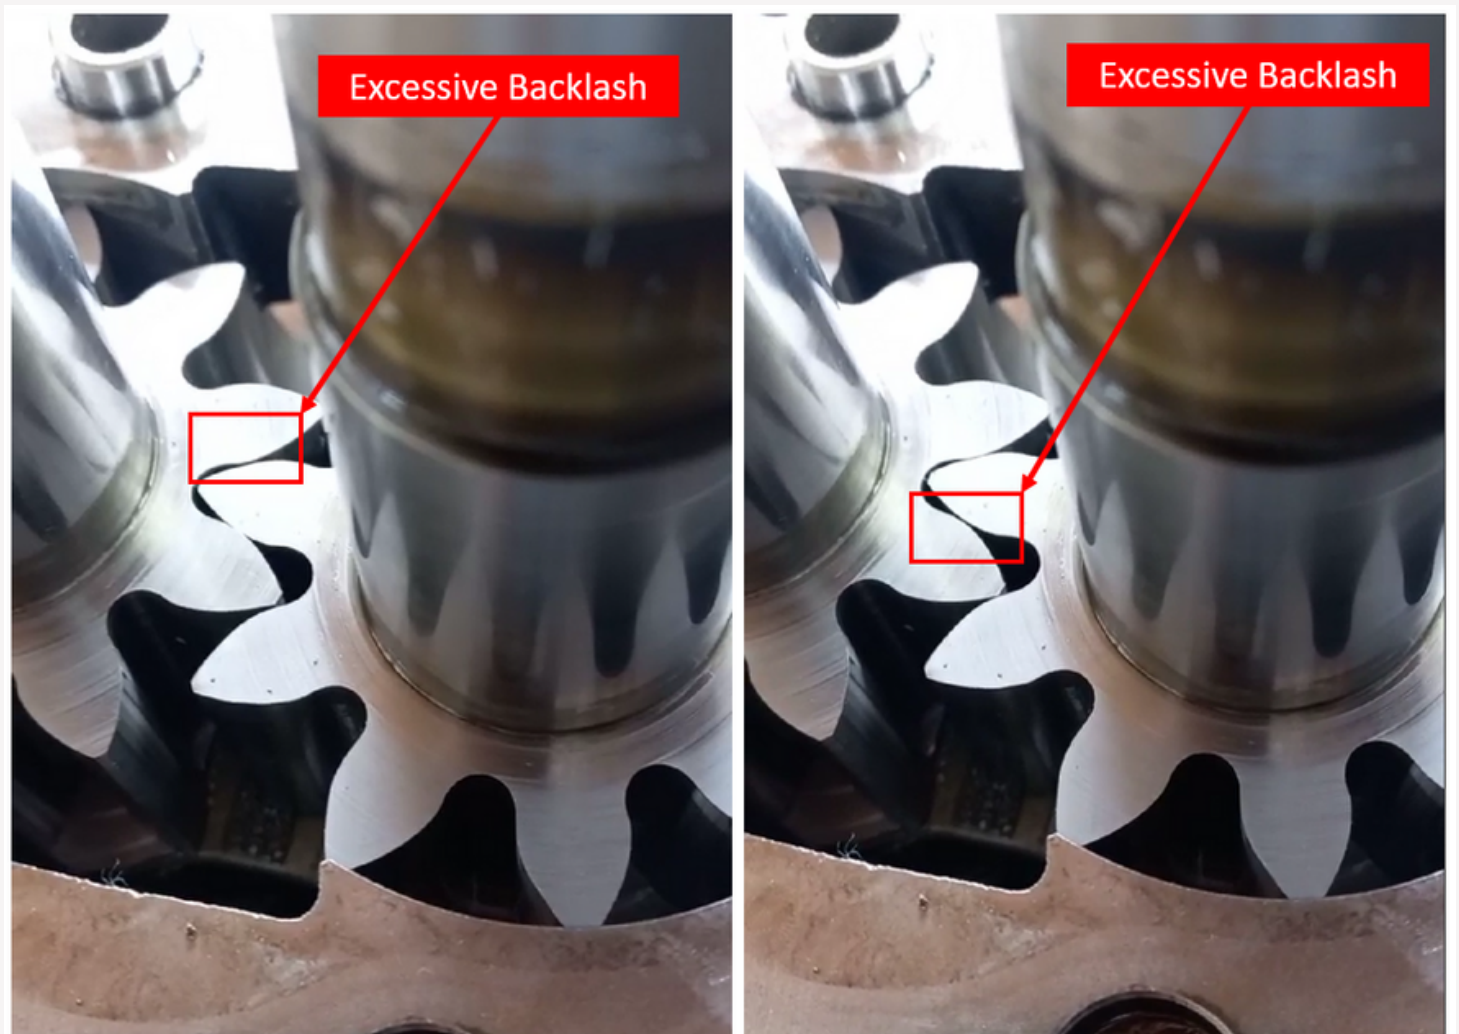
Figure 8

Upon inspection, the repair crew found excessive backlash due to wear. This condition was diagnosed correctly with vibration analysis.
