# Knowing your Frequencies

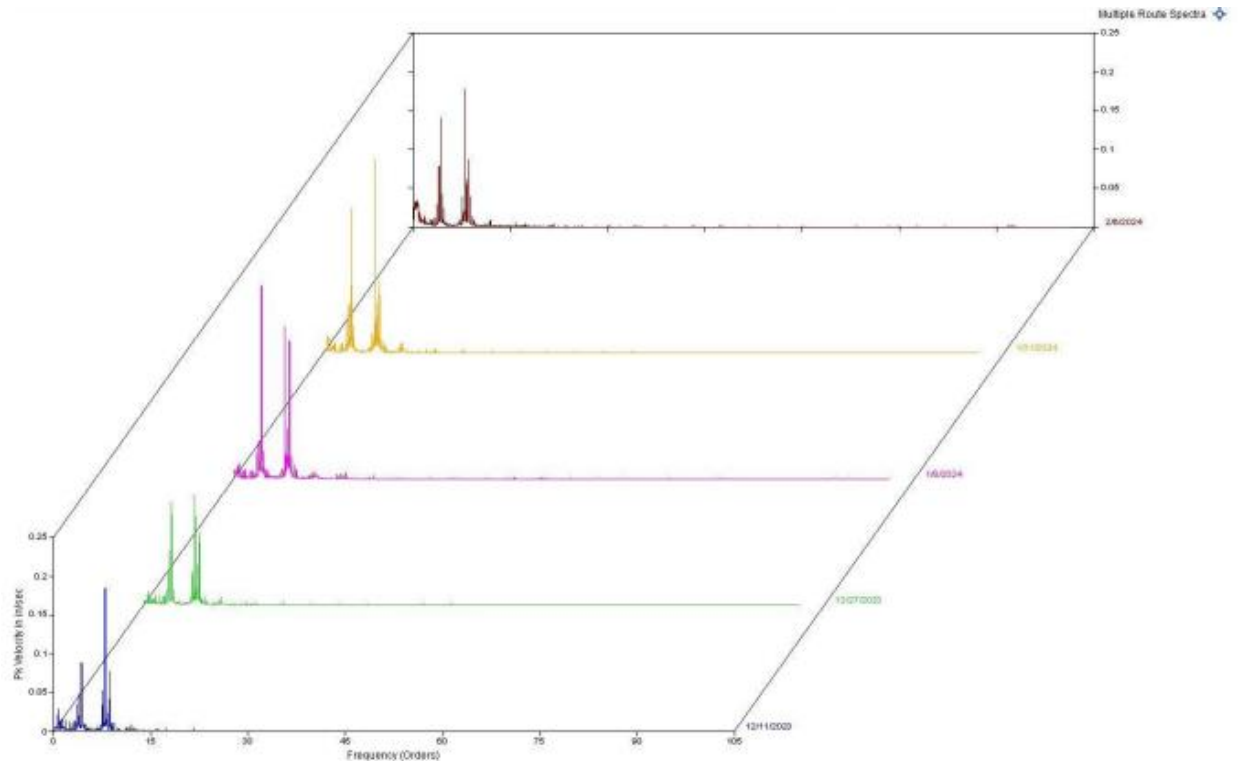
A recent vibration report indicated an issue with the gearbox and recommends replacement. This was the plot that I was shown. An initial view of the plot would indicate the report would be correct and since the 2<sup>nd</sup> peak was elevated it would suggest gear misalignment.

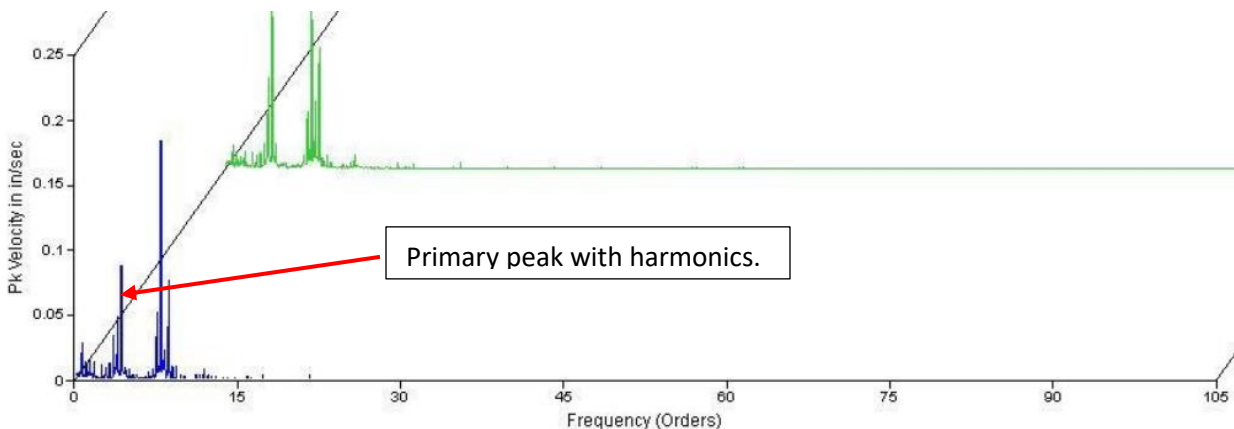
However, when you blow this up so you can see the frequencies a little better as seen below there are a few things that popped out to me.

Looking at the frequency plot of the output data it seems to show the primary peak is around 4.3 Orders. So the second peak would suggest some type of misalignment because it was higher than the primary frequency. Basic vibration education tells us that is the correct pattern assumption. But gear mesh

When we discussed this plot what I found out was the default speed for this location was set at 225 rpm thus the 4.3 order frequency when in fact it was running at 57.7 rpm. If we do the math based on the indicated orders from the software it came out to 4.332 orders times default speed this equals 974.7 cpm. As we continued the discussion I was told the side band frequencies around these peaks were spaced at 80 cpm.

As the primary peak was identified in CPM the conversation using the correct output speed data it came out to 17 times the actual running speed at the output location. The side bands that were spaced around these primary peaks were all equally spaced at 80 cpm which again suggested a possible internal shaft speed but not likely with an output speed of 57 cpm. You will also need to consider the resolution of the spectrum so the 80 cpm peaks could be a few cpm above or below this frequency.

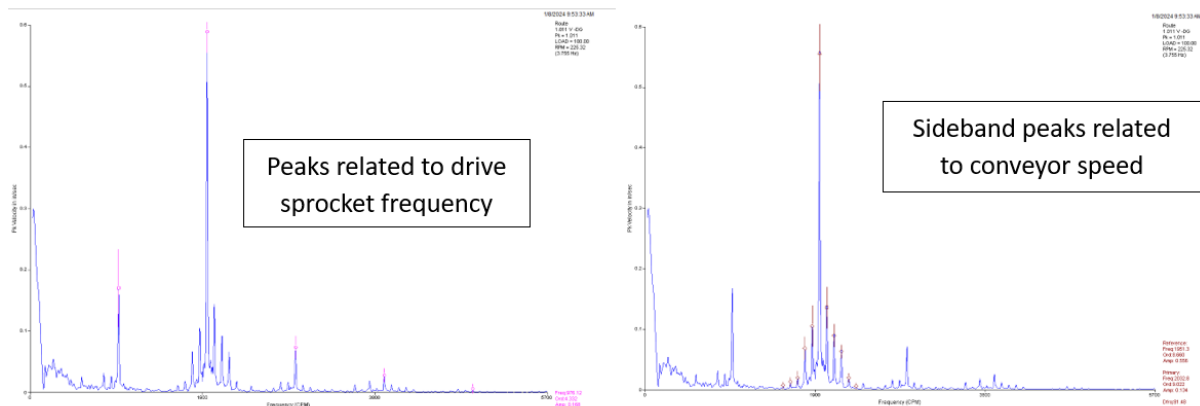
What was being shown was the 17 times the output speed with harmonics was not a gear issue but the drive sprocket frequency of this conveyor. The elevated 2<sup>nd</sup> harmonic suggests sprocket misalignment. The most recent data also shows a total of 5 harmonics of this frequency all surrounded by the 80 cpm side bands. The harmonics also suggest a possible loose-fitting sprocket since the number of harmonics were increasing. The following plot shows the primary peak with the harmonics indicated.

As I did a little more research on the conveyor what was also found was the conveyor speed was 79 feet per minute. To me this will explain the side band frequencies we were seeing around the second peak.

Check the sprocket alignment, wear, run out and drive chain tension. Inspect the internal drag chain for proper tension and paddle wear. Make the needed adjustments or repairs.

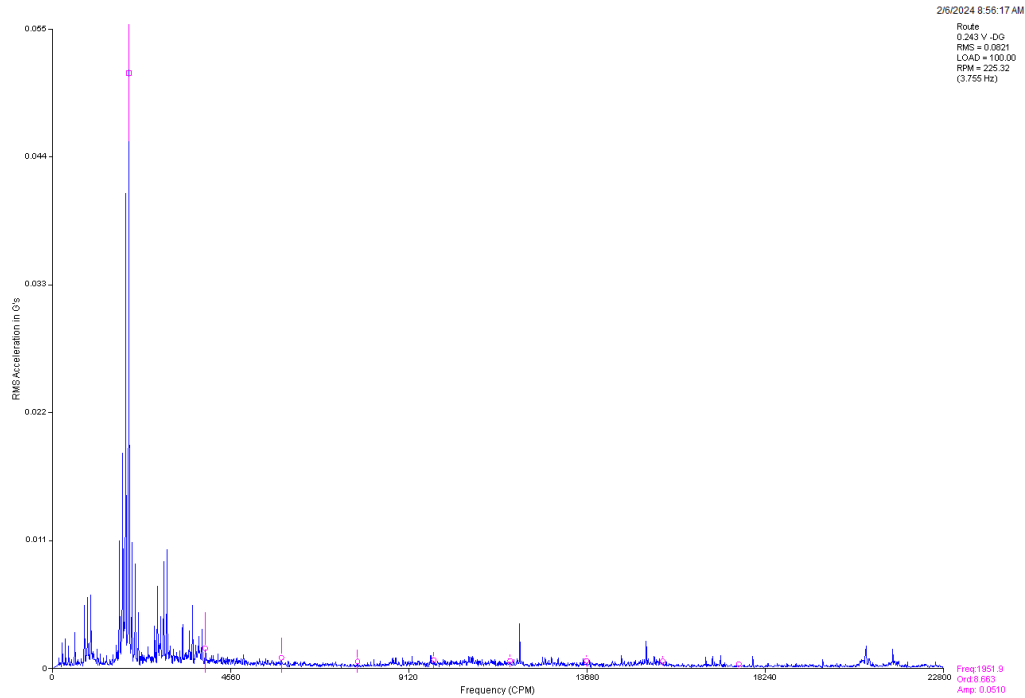
This is where the research of the machine and its components comes into play. It takes time to gather this information, but it pays high dividends in the end and helps you make correct recommendations. However just because some of these things line up it is still worth screening the data against known frequencies and vibration rules. When we go through all the possible frequencies in the gearbox we will find that the intermediate shaft bearing TMK 6576C/6535 has an BPFO of 1955 cpm when the input speed of the gearbox is 1790 cpm. So, if we look at the 2<sup>nd</sup> primary peak of the spectrum which is 1952 cpm we could argue that is the bearing outer race frequency so there is a bearing defect in the gearbox. However, if we look at the spectrum in acceleration below then you would expect to see harmonics of this frequency in the upper frequencies. As we are taught in vibration classes the bearing defect begins in the upper frequencies then as they get worse the harmonics will progress into the lower frequencies. This rule is not supported in the data we must work with.

The one for the bearing is circled and then the current gear mesh frequency is also circled with the harmonics. As we look at the vibration data we have the gear mesh frequency is not showing up and neither are the harmonics. Then again when we look at the listed bearing frequencies the BPFO is close to the 2<sup>nd</sup> harmonic of drive sprocket frequency but no other harmonic of that frequencies in the upper range of the spectrum. Another thing to look for is the side band frequencies of 80 cpm. That frequency

is not showing up in any of the known frequencies in the gearbox. If the original peak was related to gear wear the rules we are taught is the side bands are related to the shaft speed of the one of the gears. There is a rule that tells us there can be a peak in the lower frequencies between the gear shaft speeds and the 1<sup>st</sup> gear mesh frequency known as the Gear Natural Frequency and that will have sidebands spaced at the speed of the shaft with the bad gear. In this case we do not have any peaks shown at 3327 cpm or its harmonics and we have no side band peaks spaced at 57 cpm the output shaft speed of 237 cpm the intermediate shaft speed. Therefore based on the data we must work with that issue can also be ruled out.

Based on the knowledge of what is in the gearbox and the known frequencies they should generate and the rules we are taught in our vibration education the only frequencies that match up are the drive sprocket frequency of 974 cpm and harmonics of that frequency. The known conveyor paddle/chain frequency of 79 feet per minute.
