# Vibration analysis Report

## Line-1 CEMENT MILL -2 Z2M06 CM2 LIFTING SIDE

**Subject:** - On 03.05.2025, vibration readings were taken at the rated RPM of the above equipment, and it was observed that the gearbox input vibration and acceleration levels had increased.

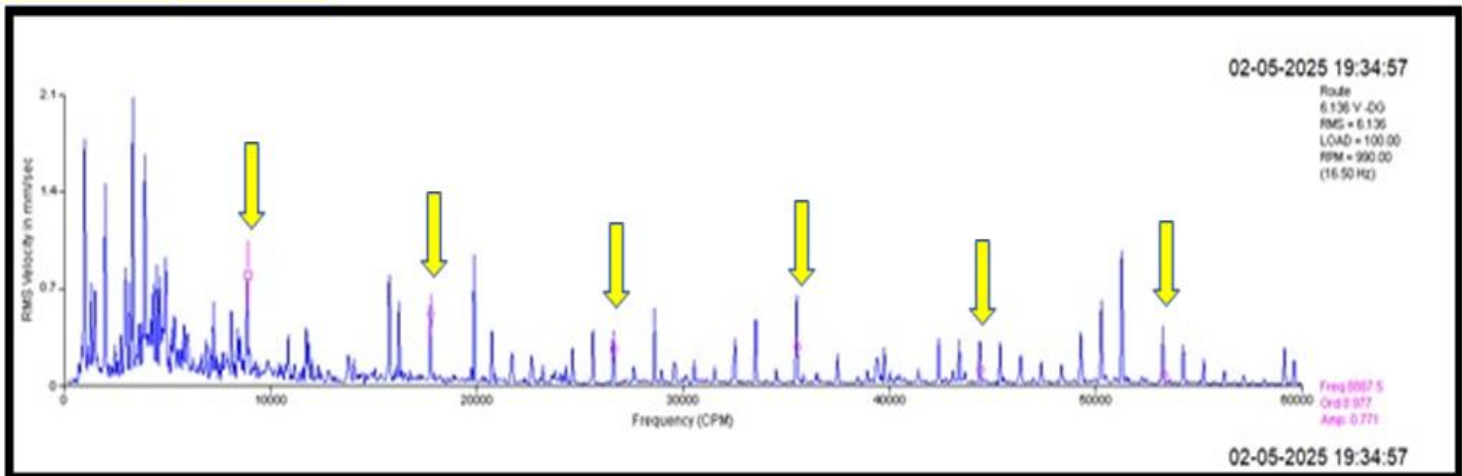
## Acceleration spectrum: -

1. The overall vibration level of the equipment is considered to be **Un-satisfactory**.
2. The FFT analysis reveals the presence of bearing defect frequency (non-synchronized with near BPFI) along with gear mesh frequency with sidebands associated with the first intermediate shaft.

3. It is recommended to proactively initiate the procurement of gearbox input bearings in order to replace them during the next scheduled opportunity stoppage, thereby preventing unexpected failures.
4. Additionally, Please inspect the 1st intermediate bearing clearances.
5. Please Inspect the coupling with review the alignment from pinion to motor via gearbox.

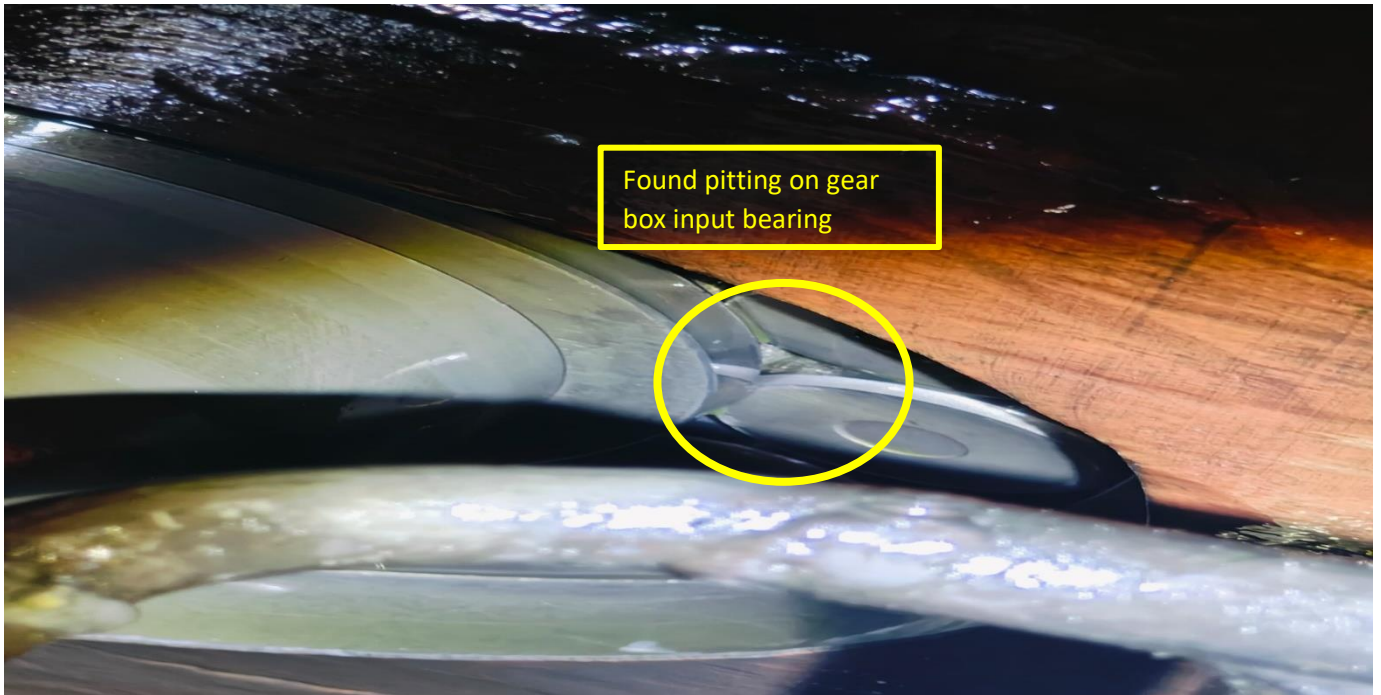
### Effected bearings images :-

On 14.06.2025 we conducted the gear box inspection found gear box input bearing severe pitting on bearing inner race

As per the vibration analysis report, the concerned team proceeded with the replacement of the gearbox on 06.07.2025, followed by the successful completion of laser alignment. Subsequent to these actions, vibration readings were conducted on 08.07.2025, which were found to be within acceptable limits.

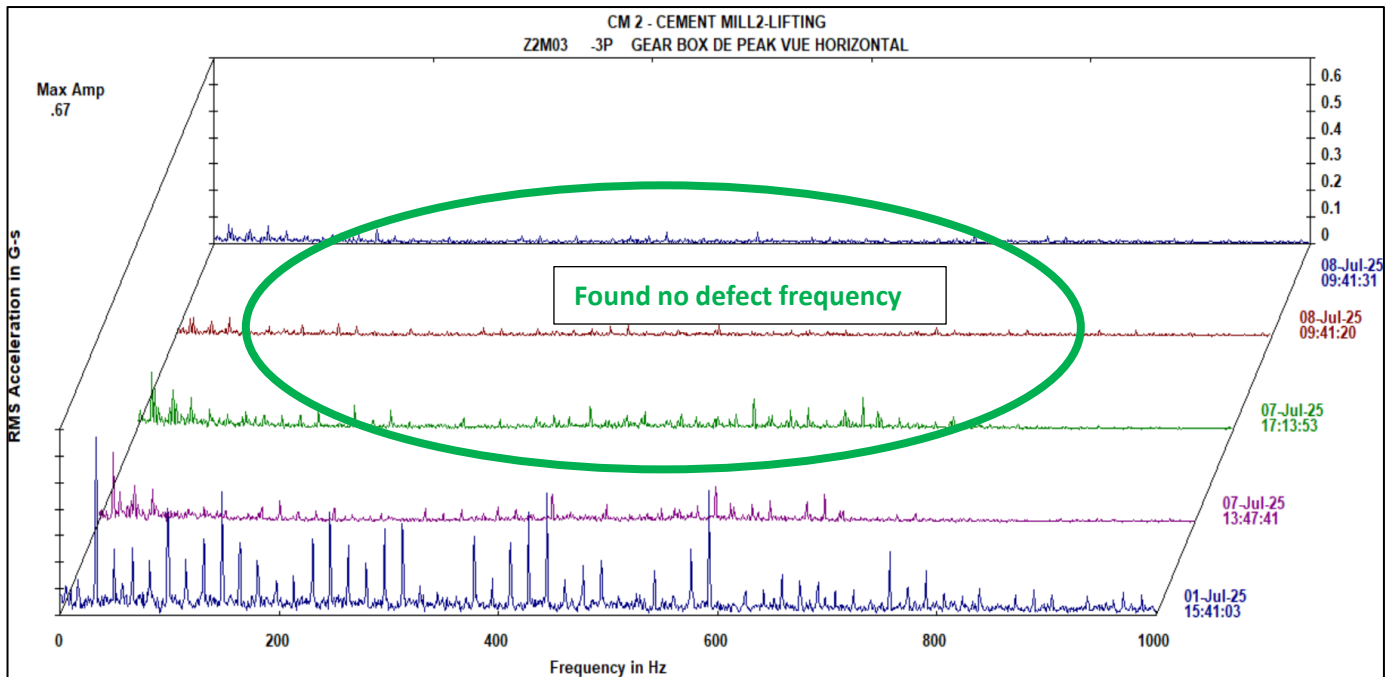
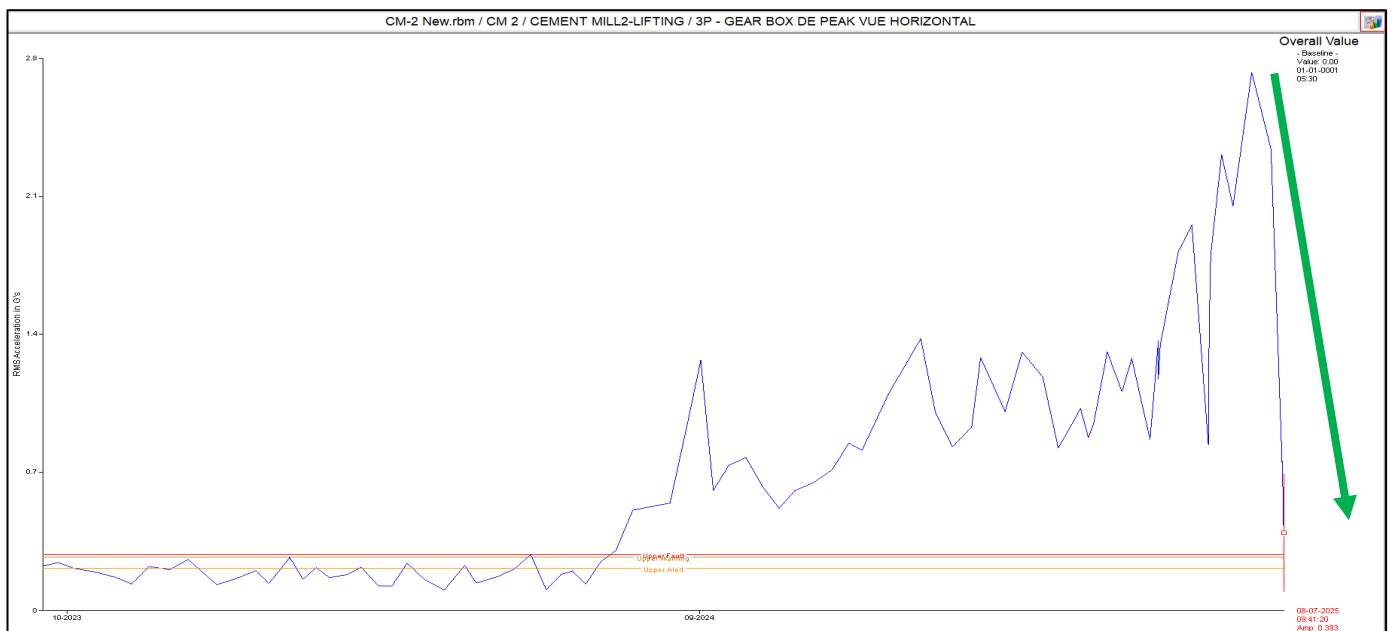
**After correction:**

- Following the replacement of the affected bearing gearbox, acceleration levels have decreased from 8.5 to 5.91 mm/sec at the input, and acceleration has reduced from 3.5 to 0.37g.
- These levels are within the acceptable range, demonstrating that the corrective actions have been successful.
- Continuous monitoring will be maintained to ensure sustained equipment performance and to promptly identify any potential issues.
