# Vibration analysis Report

Date: 24/07/2025

## LINE-1 KILN STRING FAN (J1P13):

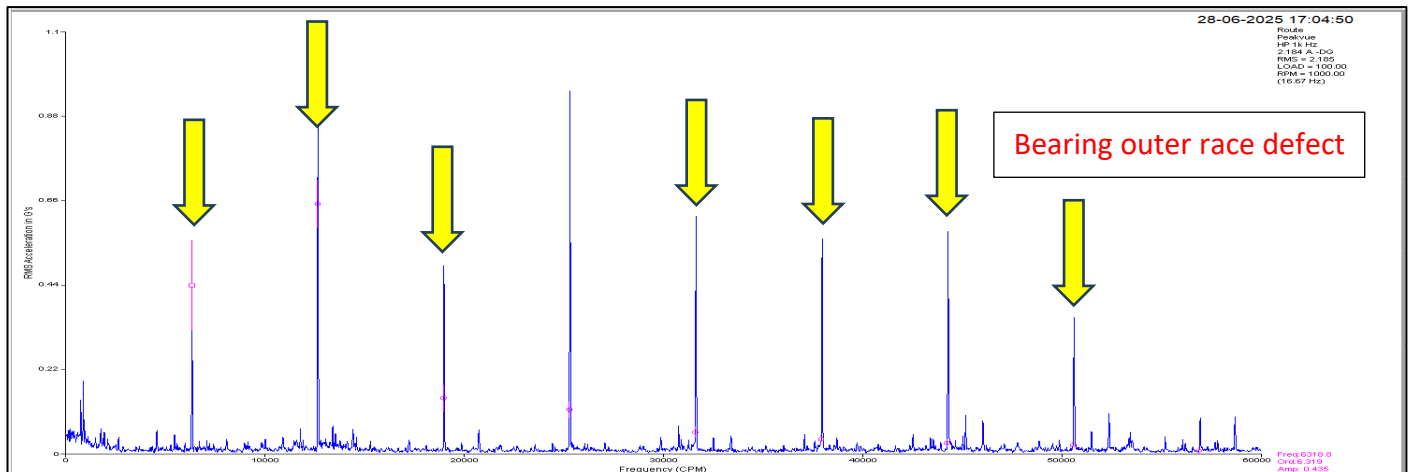
### Acceleration spectrum: -

1. Consequently, it was recommended to lubricate the motor bearings. Following lubrication by the concerned team, a reduction in 'G' values was observed; however, these values increased again on 12/12/2025. The FFT shows BPFO symptoms on the motor NDE side, indicating bearing defects.
2. As part of the condition assessment, we performed an electrical leakage test on the motor and found electrical leakage at the motor NDE bearing.
3. The same bearing failed on 07/02/2025 due to the same cause. This is the second failure within a 5-month period.

1. As the root cause has been finalized, we suggest the concerned team replace the bearing with an insulated motor NDE bearing. Until the replacement is carried out, kindly lubricate the motor NDE bearing to extend its life.

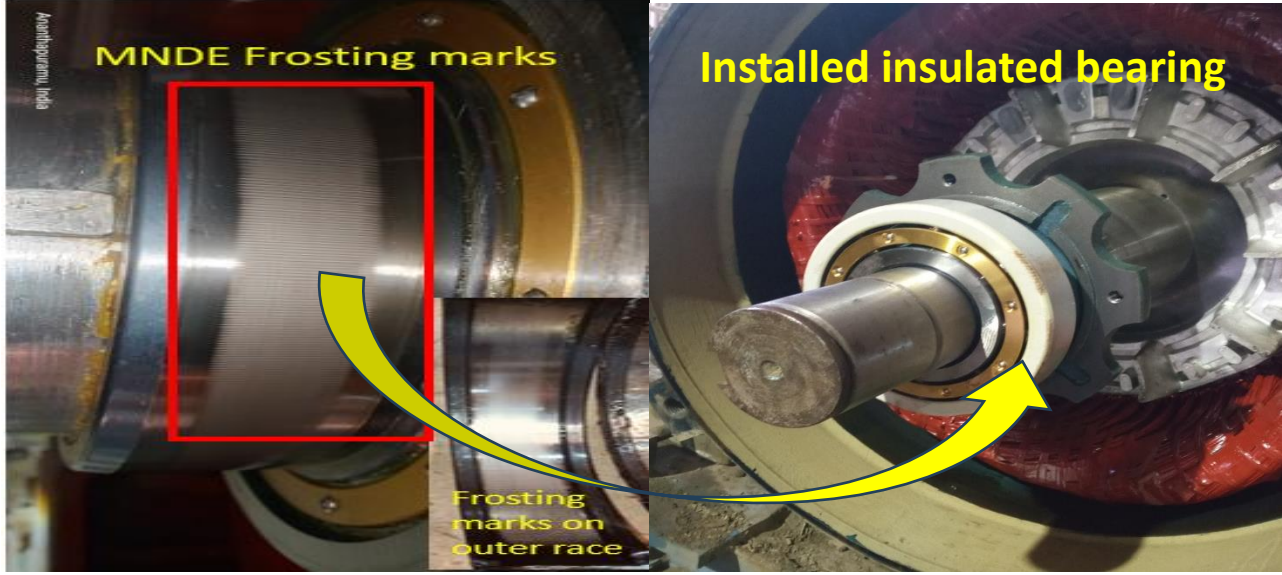
### Effected bearings with installed bearing images :-

**Root cause:** Electrical leakage at the motor NDE bearing resulted in two failures span of 5 months

As per the vibration analysis report, the concerned team proceeded with the replacement of the motor NDE bearing on 09.07.2025.

1. The motor NDE side bearing replacement has been completed, changing from a normal to an insulated bearing.
2. The fan impeller coating has been cleaned.
