# Vibration analysis Report

Date: 22/07/2025

## LINE-1 CALCINER STRING FAN(J1P12):

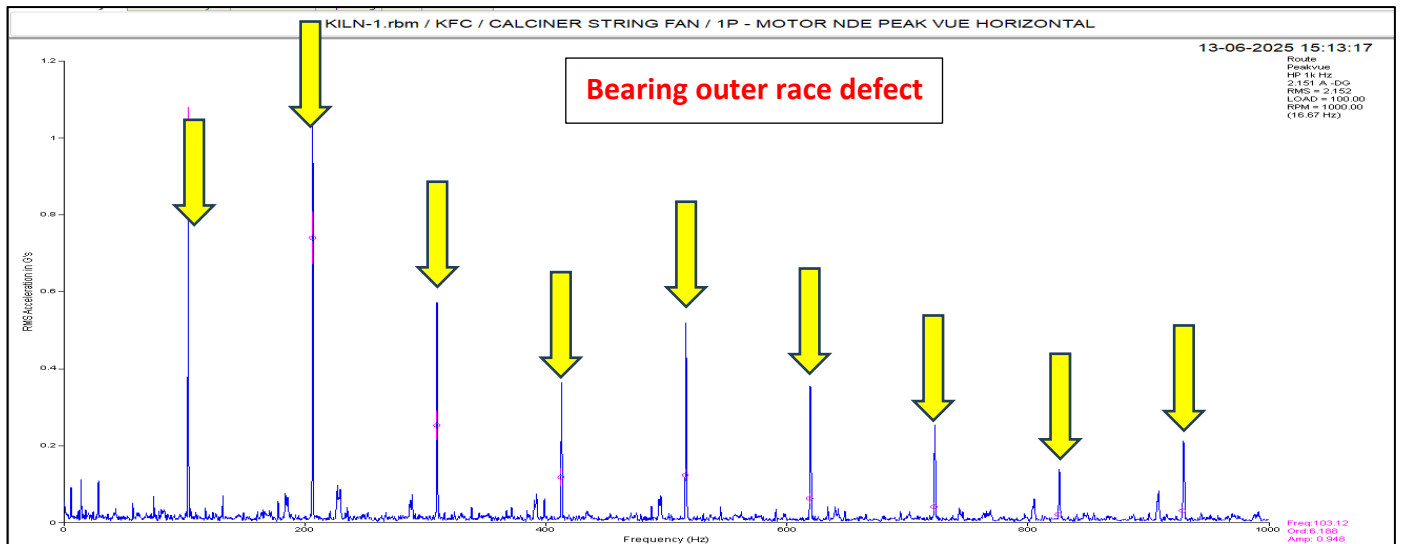
### Acceleration spectrum: -

1. Therefore, it was advised to lubricate the motor bearings. After lubrication was carried out by the responsible team, a decrease in 'G' values was noted; however, these values rose again on 26/05/2025. The FFT analysis indicates BPFO symptoms on the motor NDE side, suggesting bearing defects.
2. As part of the condition assessment, an electrical leakage test was conducted on the motor, which revealed electrical leakage at the motor NDE bearing.
3. The same bearing experienced failure on 10/02/2025 due to the identical cause. This represents the second failure within a five-month period.

1. Having identified the root cause, it is recommended that the responsible team replace the motor both bearings with an insulated bearing. In the

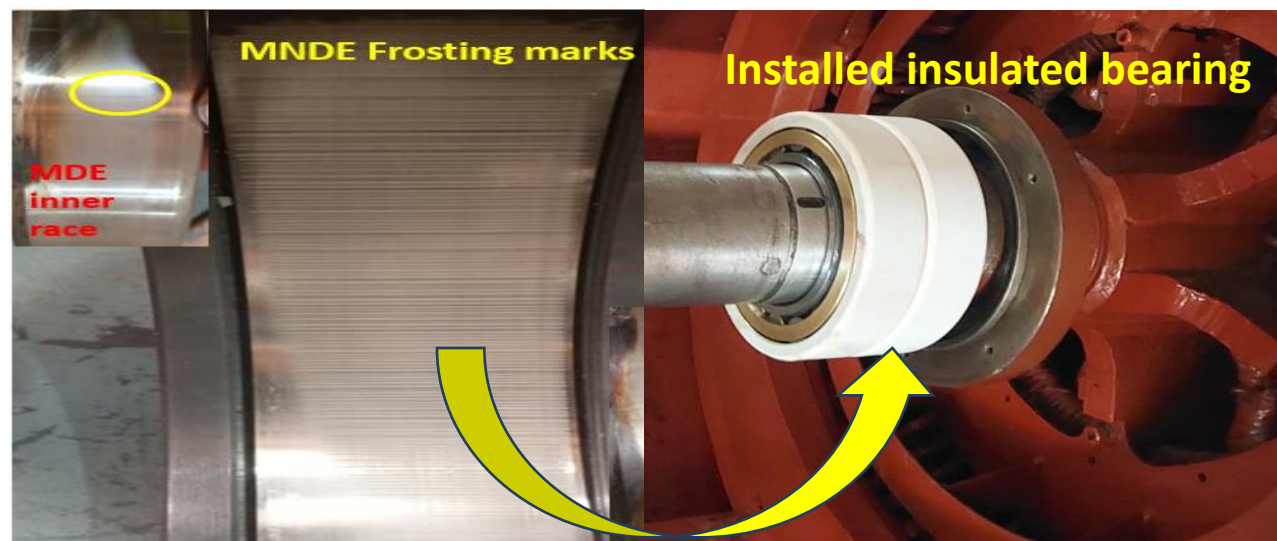
### Effected bearings with installed bearing images :-

**Root cause:** Electrical leakage at the motor NDE bearing resulted in two failures span of 6 months

According to the vibration analysis report, the concerned team completed the replacement of both motor bearings on 10/07/2025.

1. The motor both bearings replacement has been completed, changing from a normal to an insulated bearing.
2. The fan impeller coating has been cleaned.
