# SDT ULTRASOUND SOLUTION INDIA PRIVATE LIMITED

## Case Study

### Bearing Fault Identification

**Analyst:** Samarjit Behera  
**Methodology:** Ultrasound Technology  
**Device:** SDT 340  
**Site:** [REDACTED] Limited

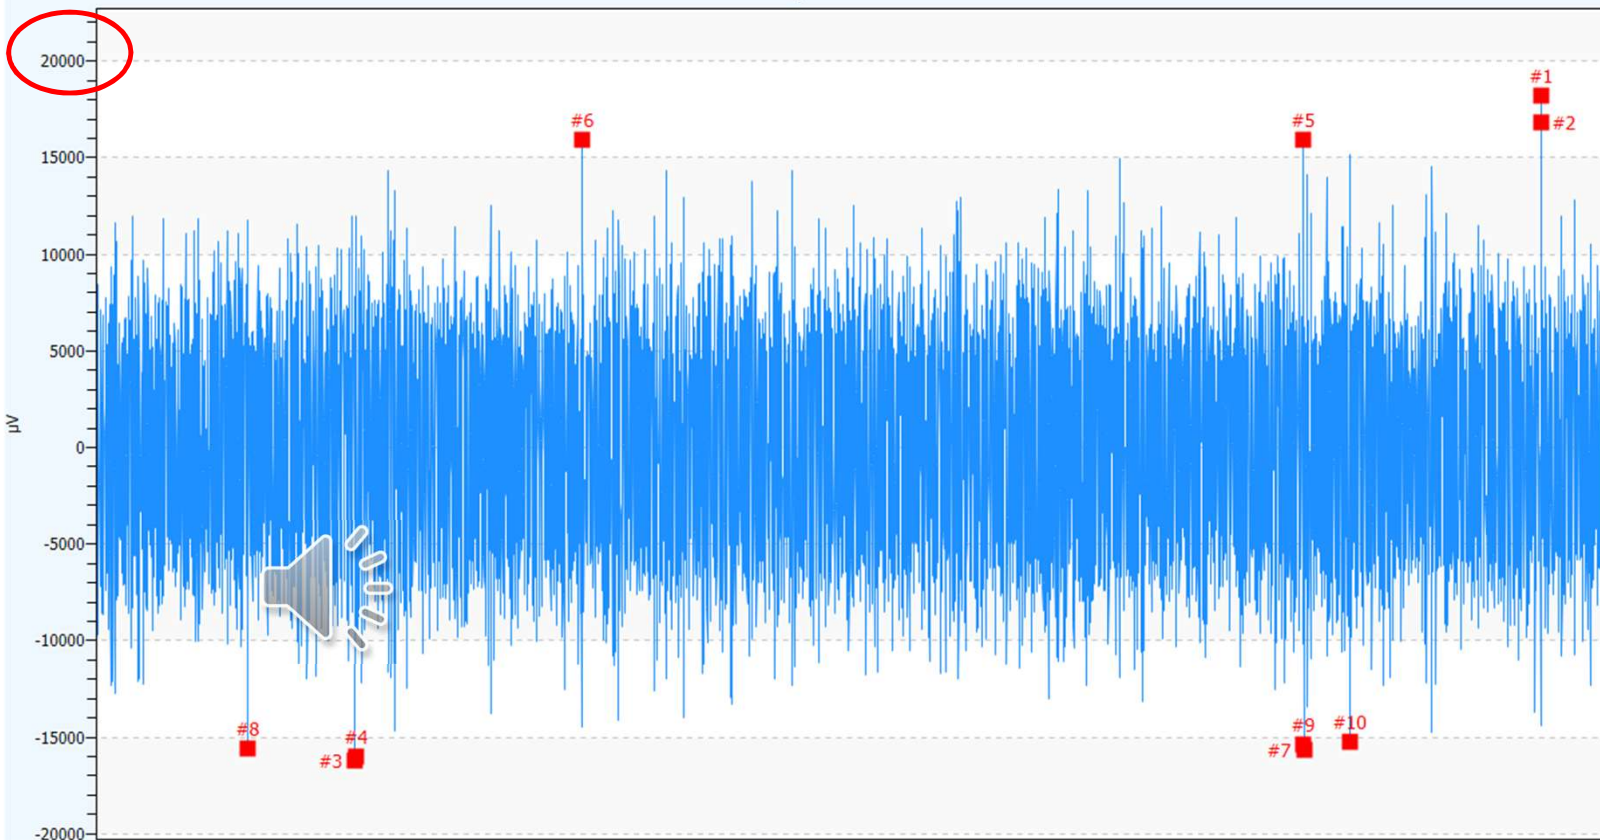
# TIME WAVEFORM(MNDE)

| SATUS | POINTS | ANALYSIS | RECOMMENDATION |
|---|---|---|---|
| Alarm Stage | MNDE & MDE | <p>In Ultrasound schedule inspection, we noticed the presence of abnormal sound at MNDE side and further analysis done and we found:</p> <ul style="list-style-type: none"><li>◆ Presence of very high energy signal in the dynamic data at MNDE side.</li><li>◆ Gradually increasing static trend value at both side bearing.</li><li>◆ Close to BPFO@383.1 Hz (non-synchronous) peak harmonics noticed with very high energy.</li><li>◆ FTF peak harmonics also noticed at both side bearing.</li><li>◆ The energy/amplitude of the signal is very high at MNDE side bearing.</li></ul> <p>Above data suggesting bearing issue at MNDE side.</p> | <p>It is recommended to inspect and replace the MNDE bearing in closest available opportunity to prevent catastrophic failure.</p> |

| US RMS | 70.25 dBµV |
| US Peak | 85.2 dBµV |
| US Crest Factor | 5.59 |

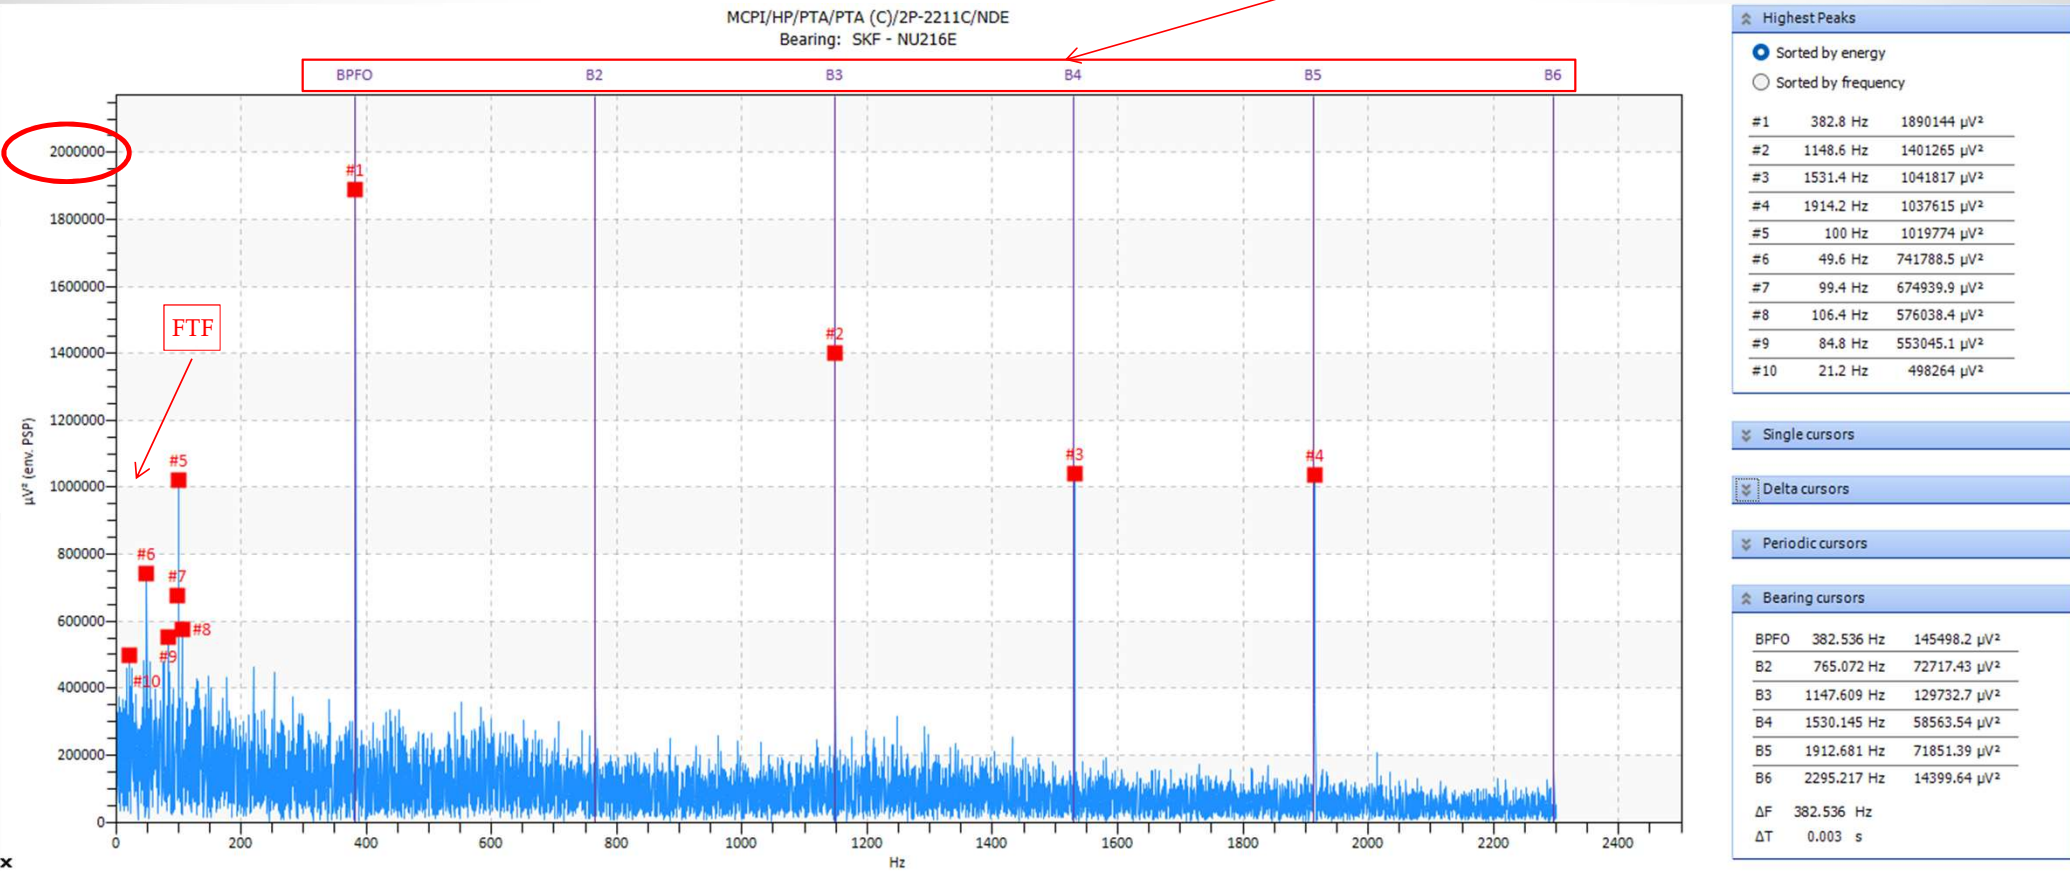
# FFT SPECTRUM(MNDE)

383.1 Hz harmonics

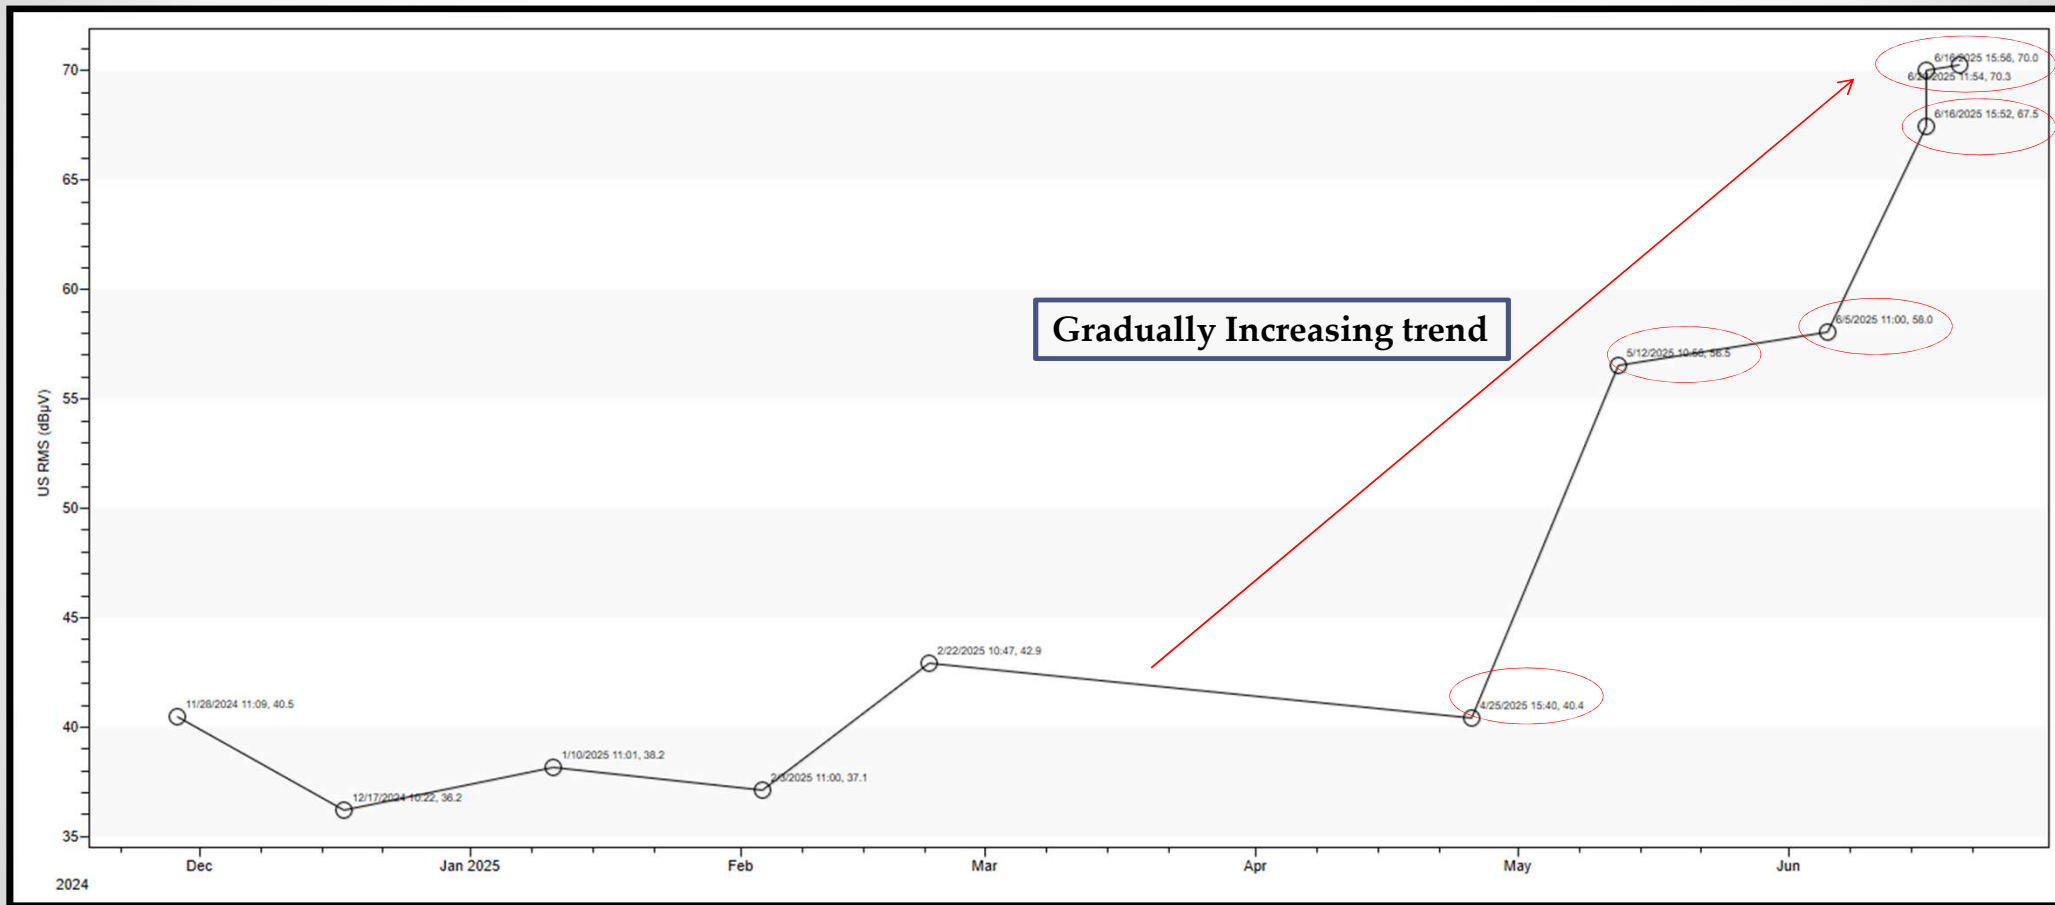
## STATIC TREND(**Before** Bearing Replacement)

- Equipment has been under observation since **November 2024**.
- **Bearing fault frequency (BPFO)** was detected with **moderate energy** during early observation.
- A **gradually increasing trend** in ultrasound signal has been observed over time.
- **Change in tonal quality** has been noticed, indicating progressive fault.
- The **amplitude of bearing fault frequency (BPFO) peaks** is increasing steadily, confirming fault development
- As the equipment spares available we continued trend monitoring to access the fault progression before taking corrective action.

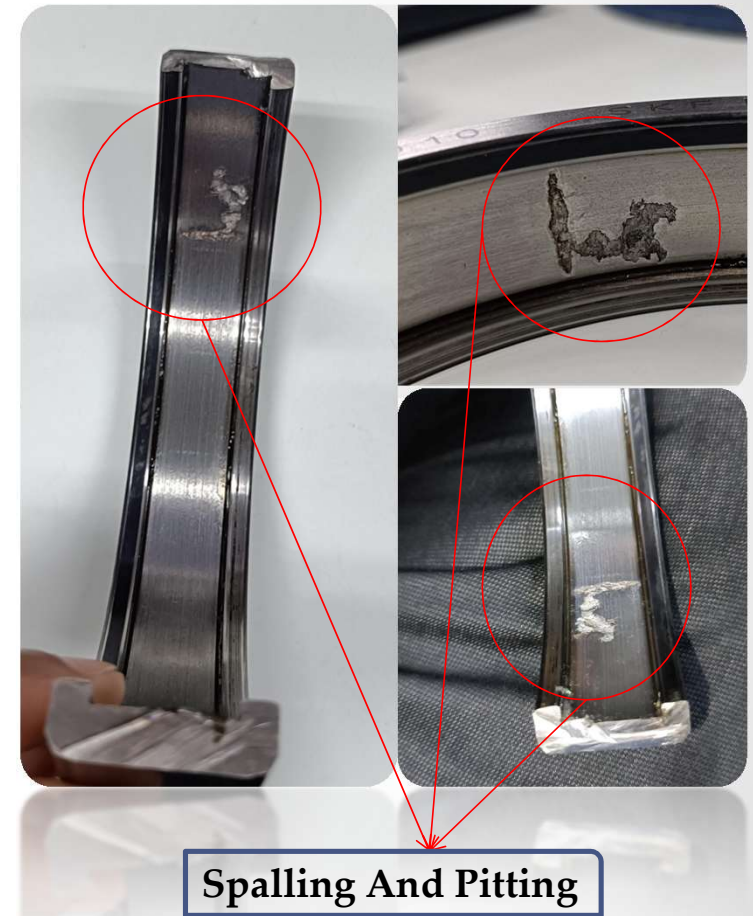
## Severe Spalling And Pitting Observed On Raceway

- **Flaking/Spalling** on the raceway surface – classic sign of fatigue failure.
- **Localized surface degradation and wear**, likely due to **inadequate lubrication** or **contaminated lubricant**.
- **Discoloration or deposits**, indicating **overheating** or **foreign particle ingress**.
- **Indentation and pitting** near the edge zone, possibly due to **improper alignment** or **overloading**.

## **Fatigue Failure**

- Repeated cyclic stresses exceeded material endurance limit.

- Misalignment of bearing during installation.
- Excessive radial/axial load.
- Shaft deflection or poor housing support.

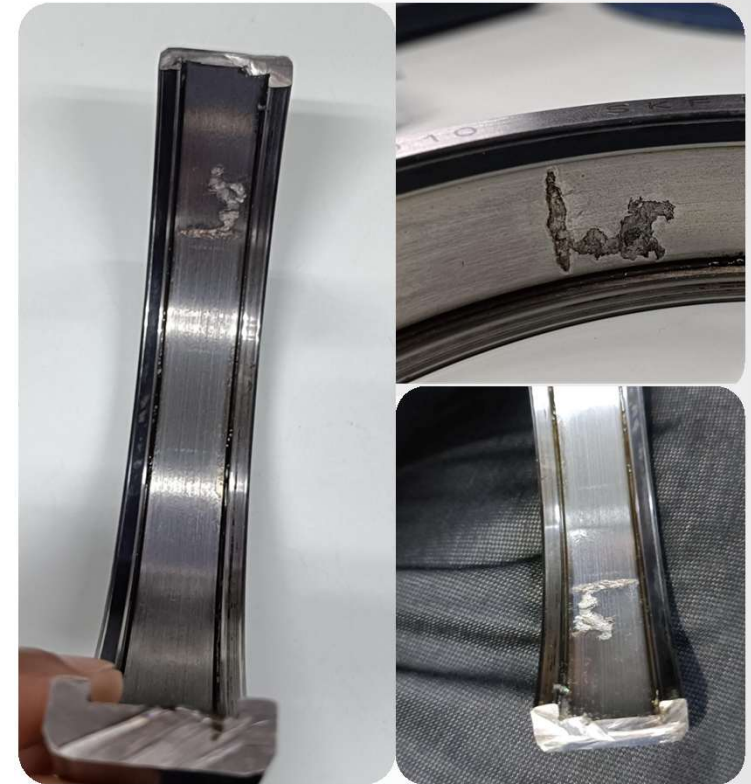
## **2. Lubrication Failure/Over Lubrication**

- Over Lubrication/Insufficient film thickness between rolling elements and raceway.

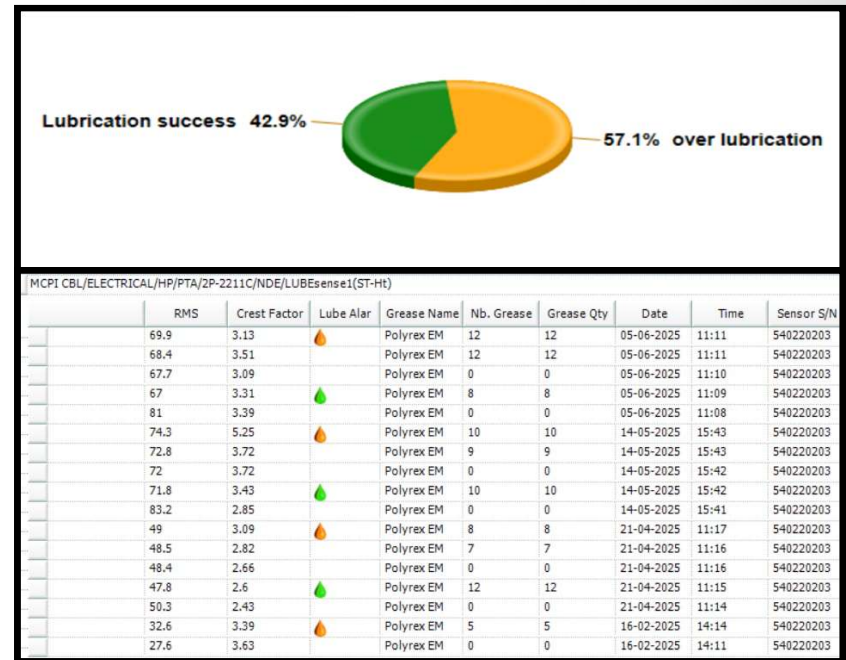
# Lubrication Data(SDT LUBExpert)

The attached LUBExpert report indicates that **57.1% over-lubricated** in [REDACTED] over the past five months—since the initiation of the LUBExpert program in [REDACTED]

This motor was lubricated on calendar-based(OEM). As part of **Phase 1** of our LUBExpert implementation, we are now using the SDT LUBExpert to observe the lubrication results.

This high rate of over-lubrication is a **significant contributing factor to accelerated bearing deterioration**.

To address this issue, we plan to **implement Condition-Based Lubrication (CBL) strategy** as part of our **Phase 2** program, **scheduled to begin in August**.

This approach will help optimize lubrication practices and extend bearing life.
