# SITE REPORT

This Report contains Vibration readings taken on Gas driven engine & alternator. Vibration measured in three mutually perpendicular directions i.e., in Horizontal Vertical and Axial direction and these readings were measured in No-Load & 100%load Condition.

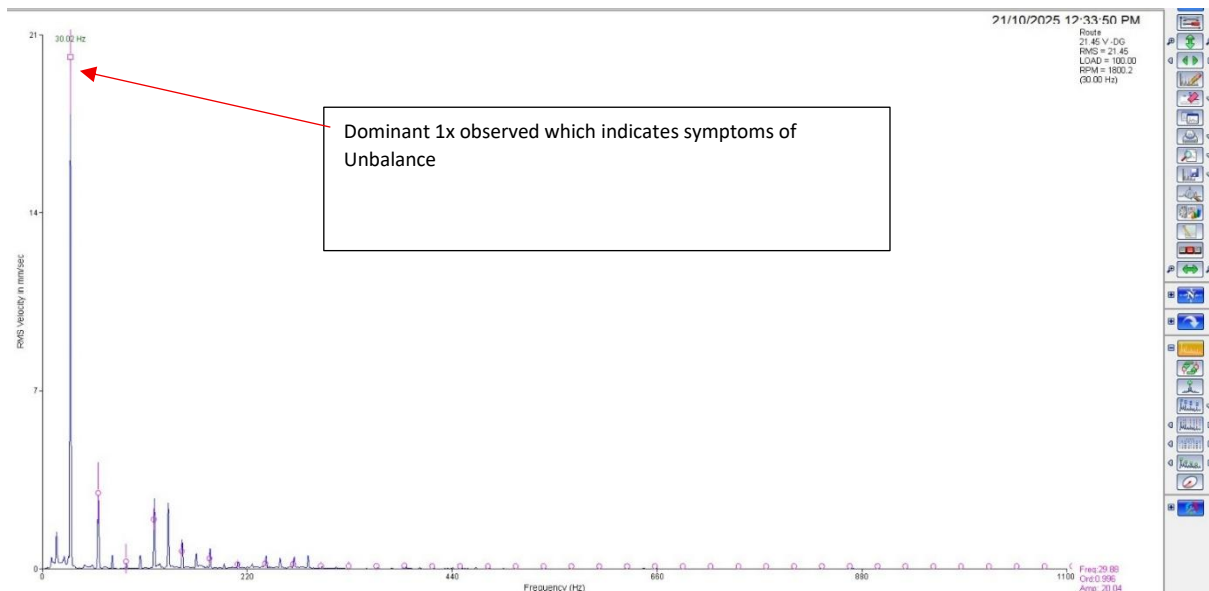
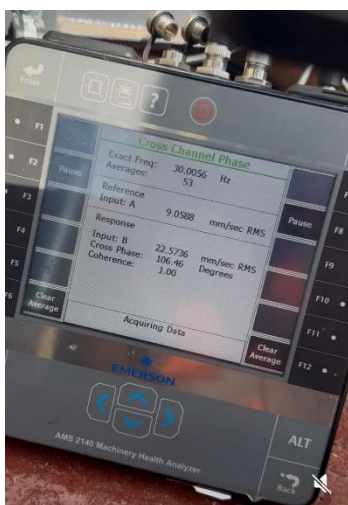
## Velocity Spectrum at Generator NDE in Vertical direction Before trim balancing :

Gen NDE Phase angle (H-V) was found to be approximately 106.4°

This generator was received in the workshop for a vibration test. The test was conducted at no load, and the vibration levels were found to be normal, below 1.5 mm/sec. However, when the generator was coupled with the engine at site, very high vibration levels were observed in all directions, with the maximum recorded on the generator NDE side in the vertical direction. The engine side vibration was also high, around 20 mm/sec.

Phase analysis was carried out, which indicated an unbalance issue, as the generator nde side phase angle (H-V) was found to be approximately 101.5°. Balancing was then performed by adding correction weights 300 gms on the DE side external fan. After balancing, the vibration levels were reduced from 28 mm/sec to 9.5 mm/sec, which is within the acceptable limit as per the relevant standard.

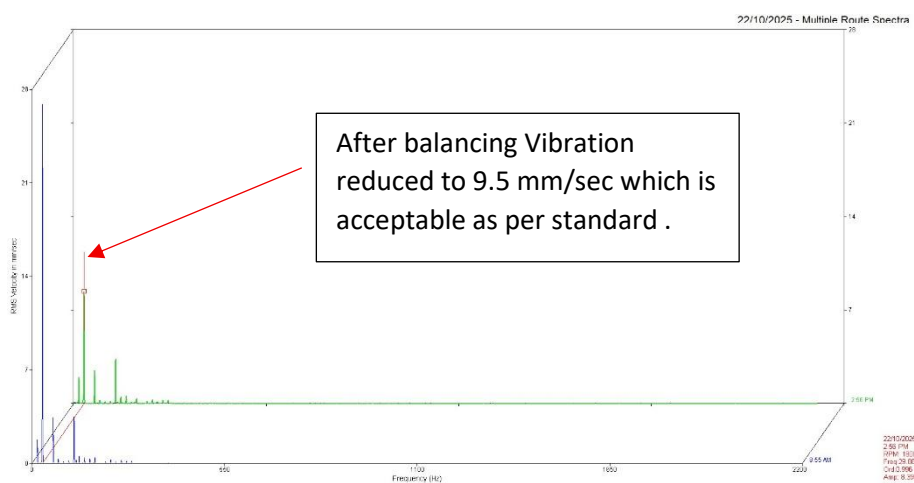
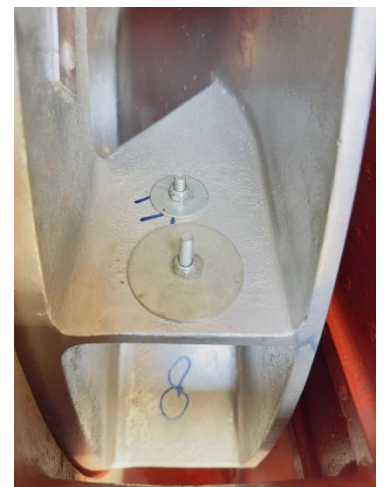
### Waterfall plot at Generator NDE in Vertical direction After trim balancing :

Around 300 gms weight added
