## Case study of Rotor Bar Crack in Cooler Fan (180 KW)

Instrument: CSI 2140.

Software: AMS Machinery Manager

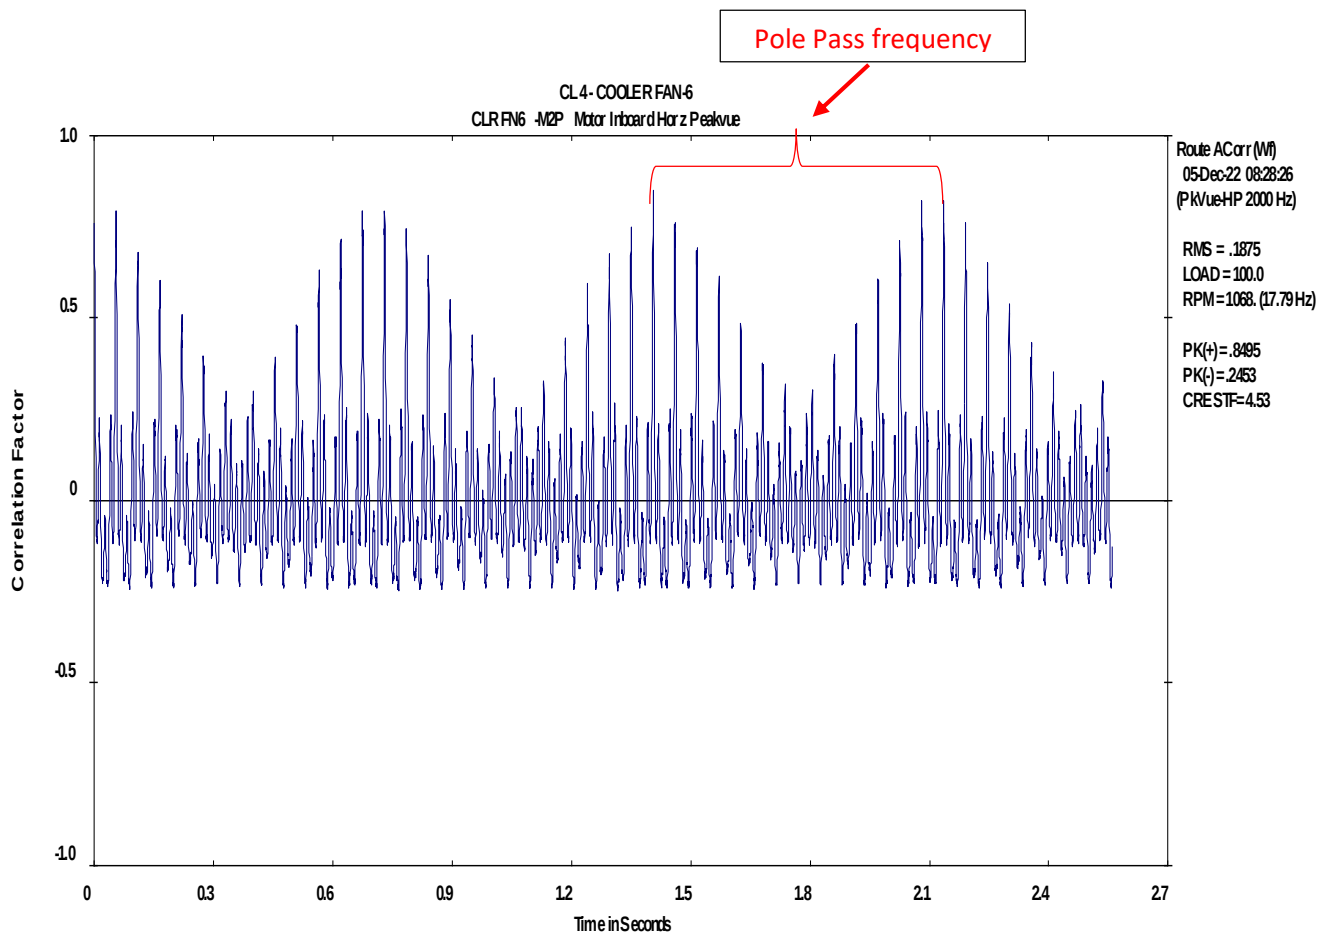
### Auto correlated Time wave form: Motor Drive End side

**Observation:** Vibrations readings found normal, but vibration spectrum and time waveform is indicating 1X harmonics with PPF sidebands and beatings in timewavform with PPF.

As per above spectrum and TWF suspected rotor bar crack. For confirmation conducted MCSA.

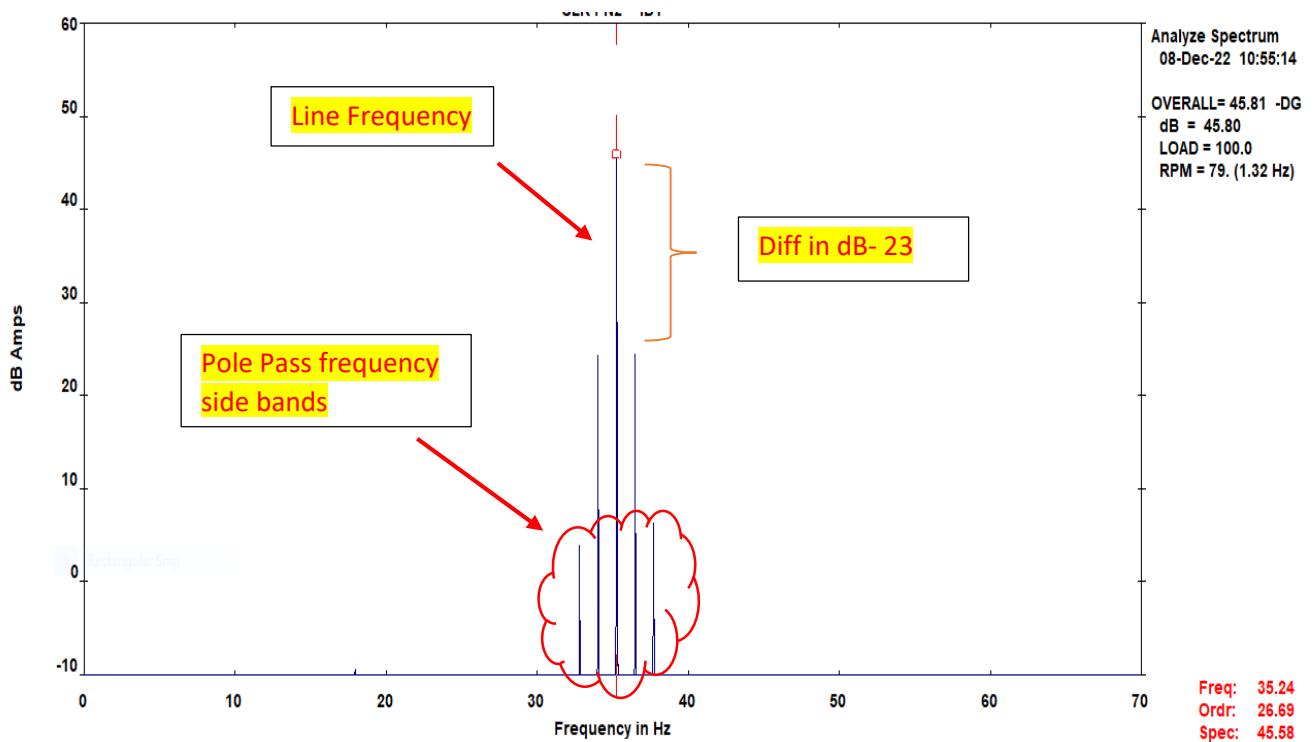
- Difference in dB level is 23 in MCSA, which is indicating severe rotor bar crack.

Recommendation: In view of the above diagnosis, it is recommended to replace the motor and check the Motor for rotor bars defect.

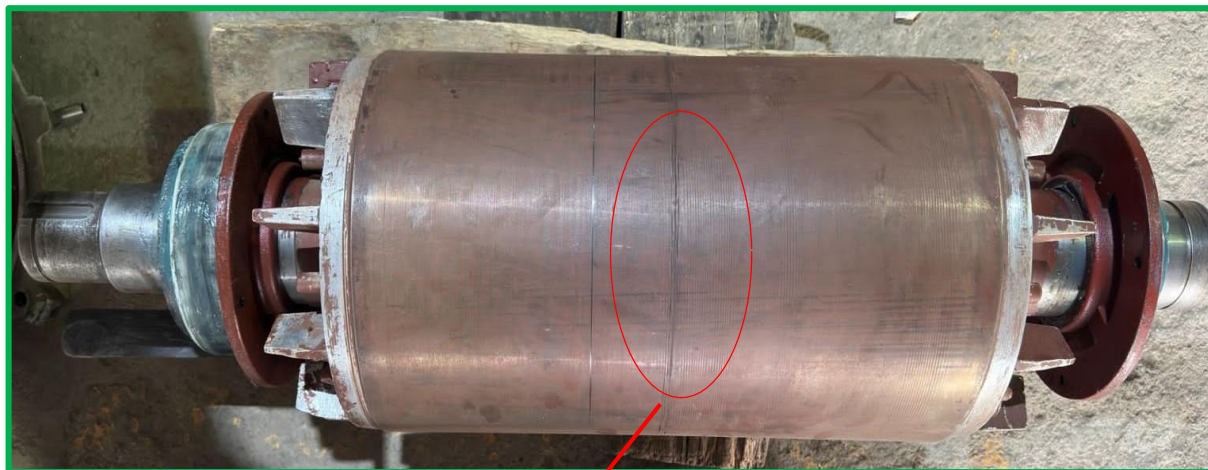
Findings after inspection: Inspected motor on 2.2.23 and observed Cracks on Rotor.

Figure 3# Rotor

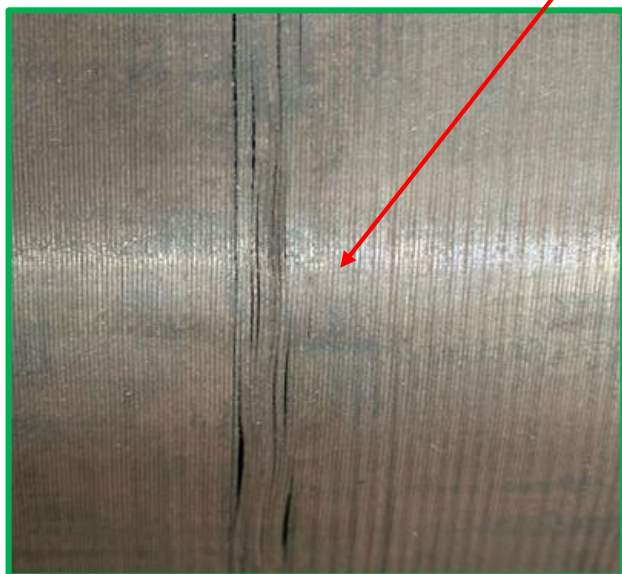
Figure 4# Rotor crack in close view

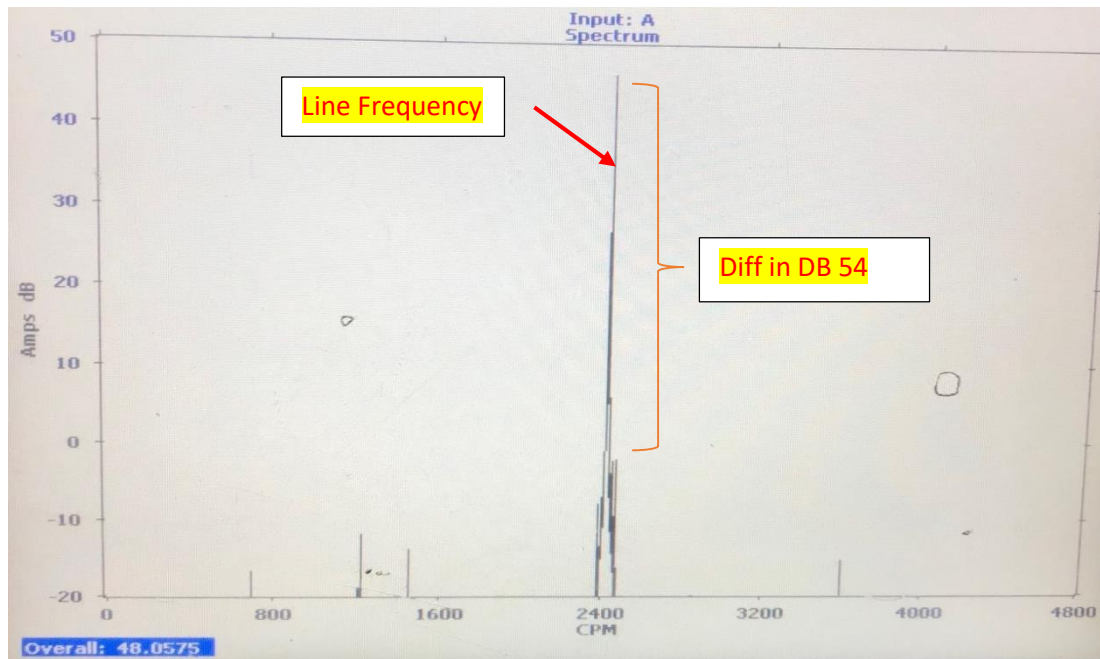
### MCSA readings after Motor replacement:

**Observations:** dB difference is 54, indicating healthy rotor condition.
