## Bearing failure of the ACC helical two-stage gearbox

**Case study:** Bearing failure in high reduction gear box (helical two-stage gearbox)

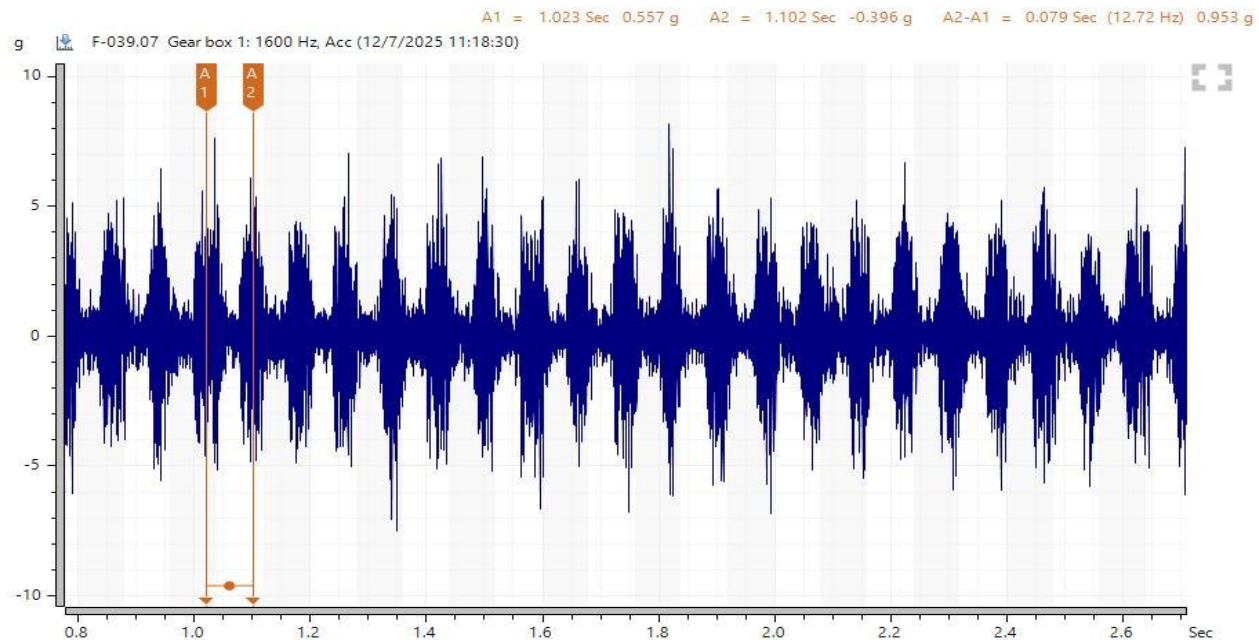
- High impact & modulation around 12.5 Hz

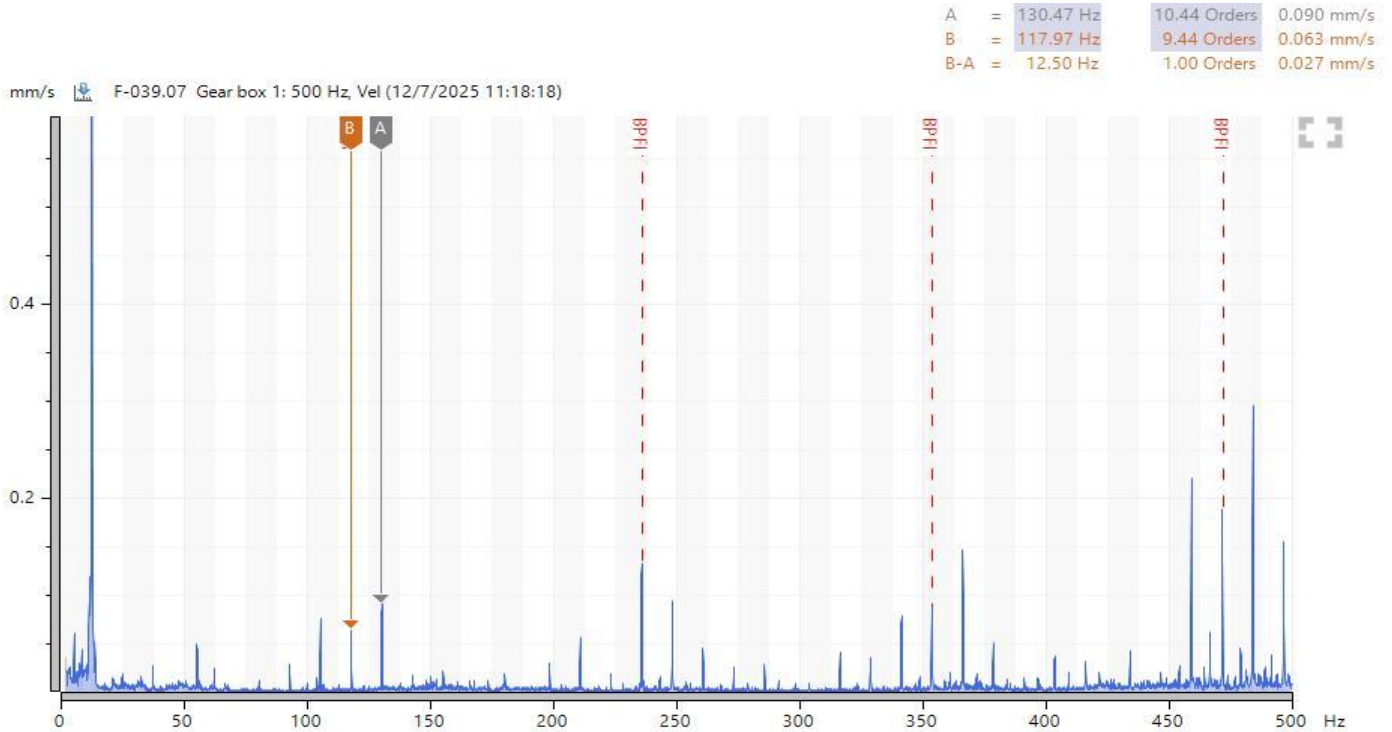
➤ **Inner race bearing frequency appeared in velocity FFT.**

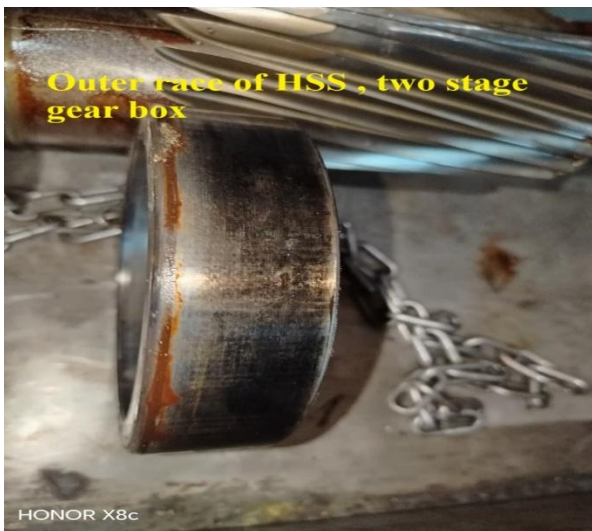
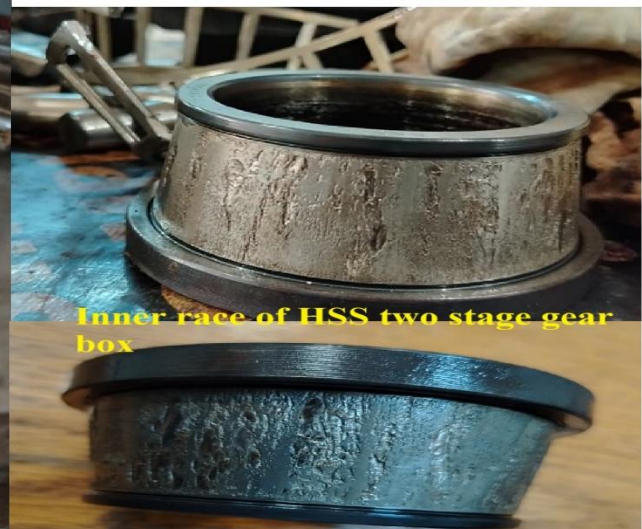
After the gear box to check, we found the lower bearing inner race of HSS damaged and outer races burnt.

The teardown inspection revealed severe surface damage on both the inner and outer bearing races. The raceways showed extensive spalling and pitting, characterized by flaked material and rough, fractured surfaces rather than smooth wear. The inner race exhibited a large, spalled area within the primary load zone, while multiple pitted regions were observed on the outer race. This damage is typical of rolling contact fatigue and indicates an advanced failure stage, suggesting the bearing continued operating after defect initiation. Metallic debris was present in the oil, and the race surfaces were dull and rough, consistent with degraded rolling contact and progressive vibration increase.

The failure was likely caused by a combination of causes. Lubrication and contamination issues, together with probable wrong preload, resulted in localized high loads that caused surface fatigue. As the damage advanced, increased vibration and dynamic loading accelerated bearing degeneration, leading to rolling contact fatigue failure.

- Implement routine oil analysis to monitor contamination, viscosity, and wear debris.
- Ensure proper oil flow to bearings and clean oil passages.
- Confirm correct bearing type and internal clearance for the bearing application and adjusted as OEM.
- Include bearings in a regular vibration condition monitoring program.
