# Case Study

## Analysis of Two Stage Planetary Gearbox Vibration

KSC Consulting LLC  
Ken Singleton – Manager

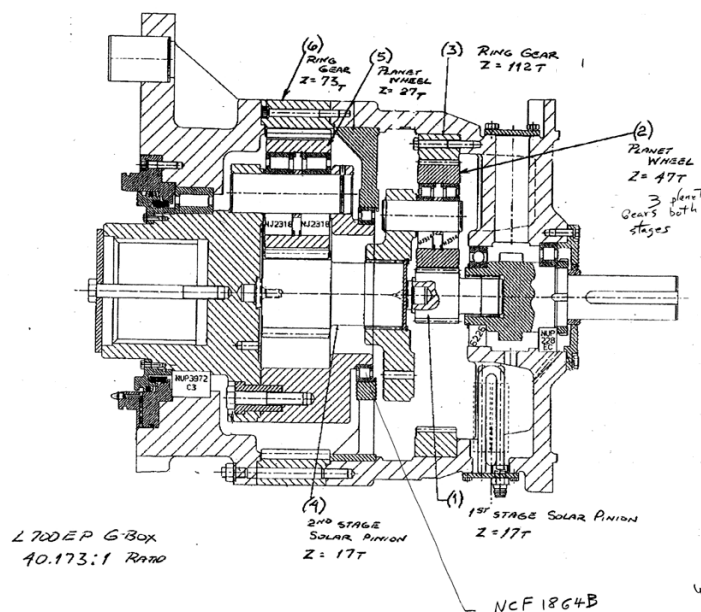
**Figure 2. Cutaway View of 2-Stage Planetary Gearbox, 40.173:1 Reduction.**

Gearboxes used in underground coal mining are of compact design. A typical two stage planetary gearbox, 800 HP, 40.173:1 Ratio with 1800 RPM input is shown in **Figure 1**. The unit was received by a repair facility for rebuild following failure from an overload incident. It was reported that the bearings were replaced and that one bearing had broken into many fragments. Following repairs a no load spin test of the gearbox was performed as a check for bearing faults, **Figure 2**. There was an audible impacting type noise from the input planetary section.

Before a determination of the source of the vibration could be made, an understanding of the gearbox design was required and calculation of the excitation frequencies. Based on the information provided by the drawing shown in **Figure 1**, several calculations were made to obtain the shaft speeds, bearing fault frequencies and gear meshing frequencies.

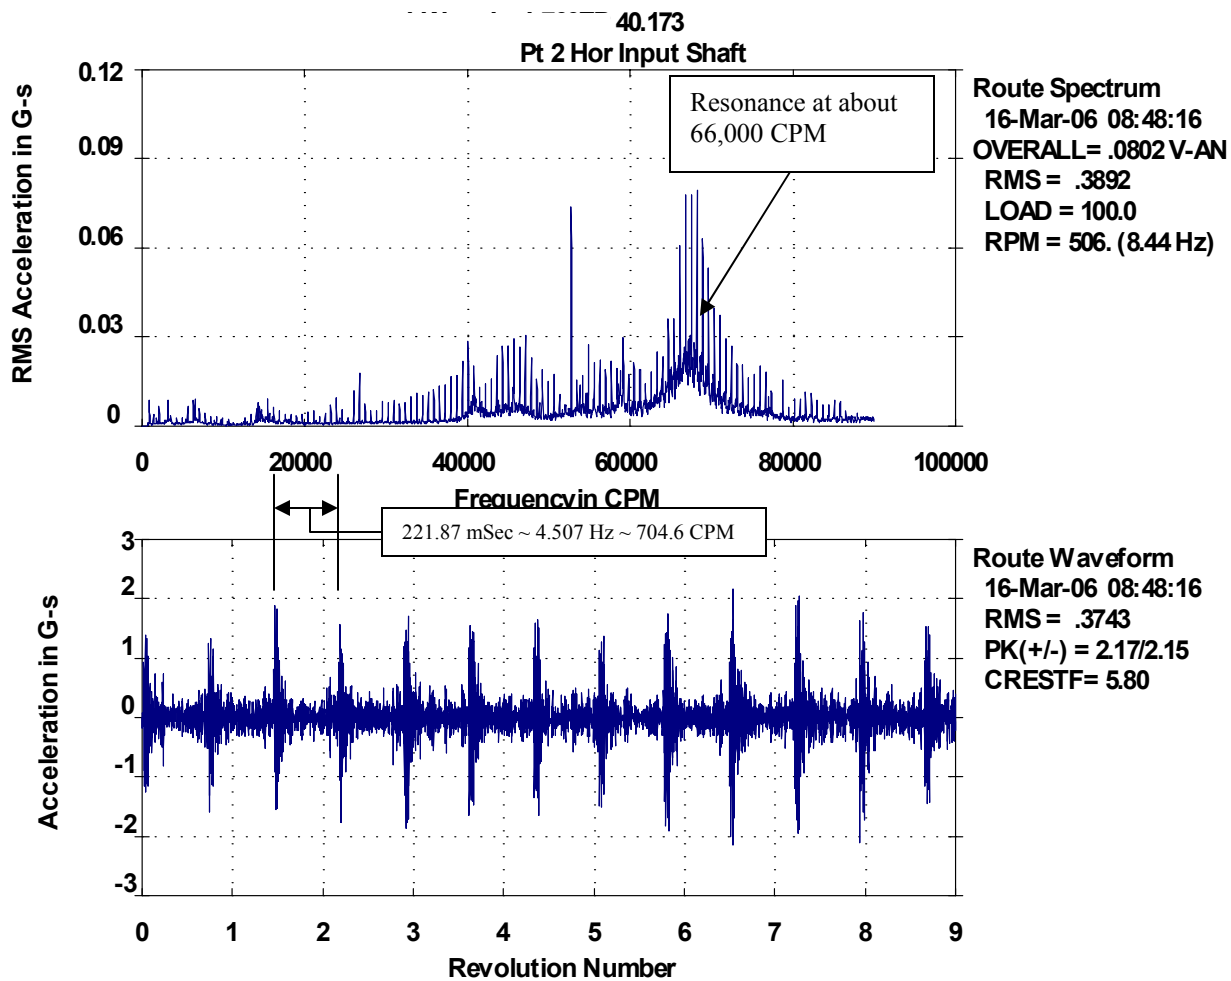
During the spin test, vibration data were measured using an accelerometer with rare earth magnetic mount. Initial inspection of the data indicated impacting and ringing of natural frequencies of the gearbox, **Figure 3**. The impacts measured a 221.87 mSec period or 4.507 Hz ~ 704.6 CPM. The FFT of the time domain data showed harmonics of 704.6 CPM and indication of excitation of several natural frequencies of the gearbox.

**Figure 3. Vibration Signal Measured at Gearbox Input Section Showed Impacts at 221.87 mSec Interval ~ 4.507 Hz ~ 704.6 CPM. The FFT (Top Plot) Indicated Excitation of Several Resonant Frequencies Including A Very Response One at About 66,000 CPM ~ 1,100 Hz.**

Referring to the data plots in **Figure 3**, it was readily determined using the vibration software cursors that the impulse frequency was 4.407 Hz ~ 704.6 CPM. A check of the frequencies in **Table 2** showed that this frequency does not match any of the bearing fault frequencies.

A check of the gearbox shaft speeds and gear meshing frequencies in **Table 1** also did not immediately identify a forcing frequency. The pulses in the time domain measured 85.42 mSec ~ 11.7 Hz ~ 702.4 CPM. Since the gearbox has three planets in each stage an impulse could occur at three times the 1<sup>st</sup> stage carrier frequency of 234.838 CPM if there were damage to the ring gear teeth. This frequency was calculated as follows:

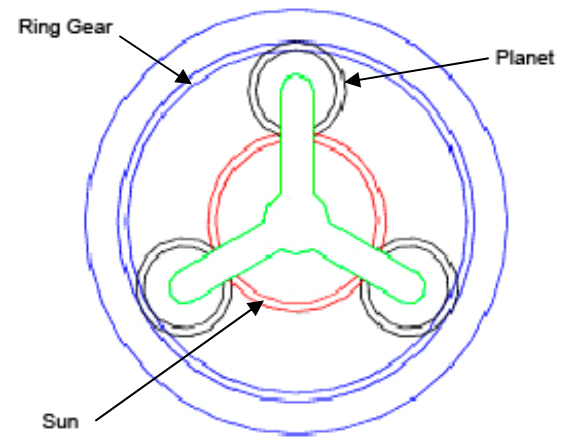
Epicyclic gear boxes derive their name from the epicycloidal curves that the planet gears produce during rotation. There are three general types of epicyclic arrangements, 1) planetary which consists of a stationary ring gear combined with a rotating sun gear and moving planet carrier, 2) star configuration which consists of a stationary planet carrier coupled with a rotating sun gear, and 3) solar gear that has a fixed sun gear combined with a moving ring gear and planet carrier. The planetary arrangement is most common and is shown by the schematic in **Figure 4**. The subject gearbox had the planetary arrangement for the 1<sup>st</sup> and 2<sup>nd</sup> stages. Input was from the sun with three planets supported by a carrier revolving about the sun pinion and the ring gear fixed.

**Figure 4. Gear Arrangement Of 1<sup>st</sup> Stage Planetary Input Section.**

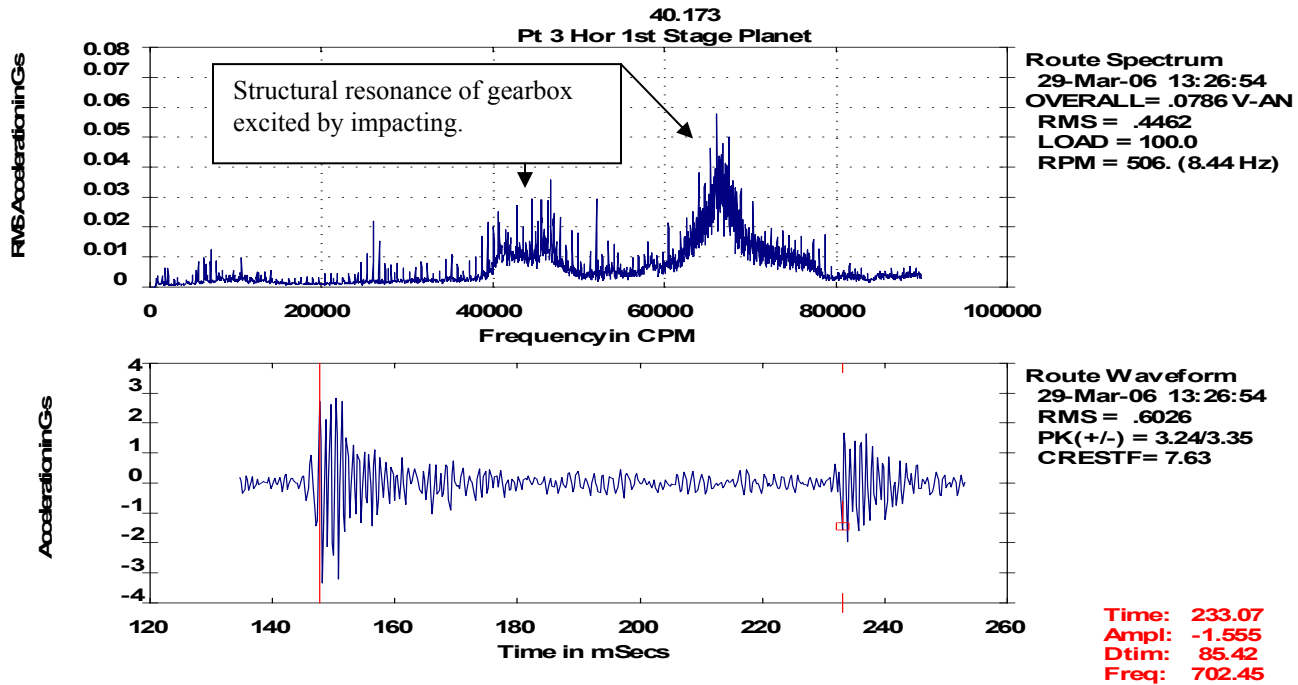
Expanding the time domain plot to show only two pulses, **Figure 5**, the pulses ring down which is typical response of structural resonance. The spectrum data also provided clear indication of resonance excitation.

**Figure 5. Time Data Expanded To Show Impacting and Ring Down.**

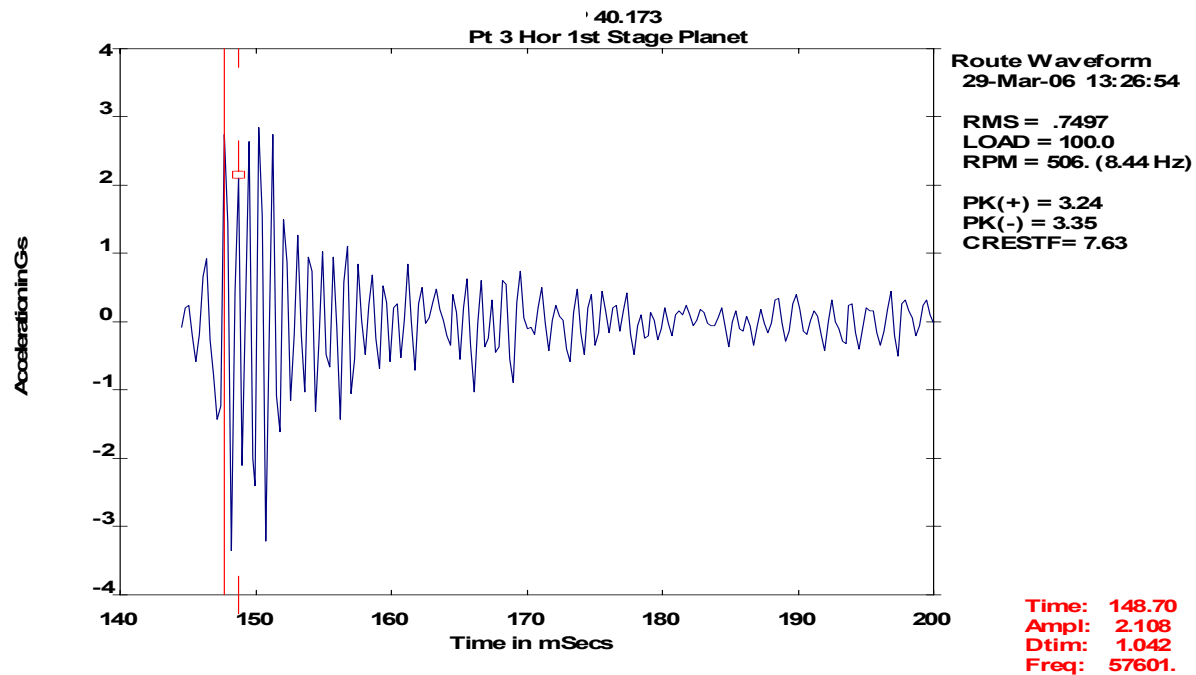
Plotting a single pulse in **Figure 6** showed more clearly the time between oscillations was about 1.042 mSec or 57,600 CPM. Note that spectrum analyzers don't make good oscilloscopes due to the rather course sampling at 2.56 times the maximum frequency to be displayed in the frequency spectrum.

**Figure 6. Expanded Plot of One of The Impact Events in The Time Domain Shows The Ring Down Frequency Is About 57,600 CPM.**

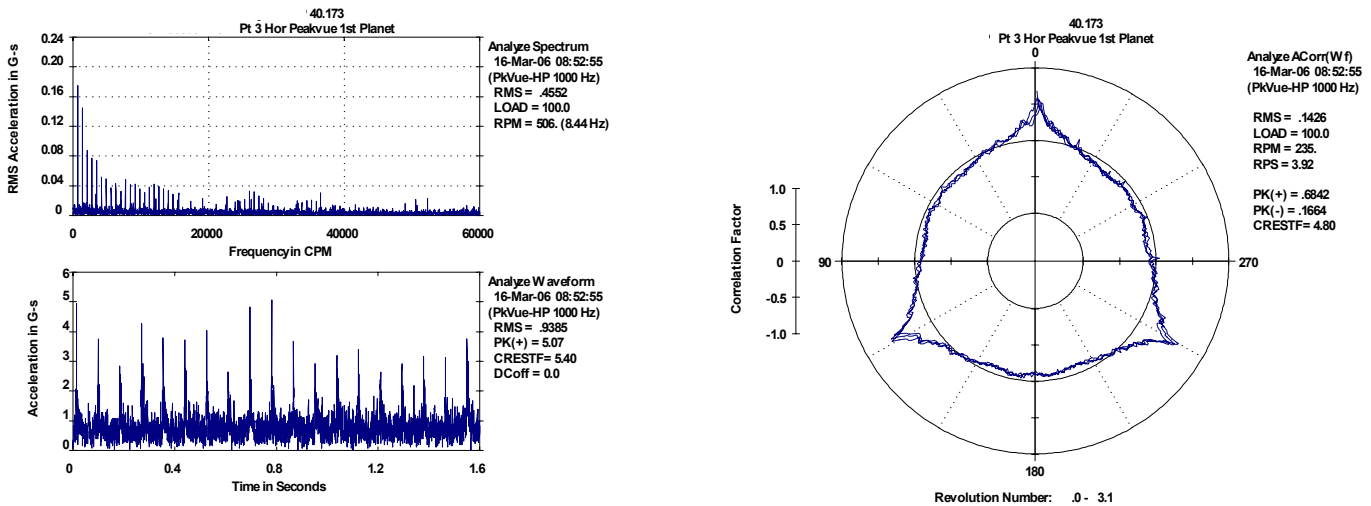
Peakvue spectrum and time domain data are plotted in **Figure 8** and shows impacting to about 5g's with the same frequency content as the normal vibration data. The auto correlation plot of Peakvue time data is plotted in **Figure 9** in a circular plot format.

**Figure 8. PeakVue Data Also Contained Impacting Data At the 3X the Carrier RPM.**

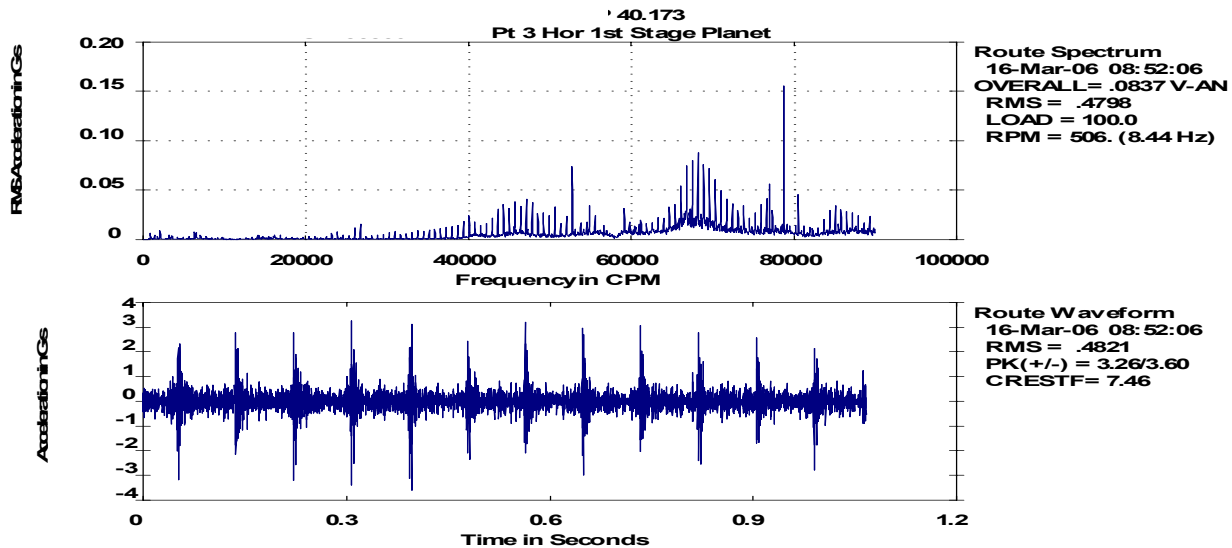
Before and after vibration data are plotted in **Figure 9 & 10**. The periodic impacting caused by the planet teeth rolling over the damaged ring gear tooth was reduced.

Figure 9. Initial Spectrum And Time Domain Data With Brg Fragment Imbedded In The Ring Gear.

With the likely problem area in the gearbox identified, the gearbox was disassembled for inspection. A small fragment of the disintegrated bearing was found imbedded in the unloaded side of one tooth of the ring gear. The bearing fragment was removed, the damaged tooth dressed, the gearbox reassembled and spin tested again.

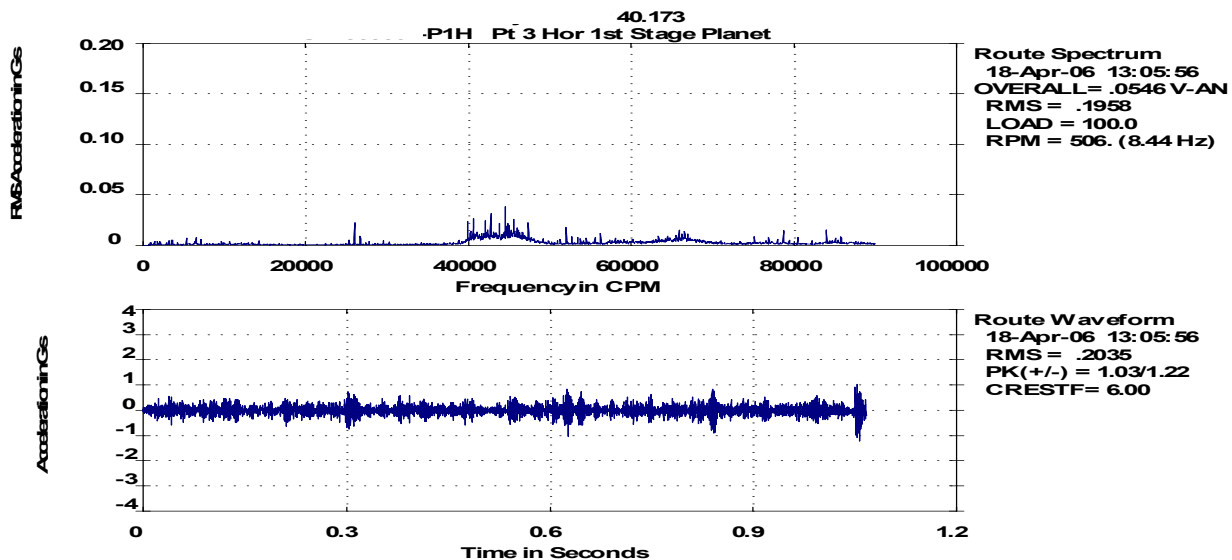
Figure 10. Spectrum And Time Domain Data After Dressing Ring Gear Damaged Tooth.

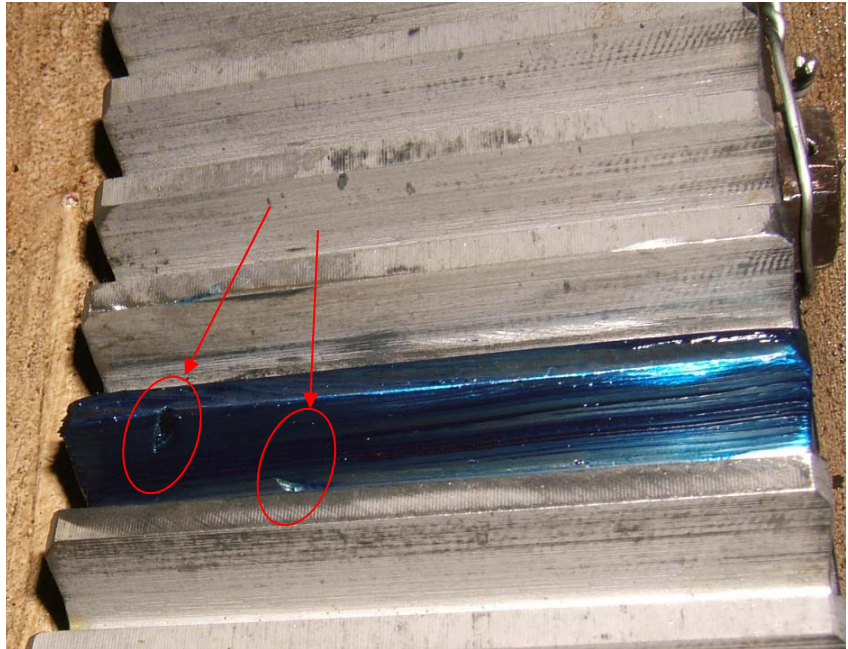
A photo of the damaged ring gear tooth is shown in **Figure 11** after dressing. Indentations can be seen where the tooth material was compressed by the bearing fragments.

**Figure 11. Ring Gear Tooth Afer Removing Brg Fragment & Dressing Raised Metal.**
