# **Fault diagnosis of electric motor by analyzing vibration and current spectrum**

# Case Study : Two Case of fault diagnosis by using MCSA and Vibration at polymer plant

## 1. CASE I. Stator Looseness Trouble Analysis

## 2. CASE II. Bearing Looseness Trouble Analysis

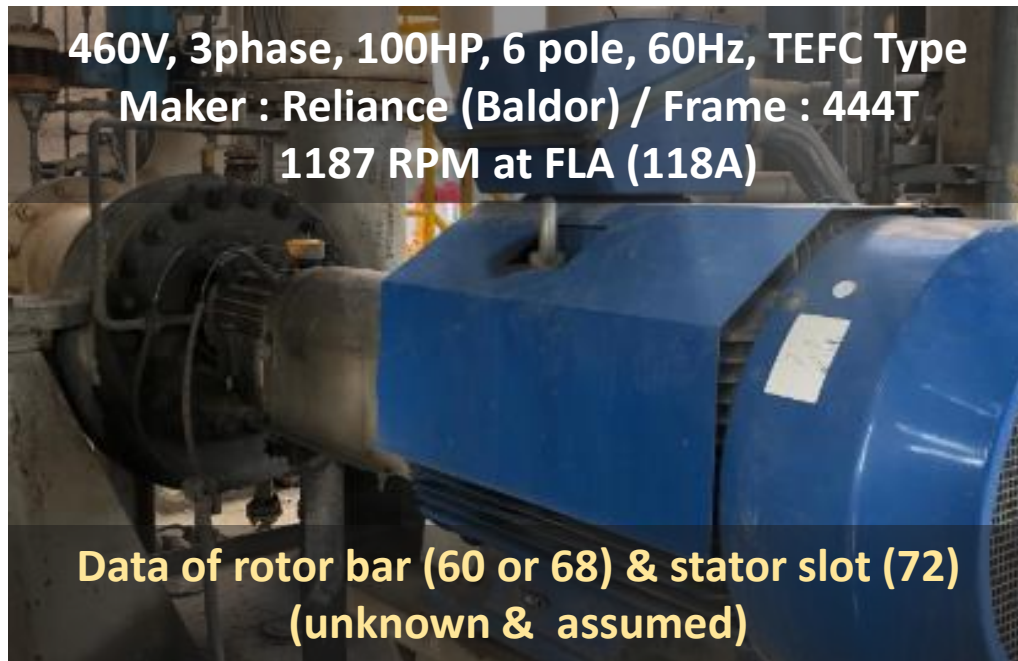
Reactor jacketing pump which located in polymer plant have no stand-by equipment.

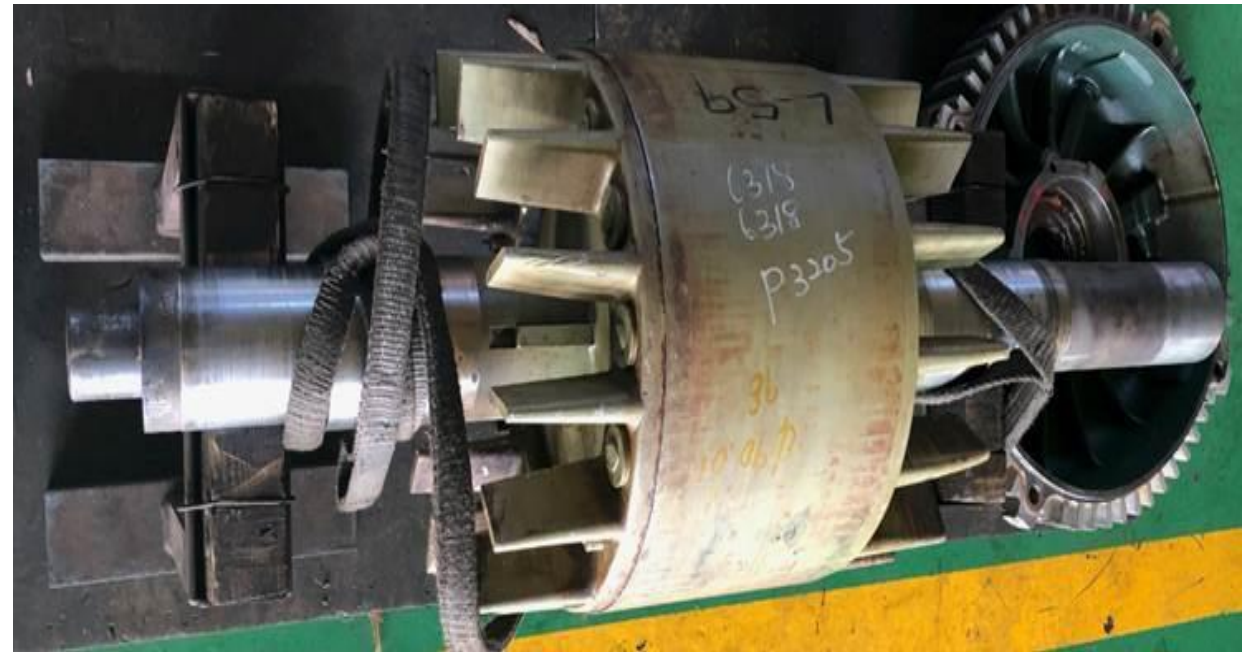
- ✓ *Stator → bad condition : Core lamination is loosen and short*
- ✓ *Rotor → Good condition : made by AL die casting method, very strongly)*

*Also, this is no stand-by item so decided to replaced new motor. After replaced, performed disassembly and detail inspection both stator and rotor of motor.*

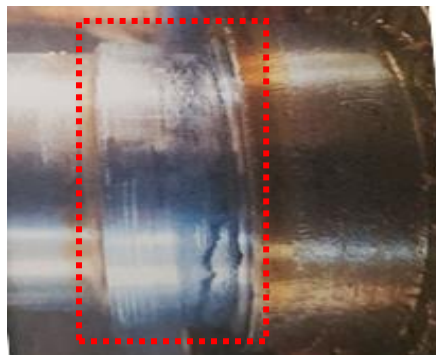
**Shaft Surface Scratch  
(Fan Side)**

Both bearing have poor clearance and shows the scratch (rotation mark) on the shaft surface and bearing housing

After overhaul performed (Shaft surface welding repair / mounting bushing in the bearing housing ) 1X and 2FL dramatically decreased.
