# Large mixer ball bearing defect detection

# Findings, Actions and Outcome

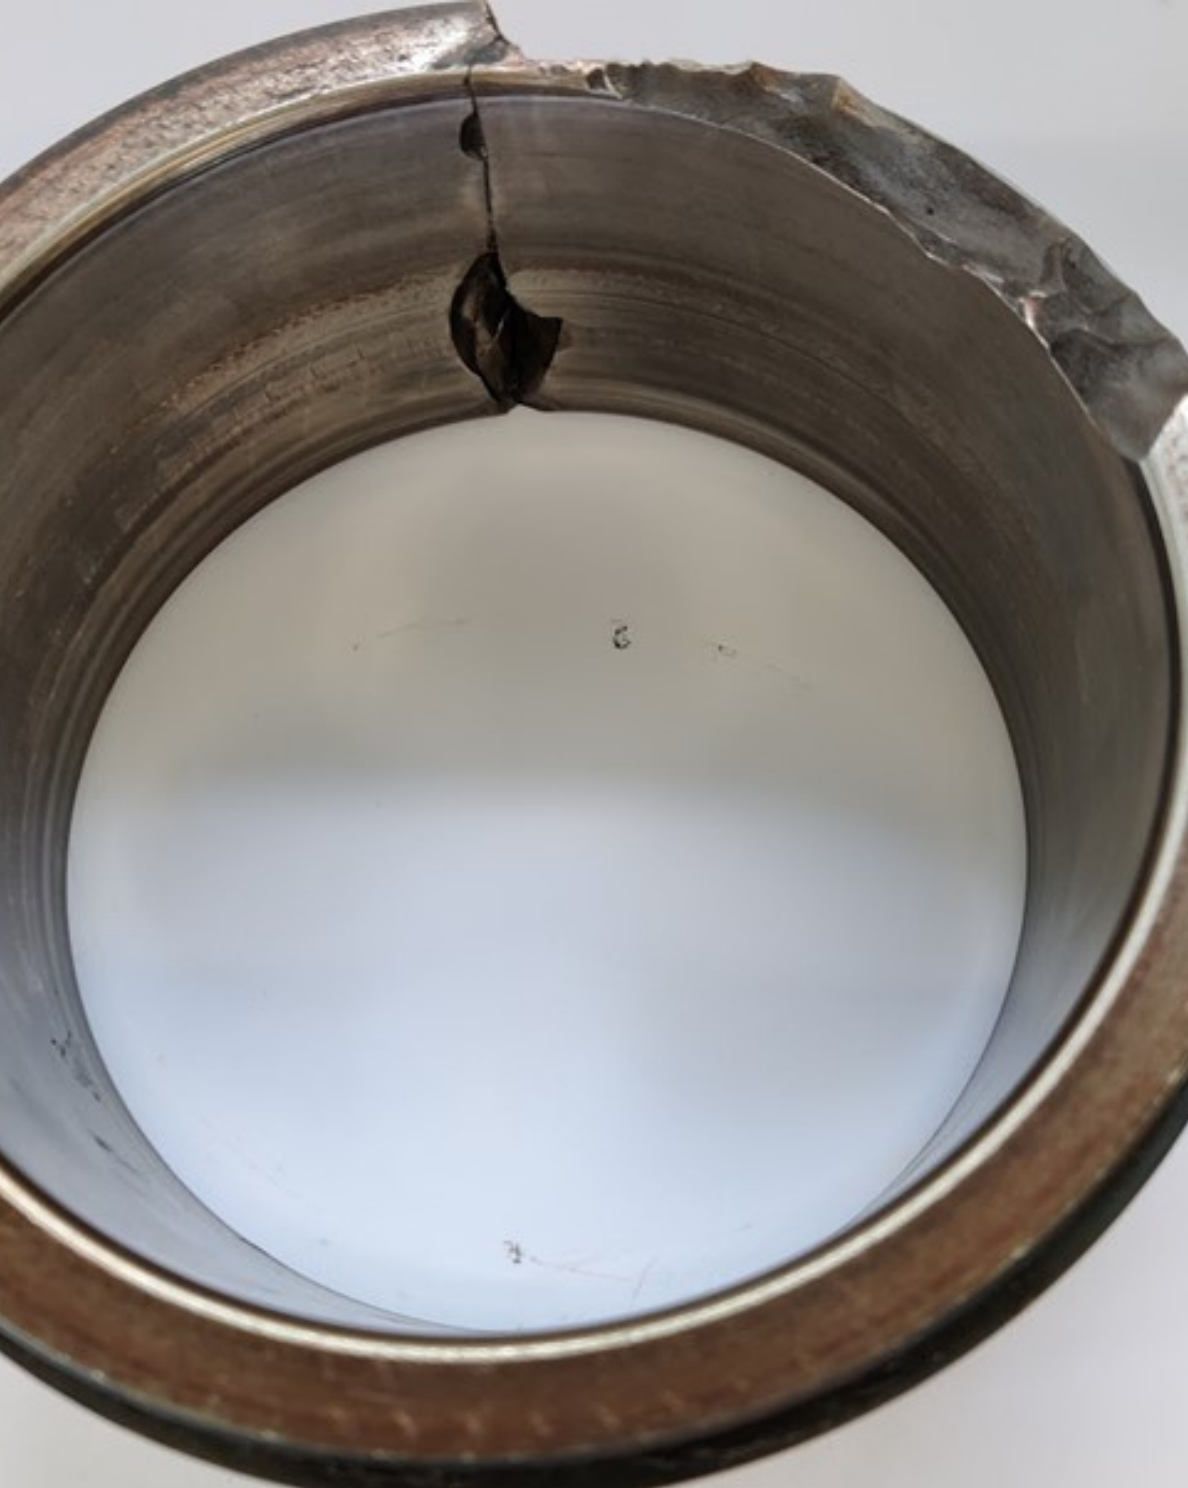
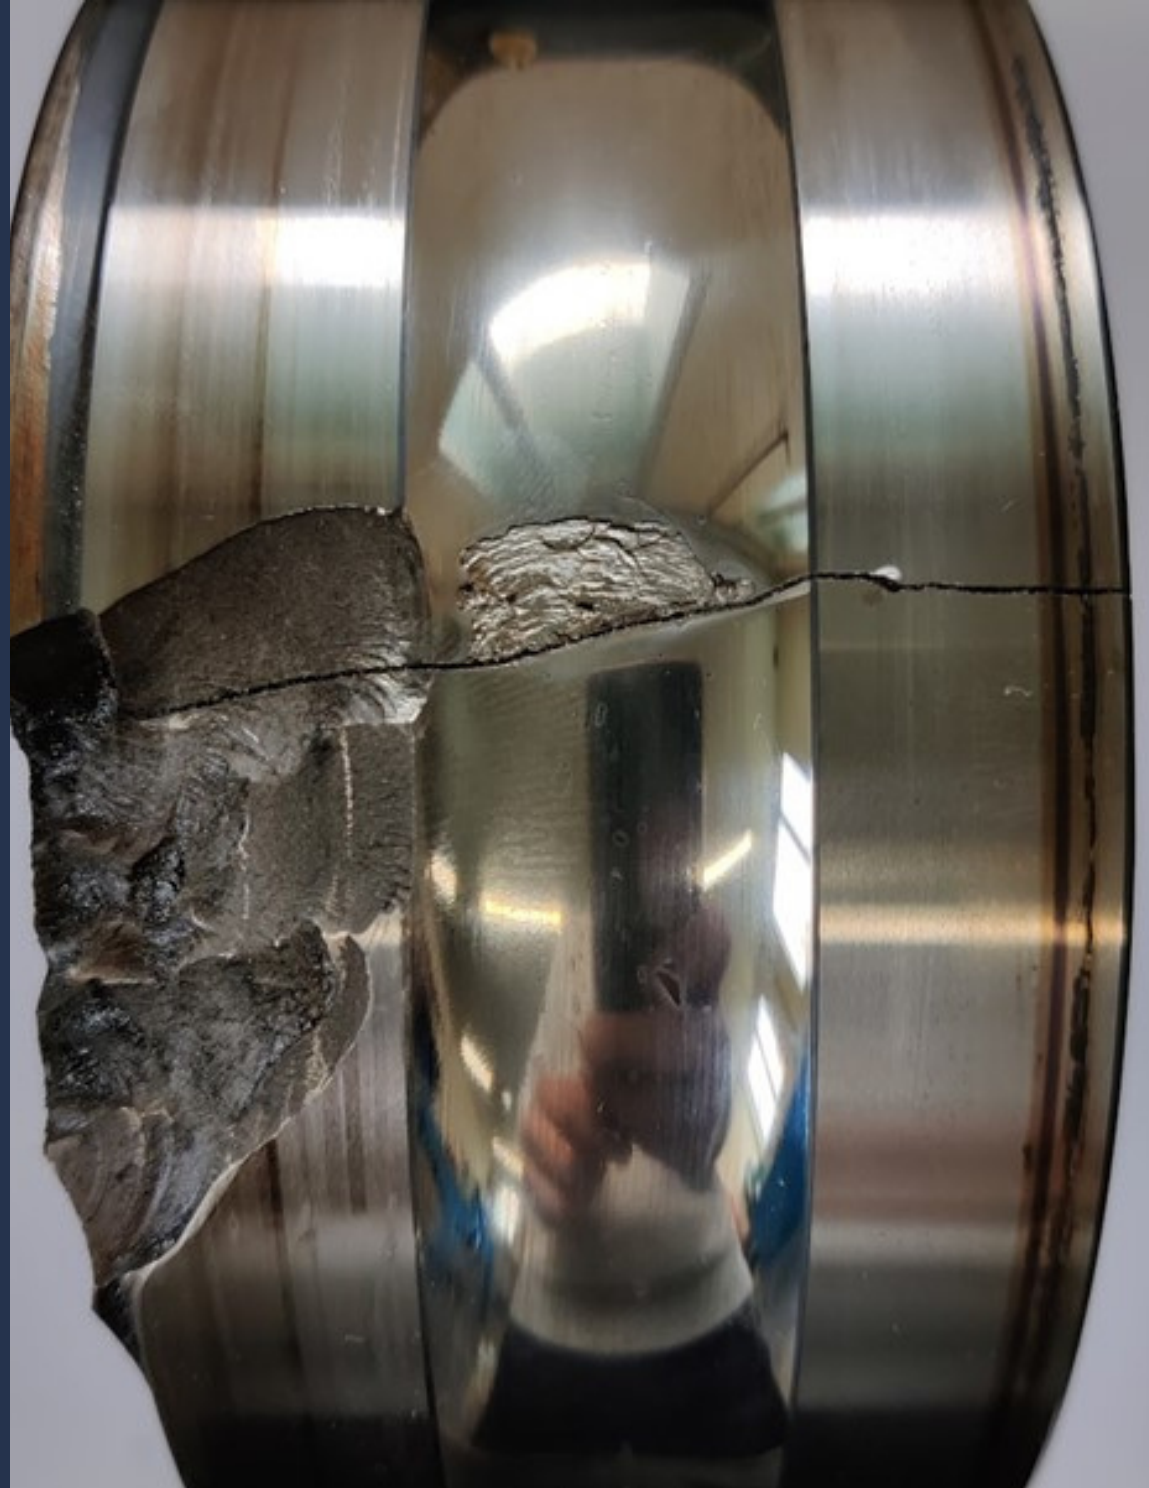
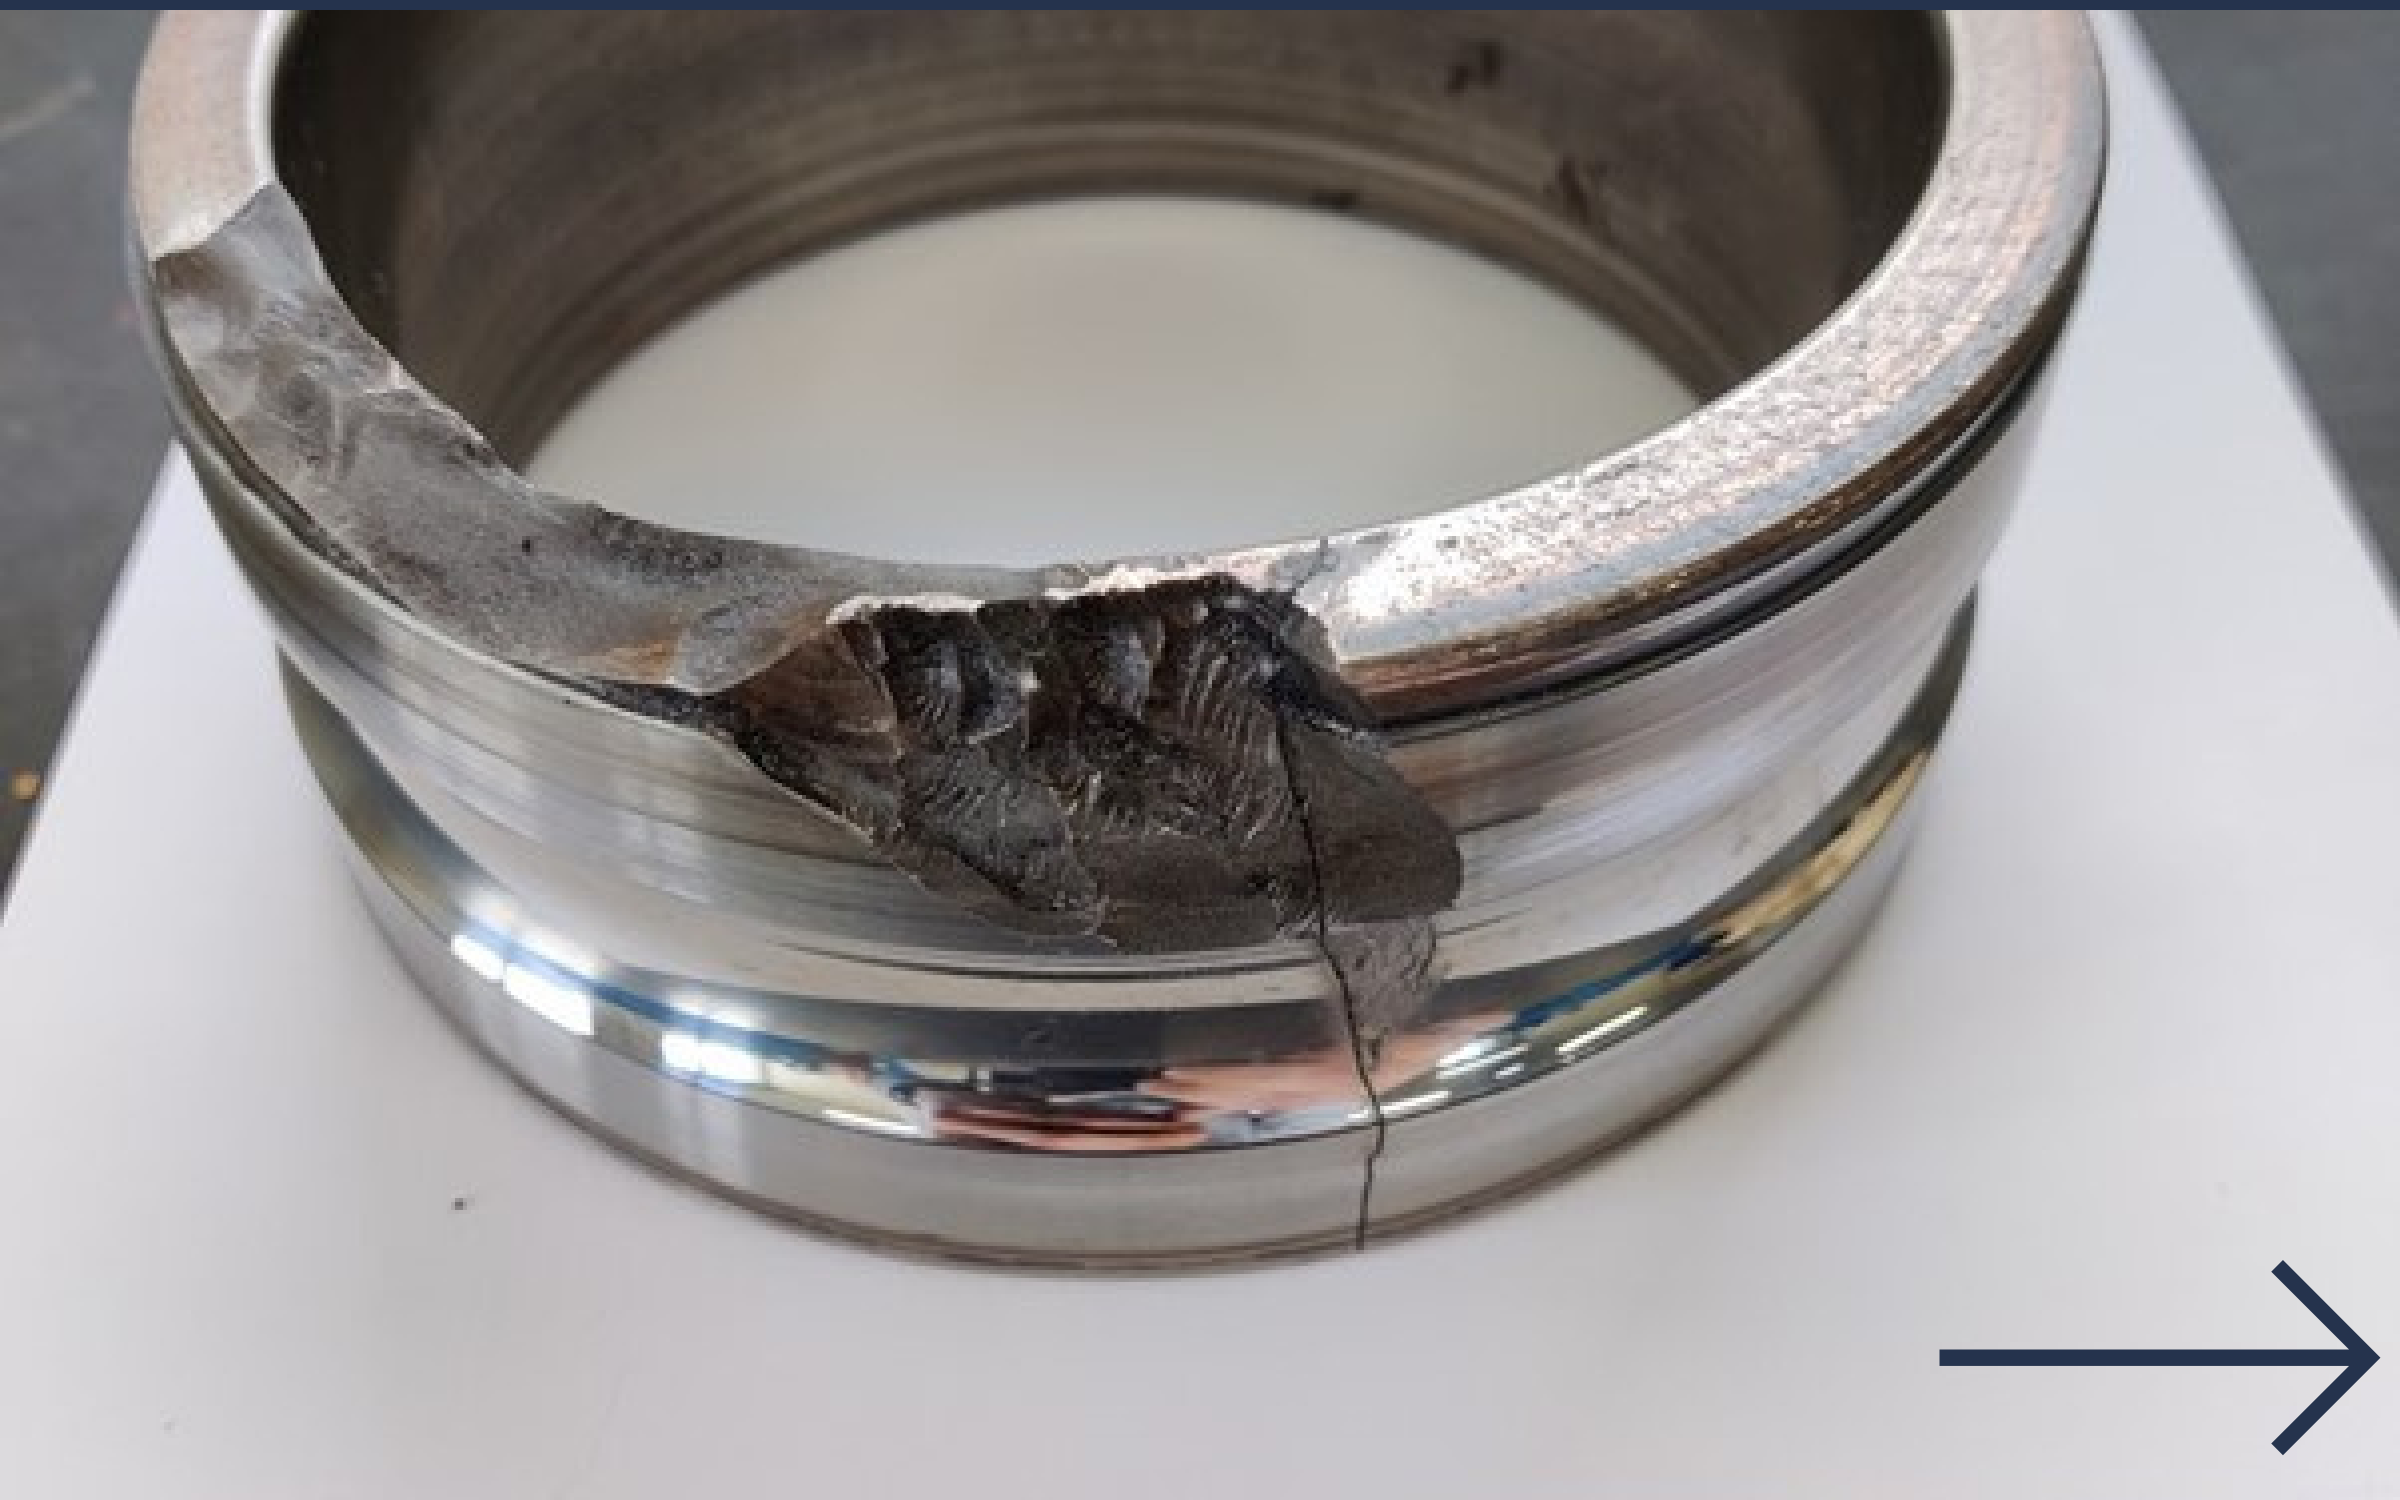
**Well this was  
unusual.....**

- Have you ever seen this elsewhere?
- What caused this failure mode?
- What came first - the fatigue pit, chips or the crack?
