# CHW Pump No.2 Vibration Analysis Case Study Report

# CHW Pump No.2

## ANALYSIS REPORT

| Description | | | |
|---|---|---|---|
| Machine | CHW Pump No.2 | | |

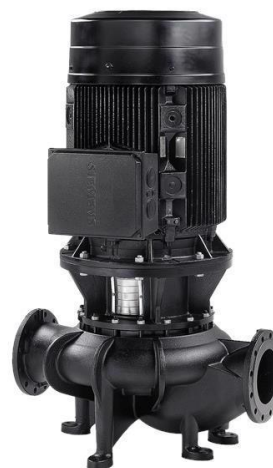
Severe bearing wear on the motor DE bearing with additional wear present on the motor NDE bearing.

The motor DE bearing spectra displayed non-synchronous harmonics of BPFO (Outer Race Defect) at 45.26 hz, and each fundamental BPFO harmonics had sub-synchronous sidebands equating to the FTF bearing defect frequency at 5.65 hz.

The time waveform analysis displayed modulation and impacting with a delta frequency of 45.26 hz equating to BPFO (Outer Race Defect)

Our recommendation would be to ensure a correctly specified VFD-rated motor is installed, examine the motor earth and ensure it is sufficient and correctly earthed or install ceramic/insulated bearings.
