# HYDRAULIC POWER UNIT FAILURES

## 1. Worn Jaw Coupling

## 2. Worn Gear Pump

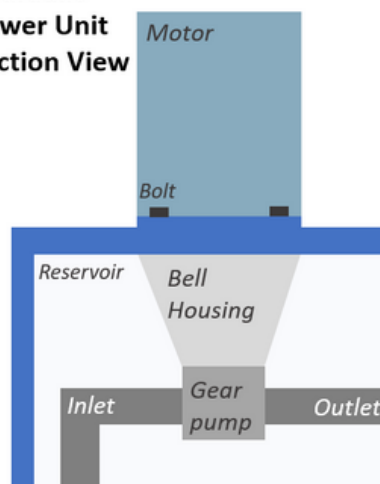
Make sure to place the accelerometer at the correct location. There has to be a direct vibration transmission path to the bell housing and gear pump.

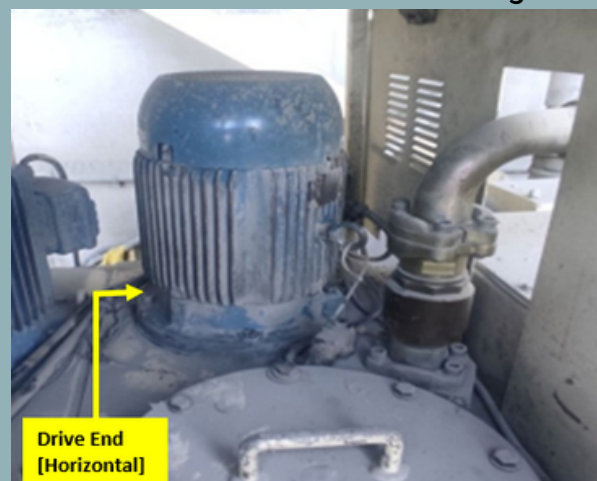
The image on the right shows the motor of the lubrication system of a cone crusher.

The design is fundamentally similar to Figure 2, comprising an electric motor and a gear pump, with the latter inside the reservoir.
