## Case study of Rotor Bar Crack in Cooler Fan (180 KW)

Instrument: CSI 2140.

Software: AMS Machinery Manager

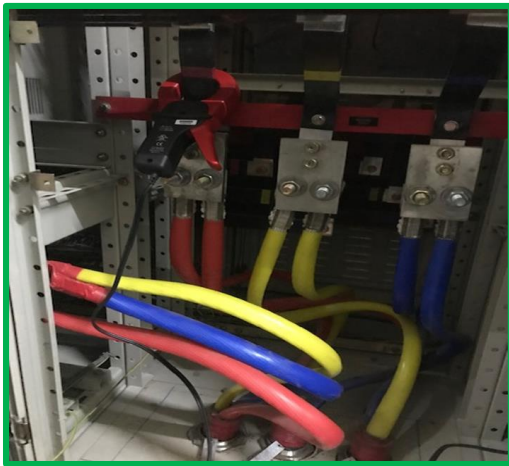
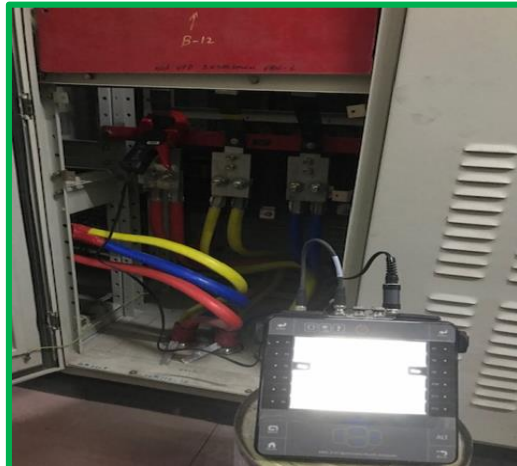
Figure 1&2 conducting MCSA

- Difference in dB level is 23 in MCSA, which is indicating severe rotor bar crack.

Recommendation: In view of the above diagnosis, it is recommended to replace the motor and check the Motor for rotor bars defect.
